Washington Phase II Fish Diversion Screen Evaluations in the Yakima River Basin

**Annual Report
1997**

DOE/BP-00029-5

February 1998

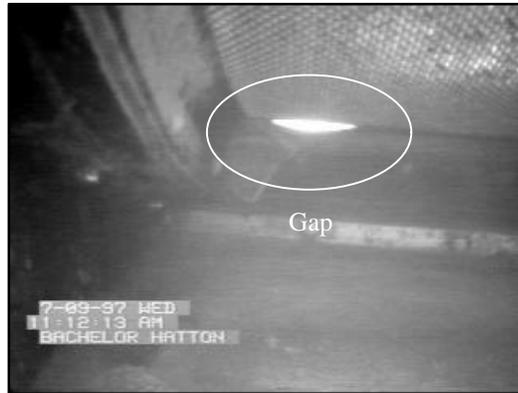
Most of the visible screen seals were in good condition (approximately 83%). Bottom frame seals were sometimes buried in sediment and could not be evaluated. Drum screen seals classified in “good condition” were tight against the screen and not cracked or punctured in any way. Many rubber seals were covered in algae, but this was not considered a defect. Flat plate screen sealant was generally in good condition. Using underwater video, we were able to identify screens with bad seals and bowed drums because gaps appeared as that part of the screen rotated past the bottom seal (Figure 8).

Figure 8. Gap at the Bottom of Screen 4, Bachelor Hatton

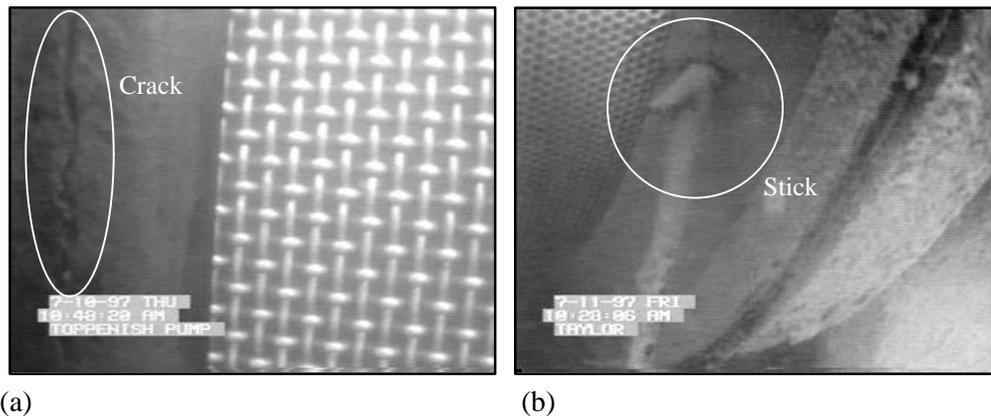
Other seal problems such as potential punctures and cracks were also observed using underwater video (Figure 9).

Figure 9. (a) Stick Possibly Puncturing a Screen Seal at Taylor and (b) What May be a Cracked Seal at Toppenish Pump.

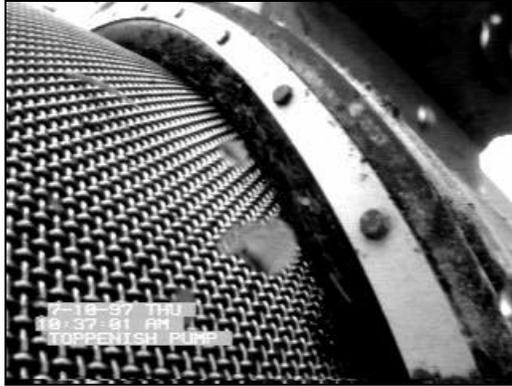
One seal was tucked under the frame (Figure 10), creating a possible pinch point for small fish seeking to get around the drum screen. In this position the seal is relatively loose and it is easy to pass debris or perhaps even a fish between the screen and the seal.

Figure 10. Drum Screen Seal Tucked underneath the Metal Frame at Toppenish Pump

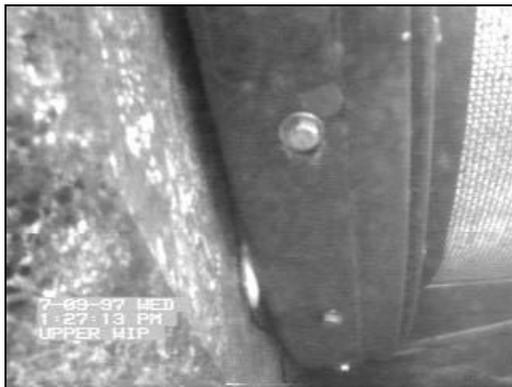
Finally, observations made with underwater video indicated that additional seals might be needed to keep juvenile fish from injuring themselves as they navigate past the screens. Young fish can (and do) squeeze into very small places. The fish shown in Figure 11 was observed wriggling to escape the crack between the drum screen and the concrete wall between screens. However, it was not able to free itself during our observation. The fish was approximately 45 mm fork length.

Figure 11. Fish Wedged between a Drum Screen and Concrete Divider at Upper WIP

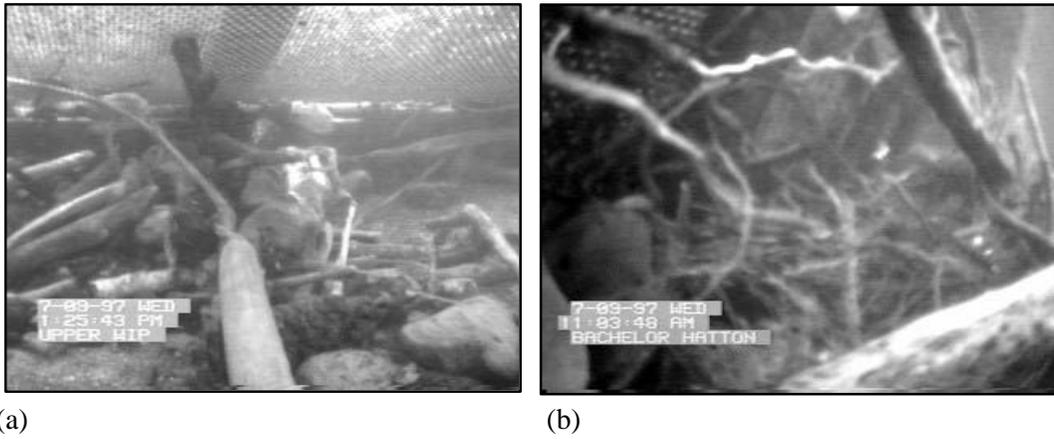
Underwater video allows researchers to monitor and document sediment and debris accumulation in front of a screen. This is important because debris can severely decrease seal life, cause drag on screen motors, and provide cover for predator fish species. Most often, it is impossible to see this debris from above the water's surface. While a pole can be placed in the water to gage the depth of accumulated sediments, one can not determine exactly the kind of debris present and how it is affecting water flow through or past the screen. Figures 12 through 14 depict some of the debris that had accumulated in front of the screen sites evaluated in this study.

Figure 12. Woody Debris at (a) Bachelor Hatton and at (b) Upper WIP

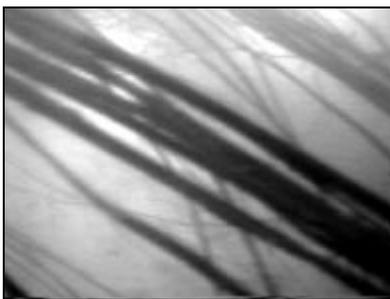
Visual inspections above water indicated that both screens at Snipes Allen had flat spots. Gaps between the screen and bottom seal could not be confirmed, however, because sediments covered the bottom seals. The flat spots were found in the center of the screens near the horizontal seams. More silt was found in front of Screen 1 than Screen 2. Maximum silt depths were 7 inches, observed during the May evaluation. Lesser amounts of silt were noted in subsequent evaluations, but there was still enough to cover the bottom seals in most instances. There was also an abundance of aquatic macrophytes growing in the forebay at Snipes Allen (Figure 43).

Figure 43. Macrophytes in the Forebay at Snipes Allen

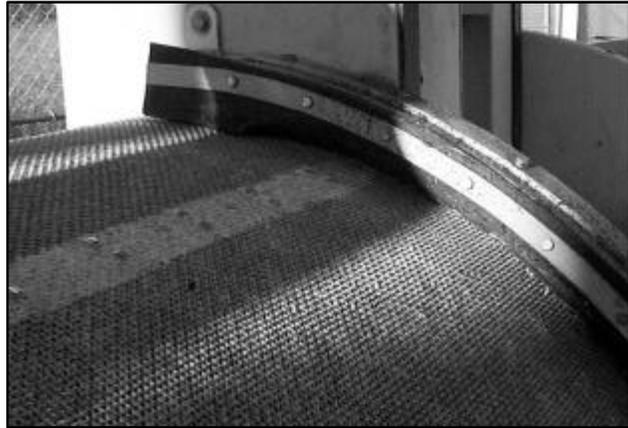
Figure 52. Tucked-under Seal at Toppenish Pump, Screen 2

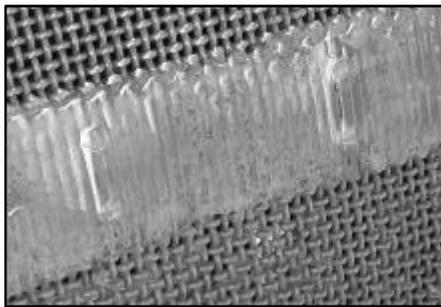
The long center seams of many drums were grooved (Figure 53). It is assumed that the wire mesh is cutting the bottom seal as the drum rotates. This indicated that the seal and screen were flush, however any future shifting may create gaps where a worn bottom seal no longer meets the wire mesh.

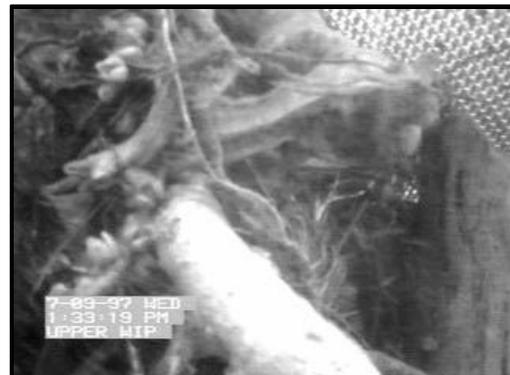
Figure 57. Woody Debris Accumulation at Upper WIP

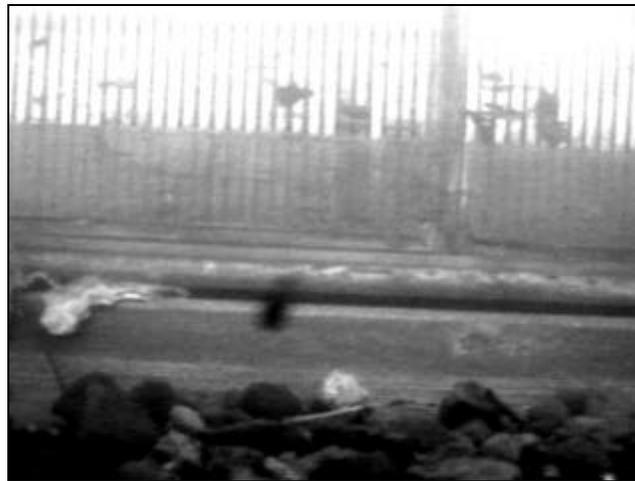
Figure 77. Missing Sealant and Debris Collected on the Screen at Yakima Tieton where the Cleaning Brushes do not Reach. Rocky Substrate Can also be Seen.

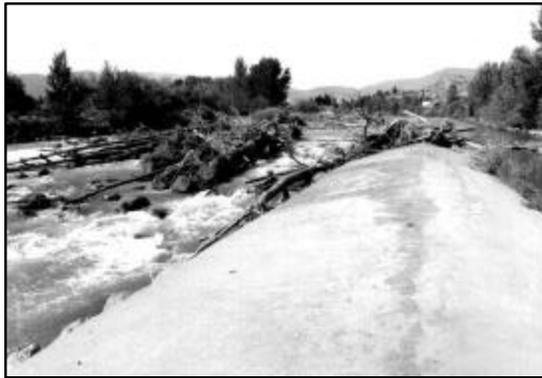
Figure 78. Woody Debris at the Gleed Diversion

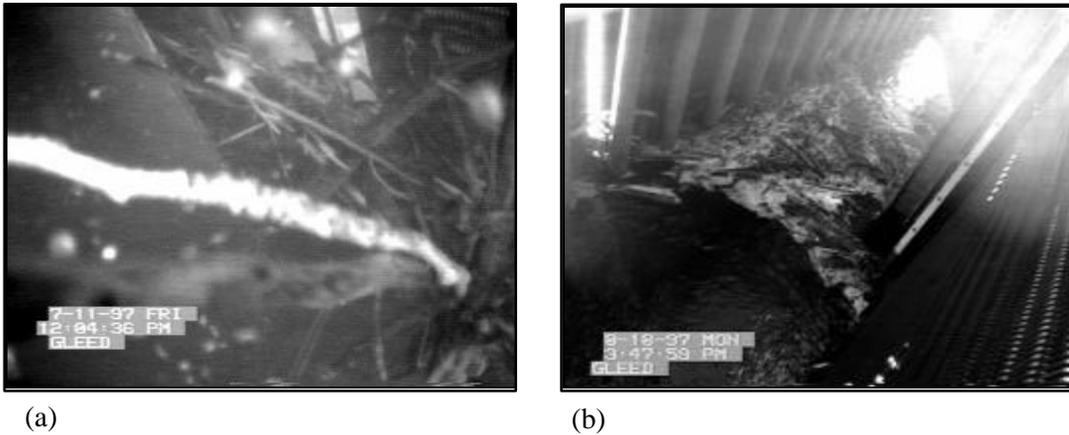
Figure 79. Woody Debris Accumulated in Front of Screen 2, Glead. (a) Underwater view of sticks along the side seal; (b) Above-water view. The bottom of the picture is downstream; the top is upstream.

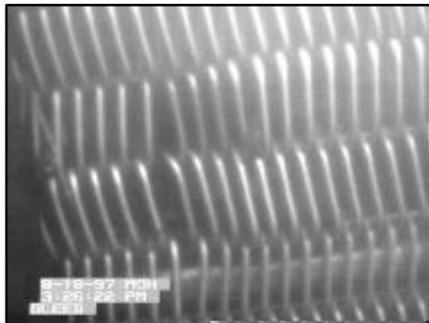
Figure 80. Bent Wires on Screen 4, Glead
