**WASHINGTON PHASE II FISH DIVERSION
SCREEN EVALUATIONS IN THE
YAKIMA RIVER BASIN, 1999**

DOE/BP-00000652-4

Washington Phase II Fish Diversion Screen Evaluations in the Yakima River Basin, 1999

Pacific Northwest National Laboratory
Richland, Washington

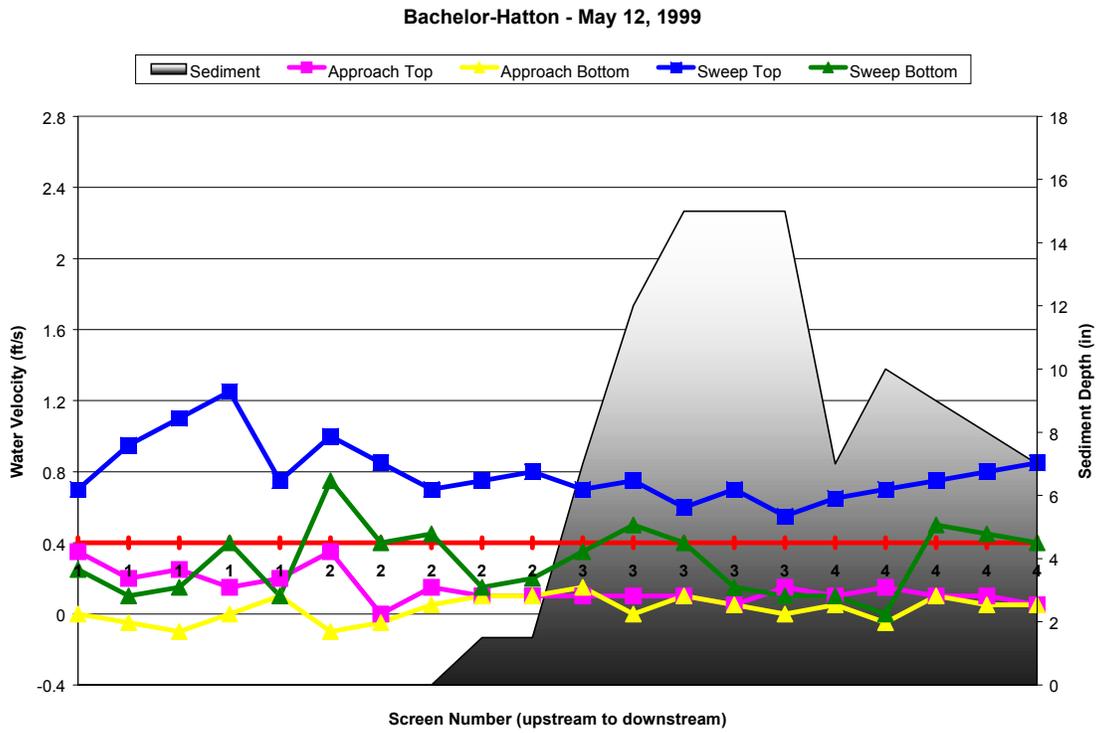
The Bachelor Hatton site was evaluated 5/12/99 and 7/15/99. The major hydraulic problems that were observed at this site in 1998 were not present in 1999. Approach velocities were always within the NMFS criteria for the first time in the 3 years this site has been evaluated (Figure 4 and Figure 5). Sediment deposits in the forebay were up to 15 in. deep during the May 12 evaluation, and were about half that on the July 7 evaluation.

Figure 4. Water velocities and sediment depths at Bachelor Hatton, 5/12/99.

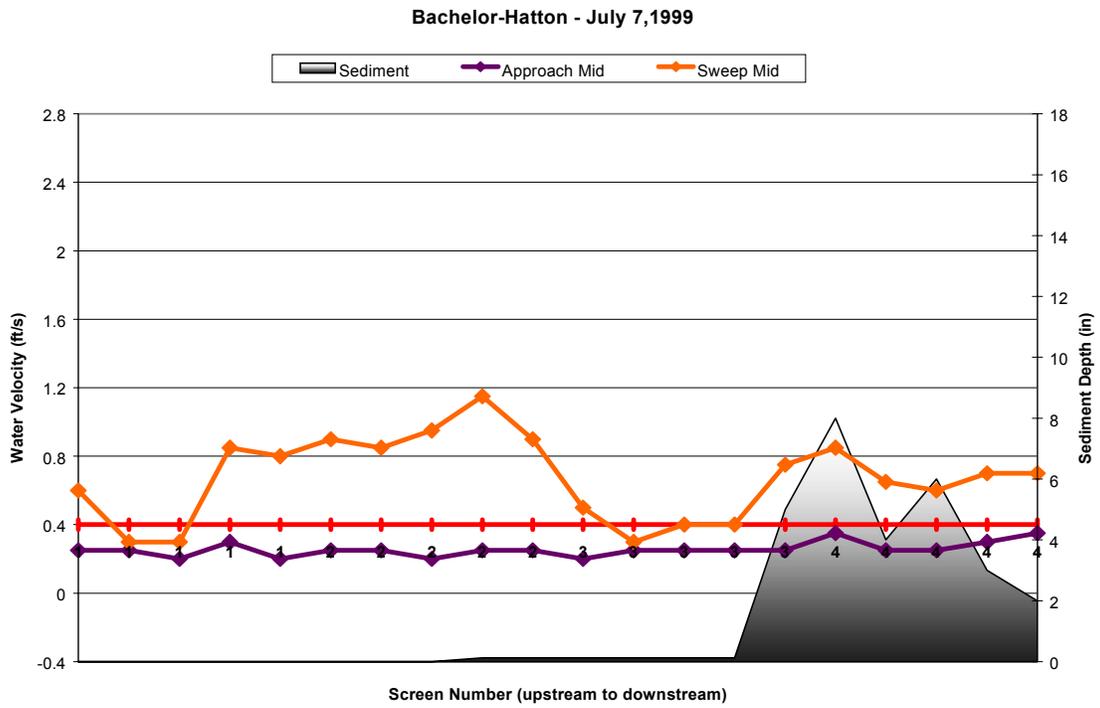
Figure 5. Water velocities and sediment depths at Bachelor Hatton, 7/7/99.

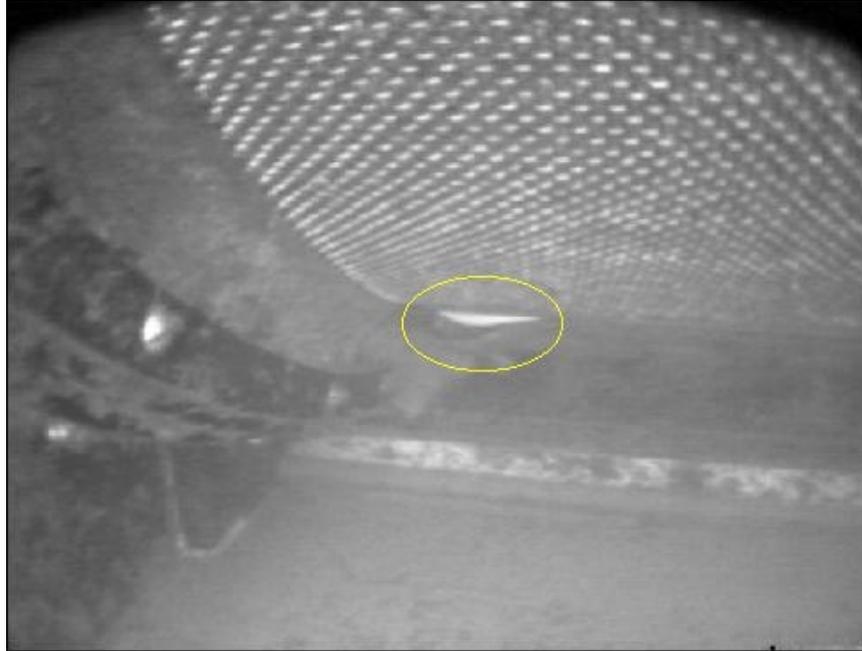
A gap was observed in the rubber seal under screen 2 on May 12 (Figure 6).

Figure 6. Gap in bottom seal of screen number 2 at Bachelor Hatton, 5/12/99.

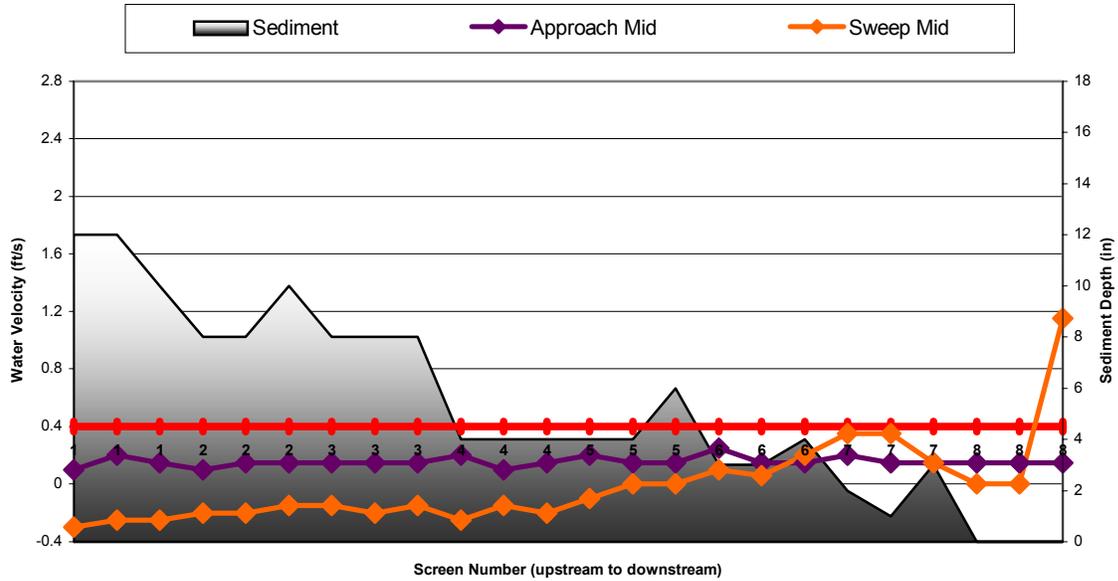
The site was evaluated 5/20/99 and 7/22/99. The approach velocities measured at New Cascade in July 1999 were below the ≤ 0.4 fps NMFS criteria. However, sweep velocities were a problem on that July survey. Sweep velocities were generally lower than approach velocities until the very end of the last drum near the bypass (Figure 17).

Figure 17. Water velocities and sediment depths at New Cascade, 7/22/99.

There appeared to be an inverse relationship between sediment depth and sweep velocity. Sediment depth at the upstream end of the screens appeared to have been interfering with the operation of screen 1. Screen 1 was not operating and was coated in algae and diatoms. Screen submergence was slightly high, 89% in May and 85% in July. Mean bypass velocities exceeded mean sweep velocities; however, many sweep velocities were negative. The screen material and seal condition looked generally good, with the exception of Screen 8, which had a worn-looking seal along the top. Water always flowed freely over the bypass weir and provided plenty of opportunity for fish passage. Outfall conditions for fish were always within NMFS criteria.

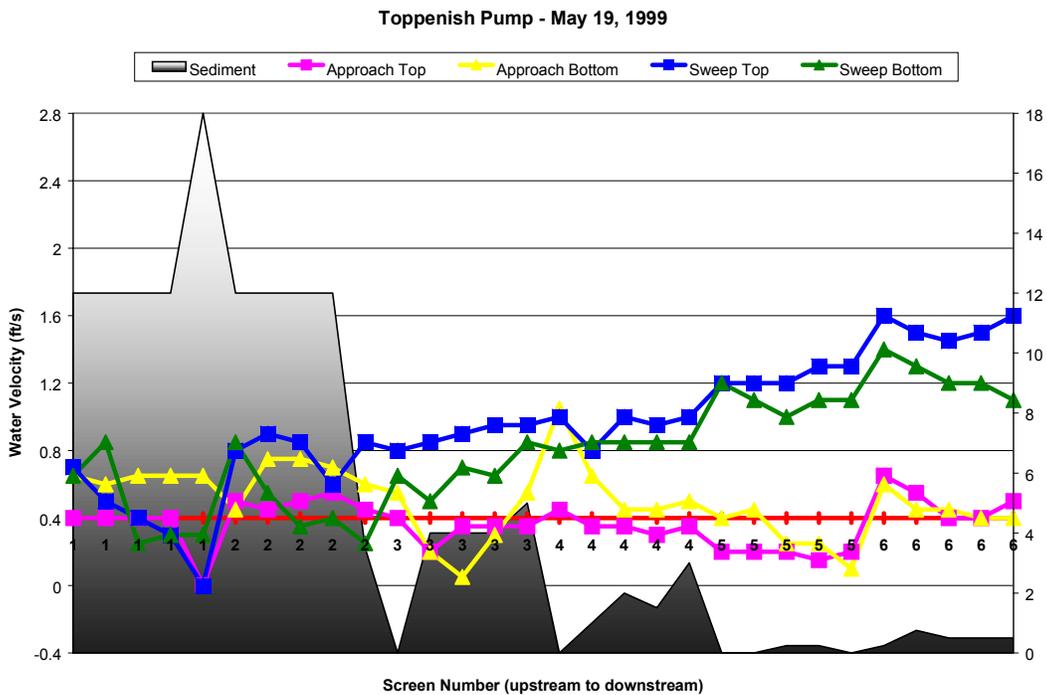
This site was evaluated 5/19/99 and 7/22/99. About one-quarter of the approach velocities measured at this site in 1999 were higher than the NMFS allowed (Figure 22 and Figure 23). This was actually an 'improvement' from 1998, when 60% of approach velocities were > 0.4 fps. Sweep velocities were generally greater than approach velocities and increased toward the bypass. Mean bypass velocities exceeded mean sweep velocities by a large margin. Screen submergence was approximately 81 and 80% on the May and July sample dates, respectively.

Figure 22. Water velocities and sediment depths at Toppenish Pump, 5/19/99.

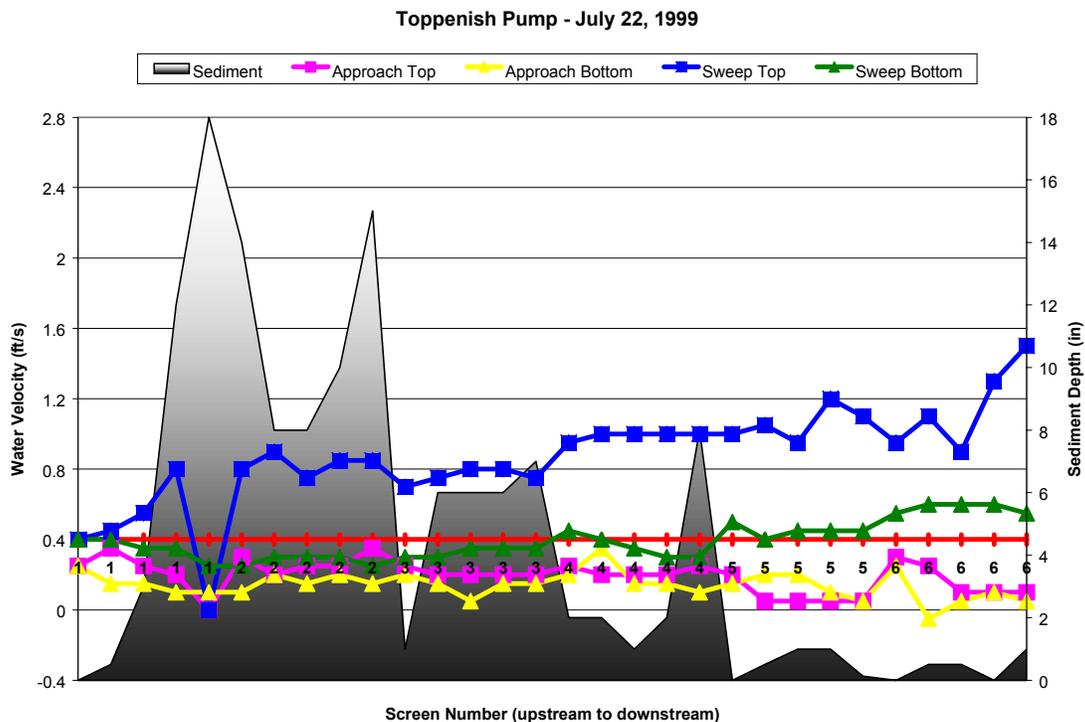
Figure 23. Water velocities and sediment depths at Toppenish Pump, 7/22/99.

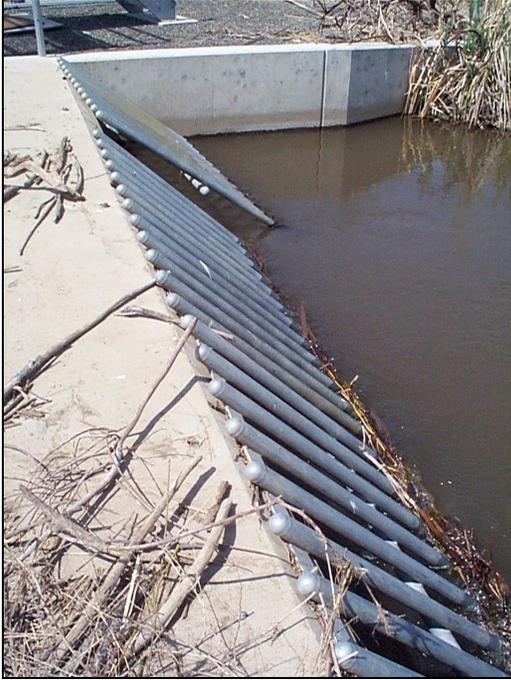
Figure 24. Trash rack at Toppenish Pump site, note separation of metal grate and concrete.

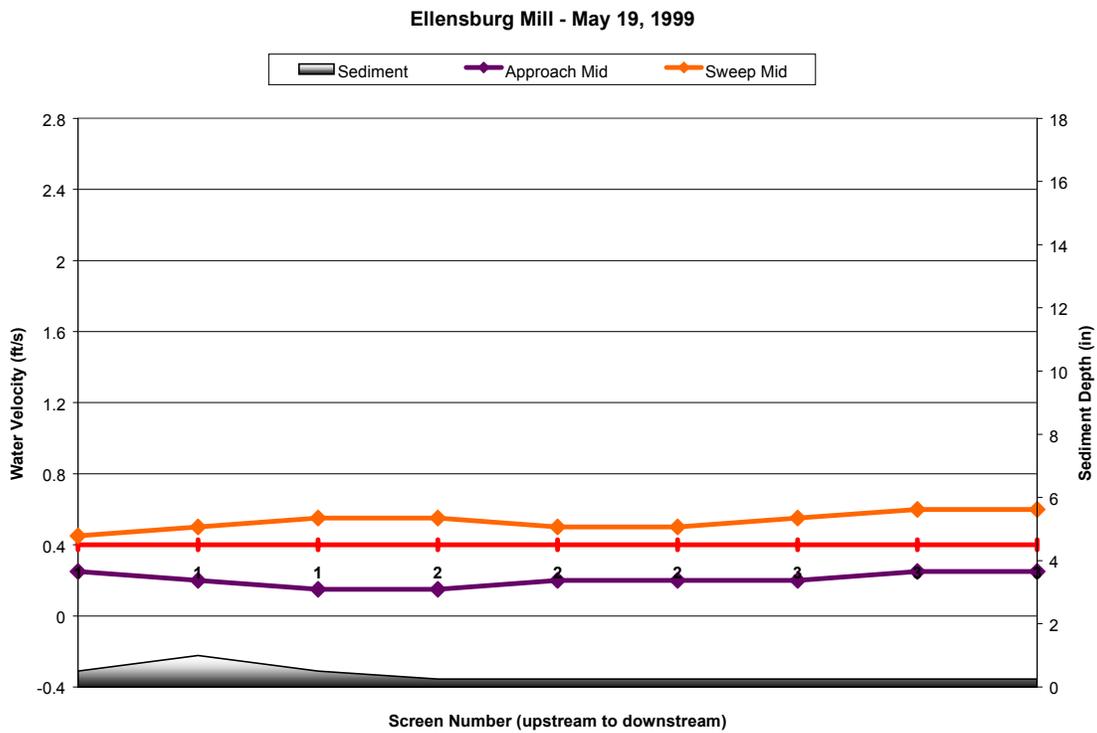
The Ellensburg Mill site was evaluated 5/19/99 and 7/23/99. In May, approach velocities did not exceed sweep velocities (Figure 29). When we measured top and bottom velocities separately in July, we found that top velocities were much faster than bottom velocities (Figure 30). When all approach velocities are considered, 33% were greater than 0.4 fps. In most other cases, sweep velocities exceeded their corresponding approach velocities. However, sweep did not generally increase near the bypass, and mean bypass velocities were lower than mean sweep velocities. This flat plate screen does not appear to have any submergence problems as measured submergence values were only 25 and 34% during the 1999 evaluations.

Figure 29. Water velocities and sediment depths at Ellensburg Mill, 5/19/99.

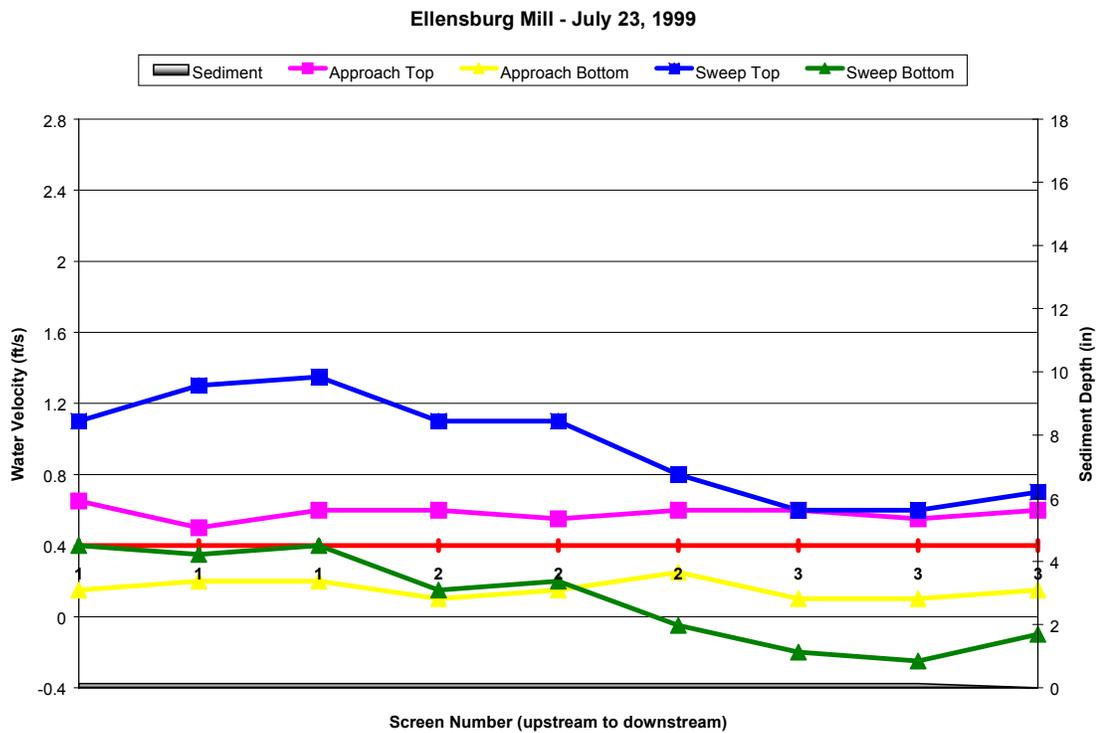
Figure 30. Water velocities and sediment depths at Ellensburg Mill, 7/23/99.

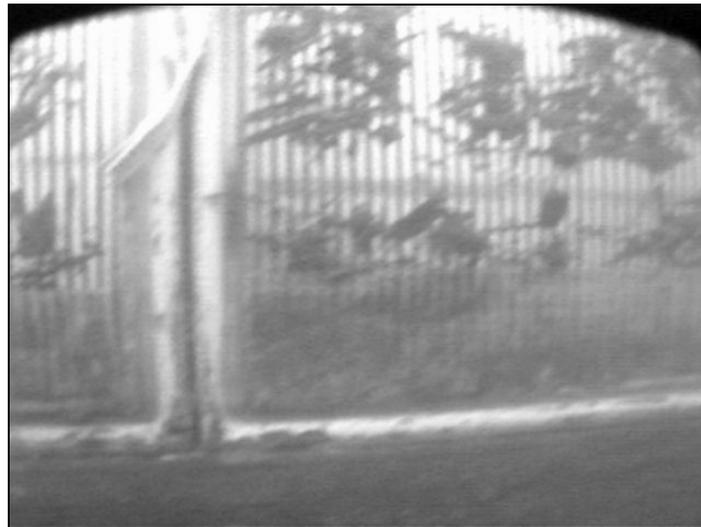
The screens were in good condition. Screen seals were in poor condition (Figure 37). On screen 3 the side seal caulking was cracking and the bottom corner was failing. On Screens 4 and 5, the bottom seal was coming out, and the side seal was cracking. On Screen 6, 6 in. of the side caulking was missing, and 1 in. was cracked. On Screens 7, 8, and 10, the bottom seal was missing, and the sides were cracking. On screens 9, 11, and 12, the bottom seals were missing or loose. Water was flowing over the bypass weir so fast in May that it hit the wall and rushed back towards the weir. Water flowed freely behind the weir in July. Outfall conditions were good for fish passage. Although there was never excessive sand, silt, or woody debris, there was a lot of leaf litter and small twigs that accumulated on the screens between brushings, especially in May. Generally, silt accumulated along the downstream half of the screen, though it was rarely greater than 4 in. deep.

Figure 37. Loose/missing caulking on Yakima-Tieton screens, 7/21/99.

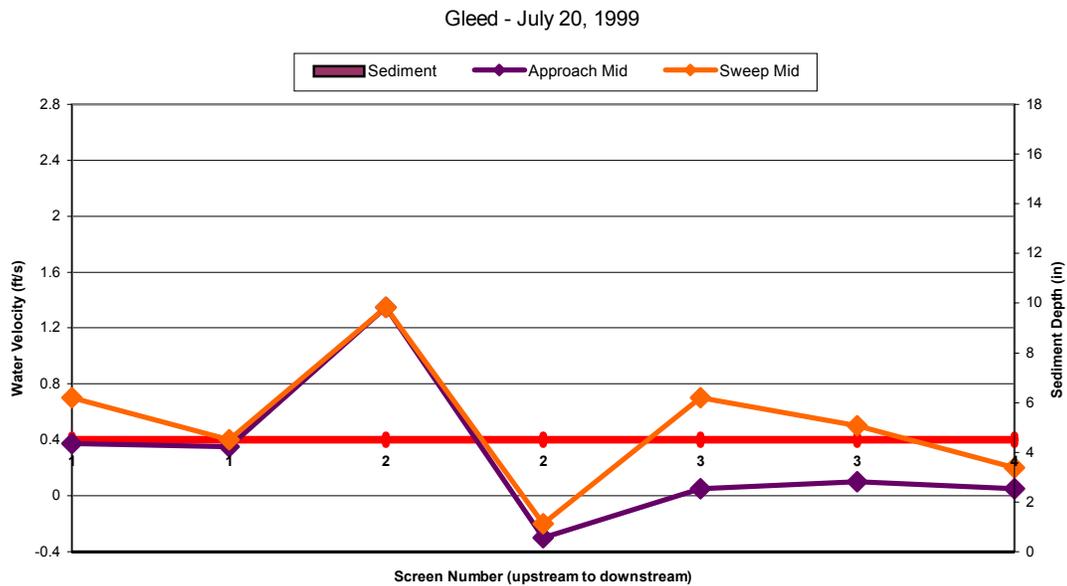
The Gleed site was evaluated 5/14/99 and 7/20/99. Electrical interference again prevented us from collecting much water velocity data. The velocity data we were able to collect (Figure 40) was limited, but showed some high approach velocities.

Figure 40. Water velocities and sediment depths at Gleed, 7/20/99.
