YAKIMA RIVER BASIN PHASE II FISH SCREEN EVALUATIONS

Annual Report 2001

DOE/BP-00000652-8

Yakima River Basin Phase II Fish Screen Evaluations, 2001

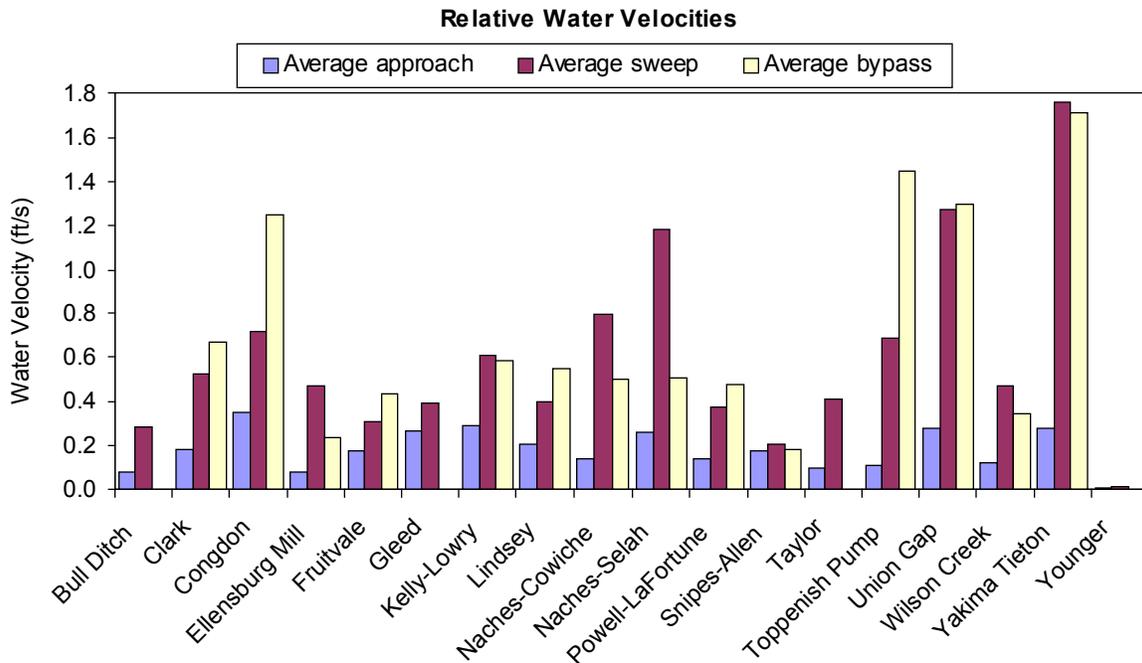
Figure 3. Mean Approach, Sweep, and Bypass Velocities at Phase II Fish Screen Facilities in the Yakima River Basin in 2001

Overall, 97% of all approach velocity measurements met the NMFS approach criteria of ≤ 0.4 ft/s (versus the 90% reported in 2000). However, the data from this year are an average of September’s data only (except, see Table 1), which may not provide an accurate representation of the velocity conditions that were present earlier in the year. Areas of the screen (i.e., top, bottom, upstream, downstream) that exceeded these criteria were dependent on factors at the individual sites.

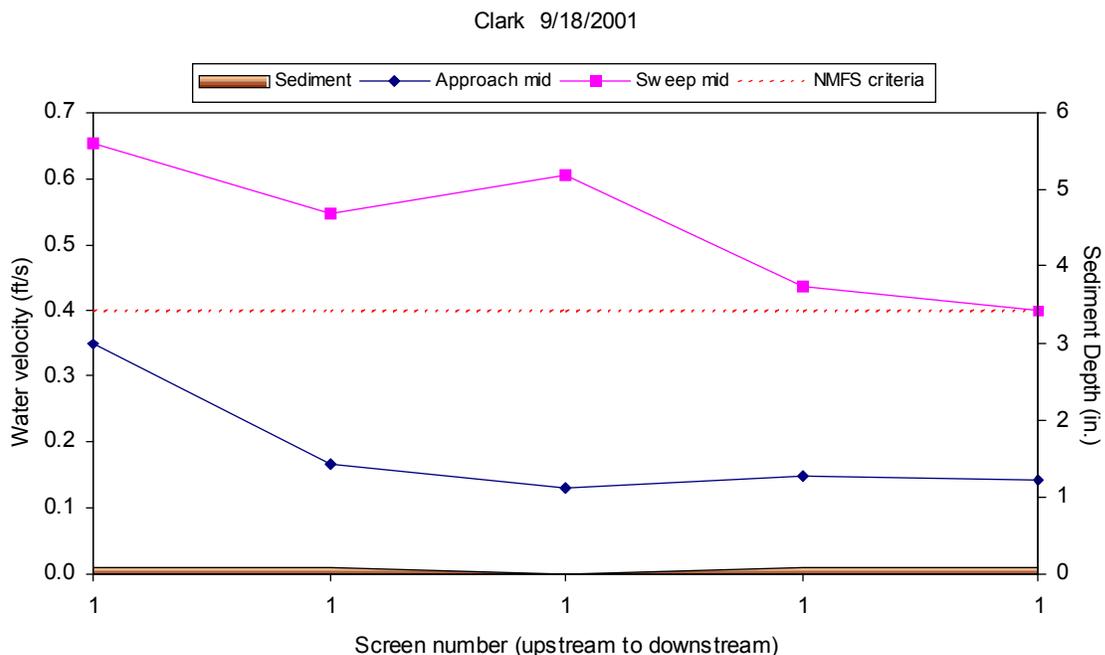
The Clark screening facility was visited on 5/17/2001, 6/21/2001, 9/18/2001, and 9/25/2001. The water velocity was measured with the ADV using an improper calibration file in May and June; consequently, only velocity data from September are presented. In September water velocities at this site complied with NMFS criteria. All approach values were less than 0.4 ft/s and sweep velocities were always higher than approach velocities (Figure 4). The water velocity in the bypass was greater than the average sweep, which created a clear trajectory toward the bypass, and should help expedite fish movement through the site.

Figure 4. Water Velocities and Sediment Depths at Clark, 9/18/2001

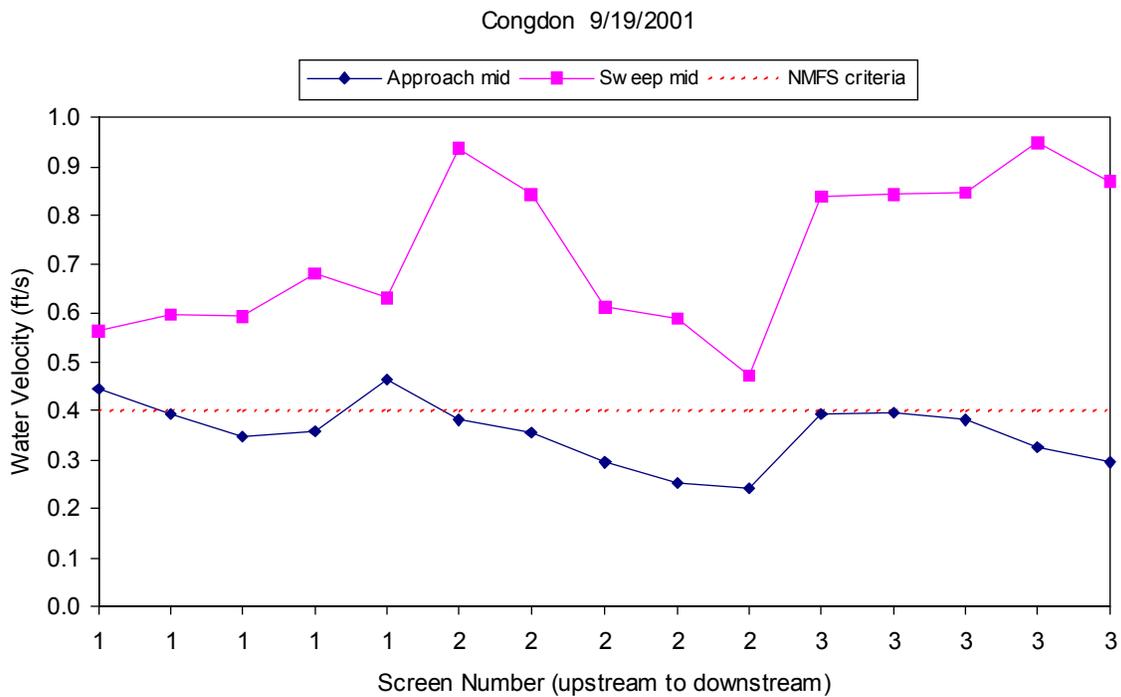
The Congdon facility was evaluated on 5/17/2001, 6/22/2001, and 9/19/2001. The water velocity was measured with the ADV using an improper calibration file in May and June; consequently, only velocity data from September are presented. Thirteen percent of measured approach velocities exceeded NMFS criteria in September (Figure 5). Sweeps were always higher than approaches, and the velocity in the bypass was higher still, creating a clear trajectory towards the bypass in September.

Figure 5. Water Velocities at Congdon, 9/19/2001

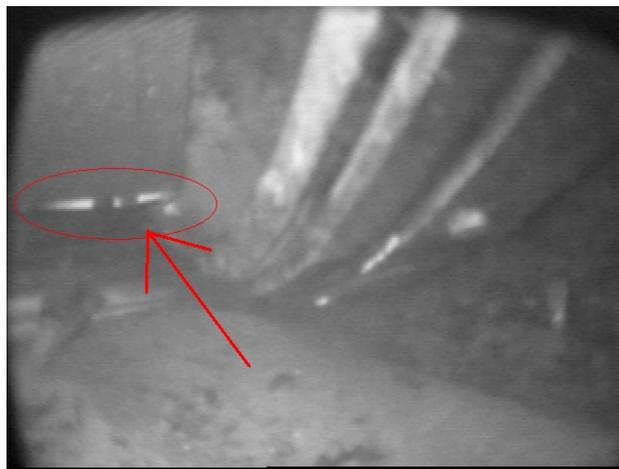
The screen seals appeared to be in good condition, although a gap was noted in May in the downstream corner of screen 2 (Figure 6). In May water flowed smoothly over the weir, though the water depth at the outfall was only 6 in. in the pipe and 3 in. over the concrete apron. Some small fish were noted in the forebay in June and September, though the water level was below the rubber seals on the screens and they could not get through the bypass.

Figure 6. Gap in the Downstream Seal of Screen 2 at John Cox in May

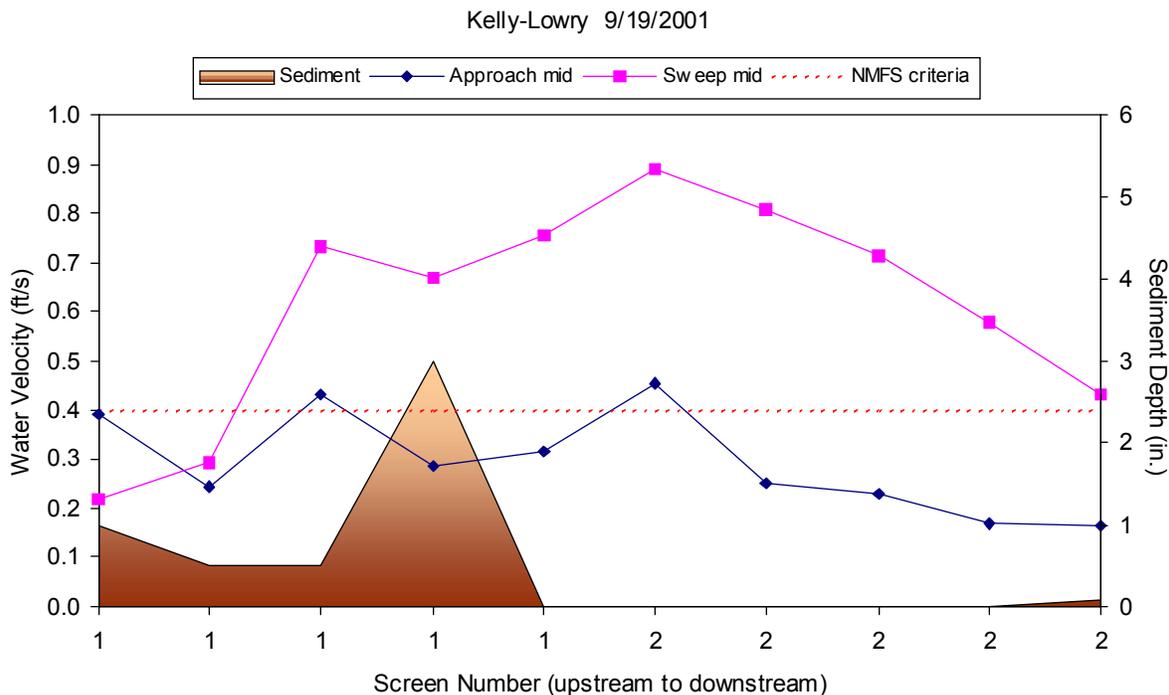
The Kelly-Lowry site was evaluated on 5/11/2001, 6/21/2001, and 9/19/2001. The water velocity was measured with the ADV using an improper calibration file in May and June, so only velocity data from September are presented. Eighty percent of approach velocities met NMFS criteria in September (Figure 7). Sweep was generally higher than approach, though sweep did not increase toward the bypass, and the bypass velocity was slower than the average sweep.

Figure 7. Water Velocities and Sediment Depths at Kelly-Lowry, 9/19/2001

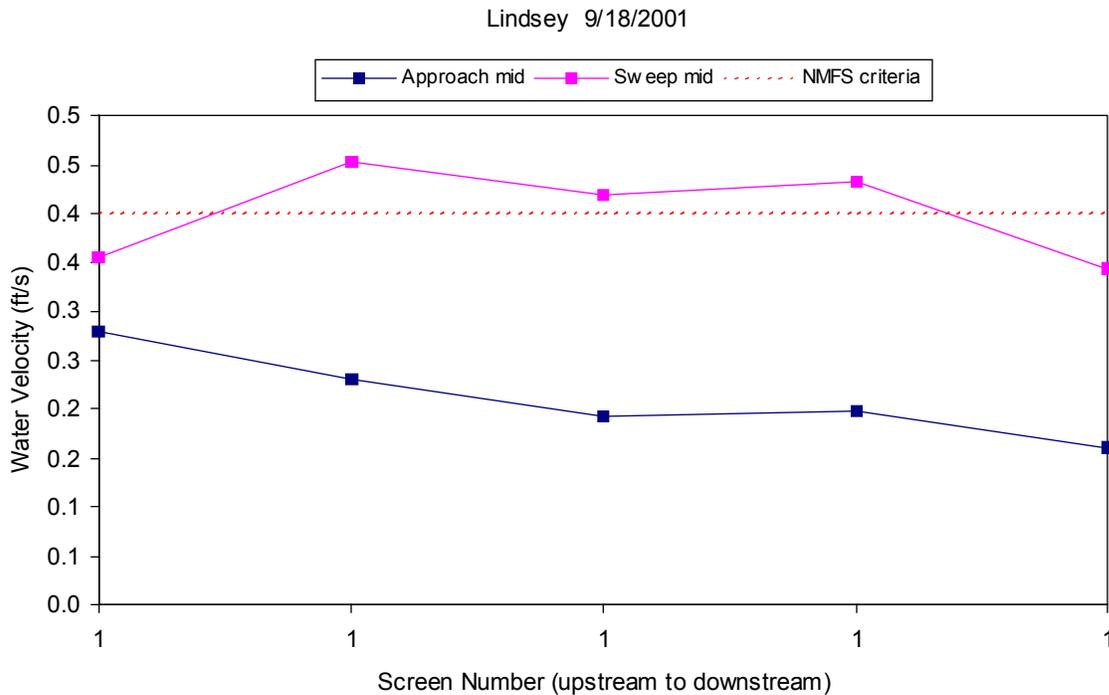
The Lindsey site was evaluated on 5/16/2001, 6/21/2001, and 9/18/2001. The water velocity was measured with the ADV using an improper calibration file in May and June, so velocity data from those months are not presented here. In September, all approach values met NMFS criteria (Figure 8). All sweeps were greater than approaches, and the bypass velocity was greater than the average sweep. Sweep did not increase toward the bypass.

Figure 8. Water Velocities at Lindsey, 9/18/2001

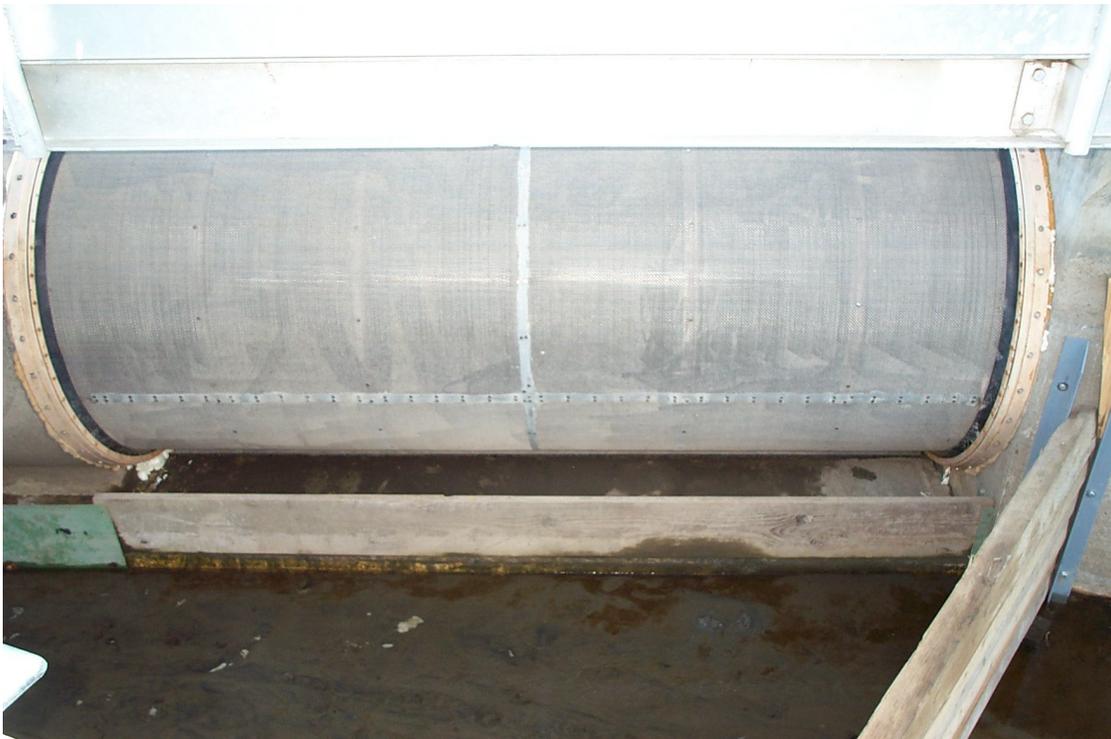
Figure 10. Screen 1 at Naches-Cowiche, with Stoplogs in Front of the Screen (parallel) and Upstream of the Screen Bays (perpendicular to the direction of water flow)

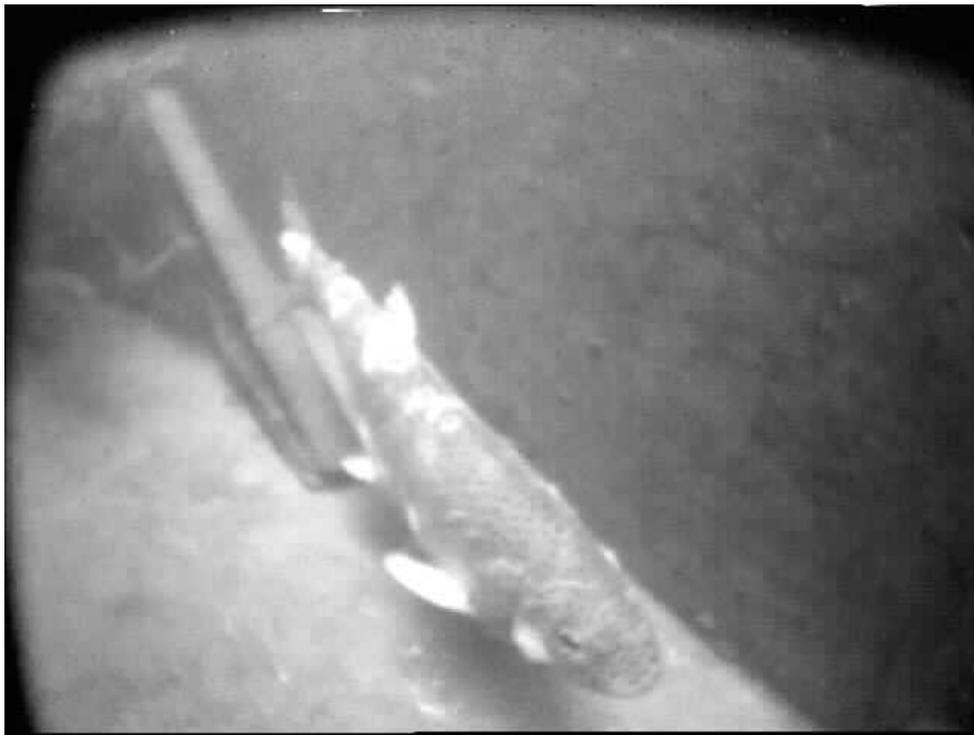
Many fish were seen both in the forebay and in the aftbay of the canal during all surveys, including some large trout in September. Steelhead kelts were observed near the bypass ramp at this site on 5/15 (Figure 11). The ramp was up, but the flush gate was closed. The WDFW determined that this configuration discouraged the kelts from moving through the bypass. The WDFW decided to keep the ramps down during the migration period and to paint them a dark color to encourage fish movement through the bypass.

Figure 11. Steelhead Kelt in the Screen Forebay at New Cascade on May 15, 2001

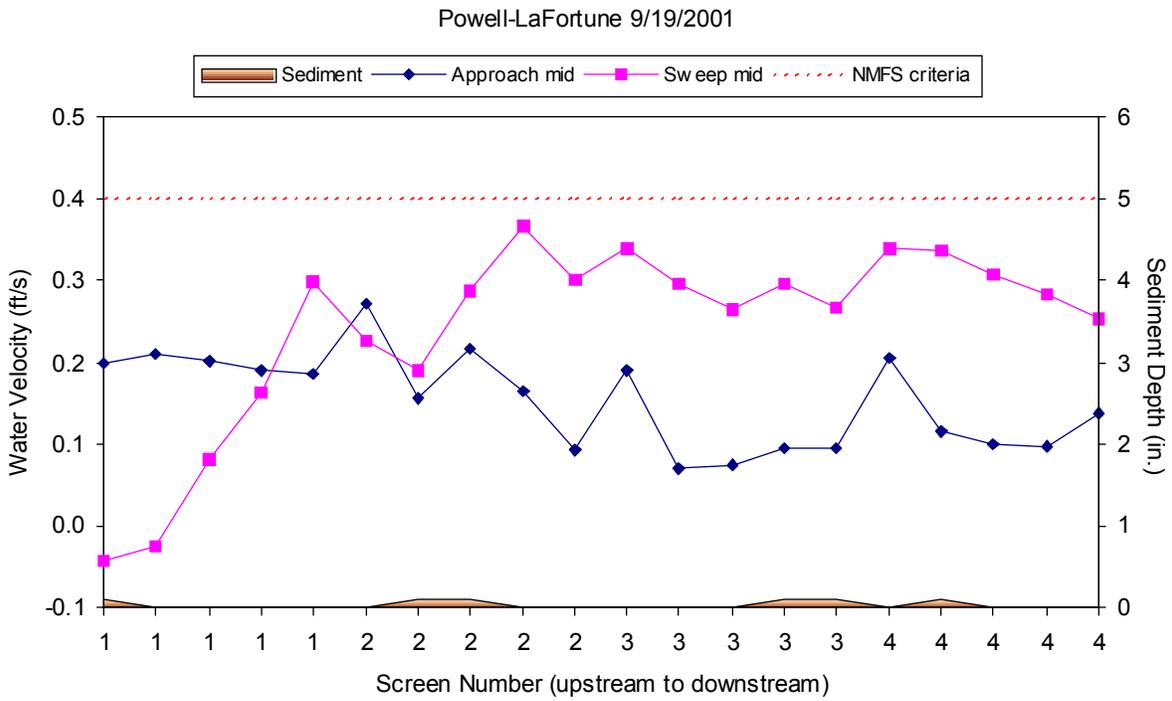
Powell-LaFortune is a new site that was added to our itinerary after the May surveys. This site has four drum screens. It was evaluated on 6/27/2001, 9/19/2001, and 9/25/2001. Water velocity were measured with the ADV using an improper calibration file in June, so only velocity data from the two September surveys are presented. Approach velocities met NMFS criteria 100% of the time. Sweeps were generally higher than approach, and increased towards the bypass during the second survey in September (Figures 12 and 13). During the first survey in September, submergence was less than 40%, and no water flowed through the bypass, despite high flows in the river. Thus, the velocities measured during this inspection may not be characteristic of flows during normal conditions at this site. Following this visit, the WDFW

Figure 12. Water Velocities and Sediment Depths at Powell-LaFortune on 9/19/2001

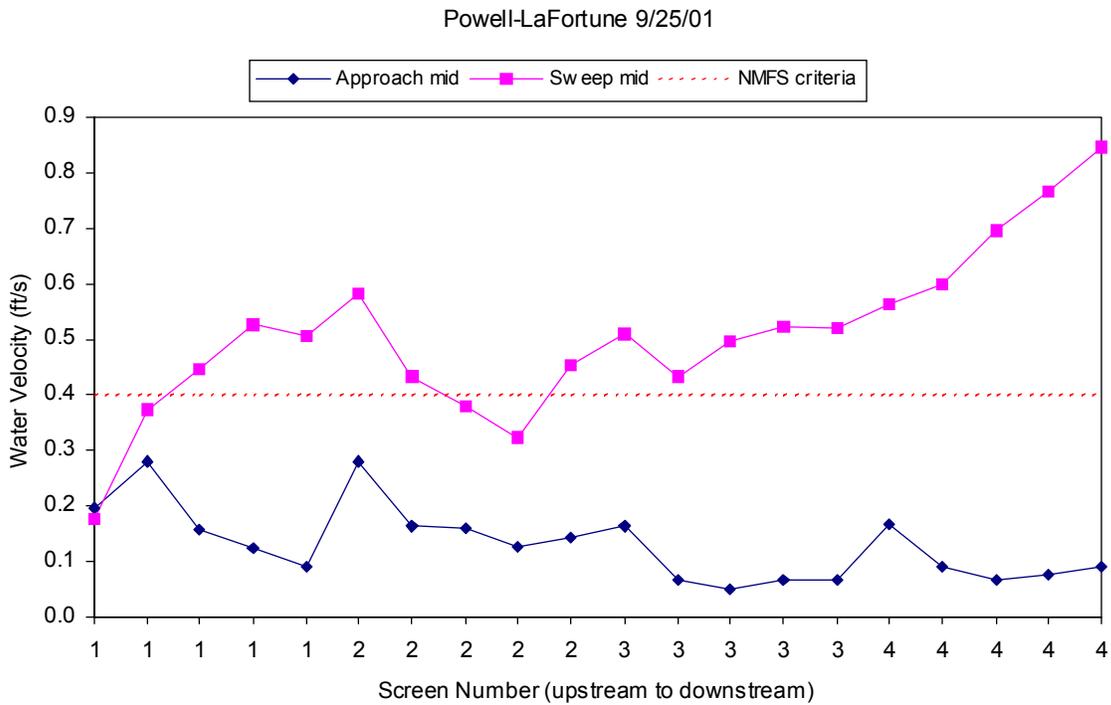
Figure 13. Water Velocities at Powell-LaFortune on 9/25/2001

found that the trashracks near the river were mostly plugged with debris. Once the debris was removed, we conducted a follow-up inspection of this site and found that submergence had returned to approximately 80%, and water flowed through the bypass (Figure 13).

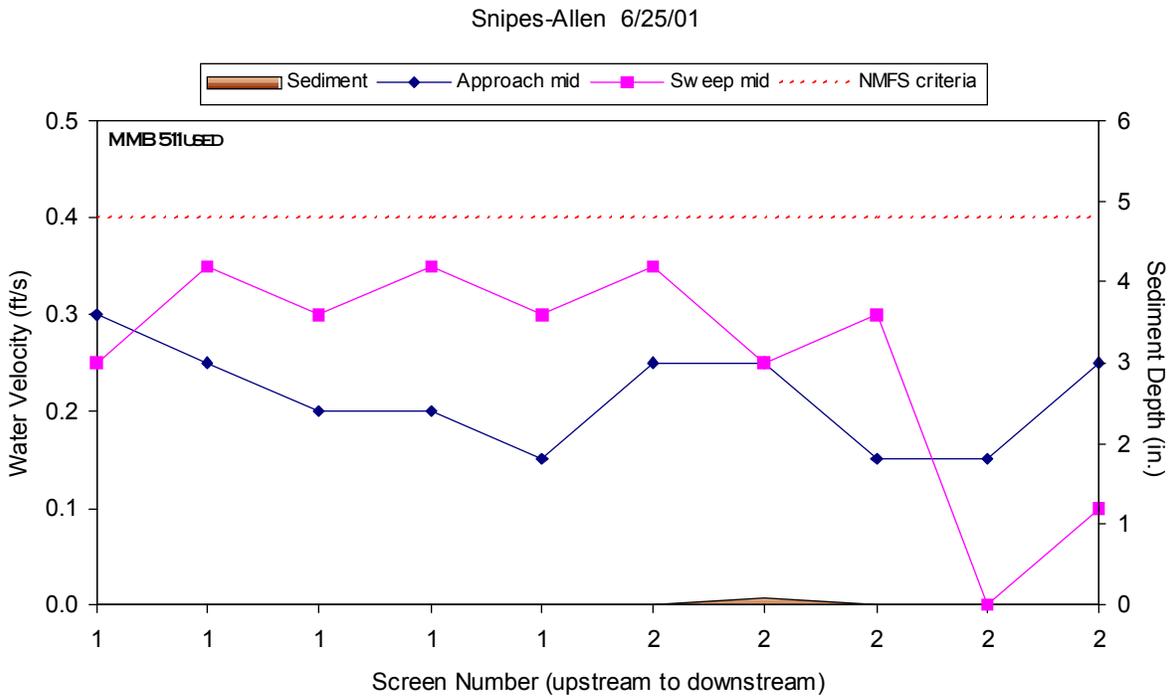
The Snipes-Allen site was evaluated on 5/24/2001, 6/25/2001, and 9/12/2001. The water velocity was measured with the ADV using an improper calibration file in May, so velocity data from that month are not discussed here. Velocities were measured using the Marsh-McBirney in June and the ADV in September. All approach velocities met NMFS criteria in June and September. Sweeps were generally higher than approaches, though in September we observed sweeps that were lower than approaches across the first screen (Figures 14 and 15). This is a pattern that is consistent with data from previous years (Chamness et al. 2001). Sweep did not increase toward the bypass, and the average bypass velocity was lower than the average sweep.

Figure 14. Water Velocities and Sediment Depths at Snipes-Allen on 6/25/2001

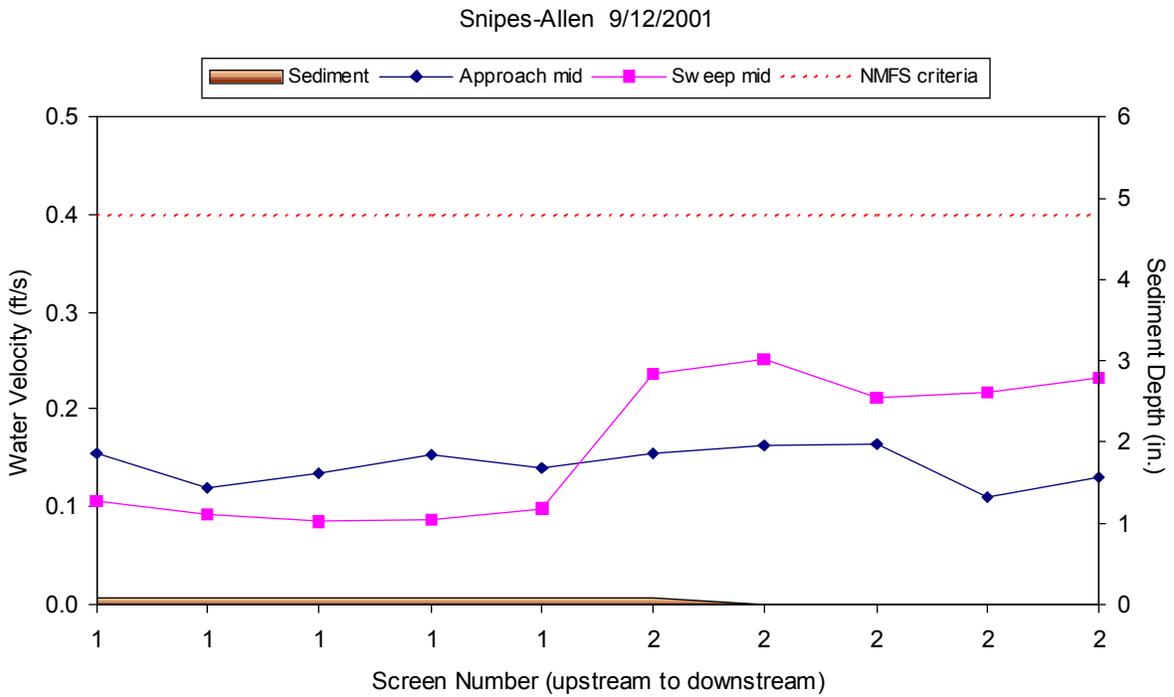
Figure 15. Water Velocities and Sediment Depths at Snipes-Allen on 9/12/2001

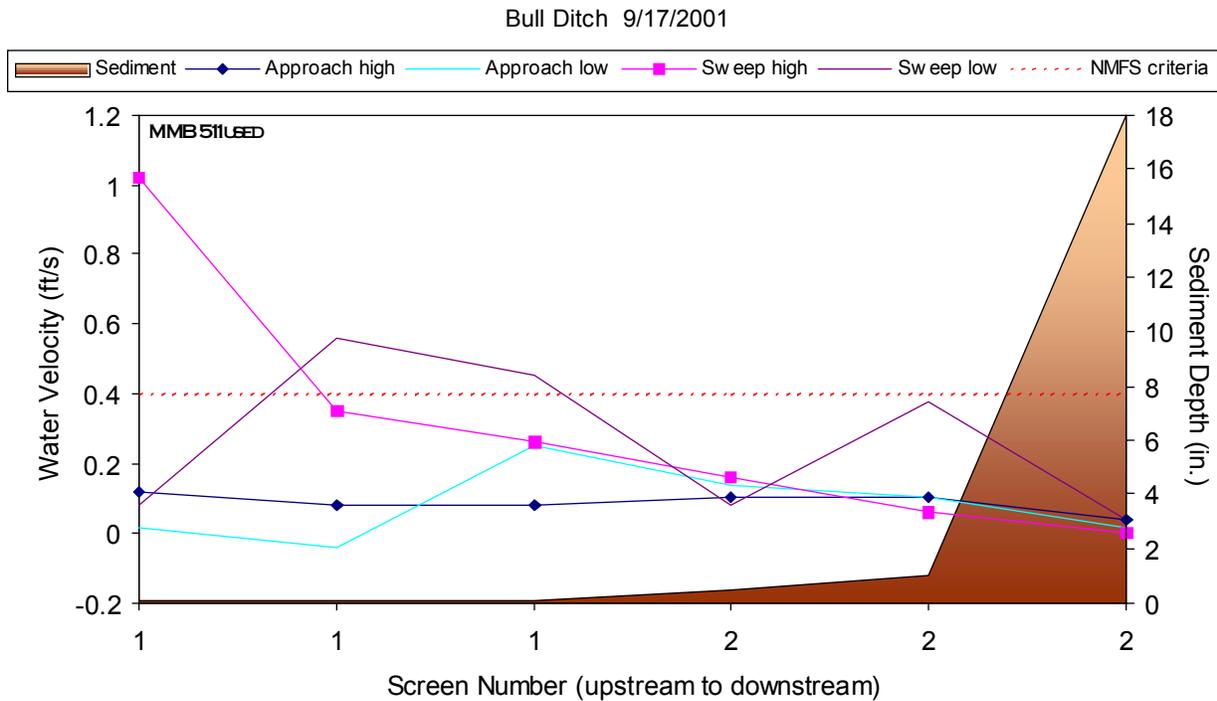
Figure 19. Water Velocities and Sediment Depths at Bull Ditch on 9/17/2001

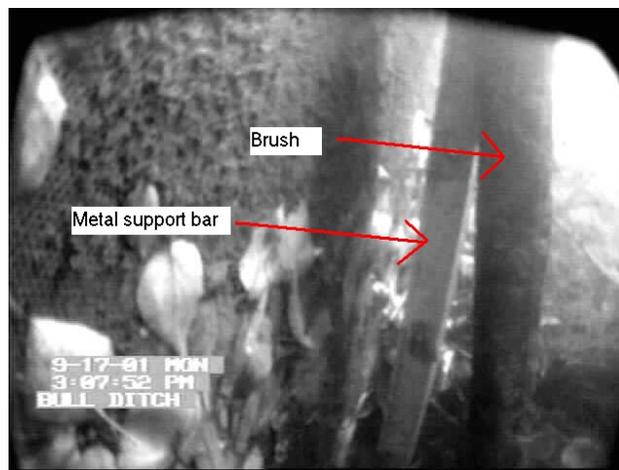
The accumulation of sediment and debris is not unusual for this site, but during our September survey, we noticed that it was causing several problems. Sticks and leaves had built up on the upstream trashrack that runs perpendicular to the screens, which slowed the flow of water through the site. We estimated that there was 18 in. of debris in the downstream corner of the site, and this debris had caused one of the automatic cleaning brushes to break and bend away from the screen (Figure 3.20).

Figure 20. Looking Downstream Toward the Broken Brush at Bull Ditch. On the left is the screen covered with algae and leaves. In the background is the pile of sediment and debris that may have caused the brush to break.
