Washington Phase II Fish Diversion Screen Evaluations in the Yakima River Basin

**Annual Report
2002**

January 2003

Yakima River Basin Phase II Fish Screen Evaluations, 2002

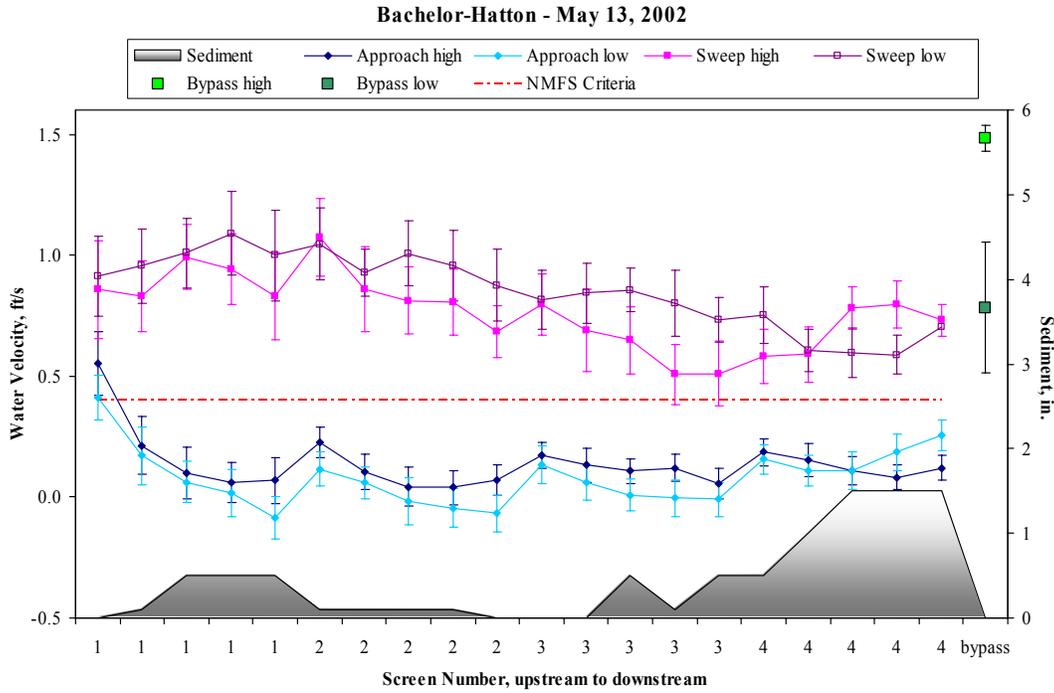
Figure 4. Water Velocities and Sediment Accumulation at Bachelor-Hatton in May 2002. Error bars (\pm the root-mean-squared [RMS]) represent turbulence at each point.

Approximately 4 in. of sediment had accumulated in front of screens 3 and 4 in May, which increased to 5 in. in June and was still present in September. A fair amount of twigs and other debris were present in front of screen 4 and in the bypass during all surveys. Bypass conditions were good in May, but in June the bypass appeared to be backed up and did not drop into the downwell. Bypass outfall conditions met standards for safe fish passage in May and June. A juvenile salmonid was observed in front of screen 2 in June, and several small, unidentified fish were seen in the forebay in September.

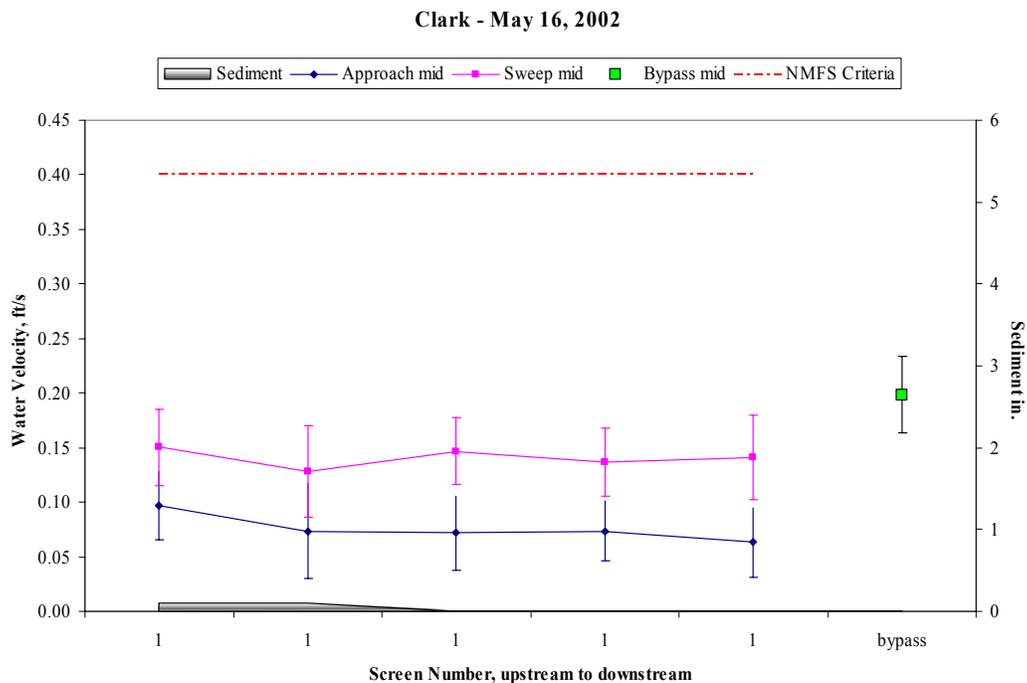
Figure 6. Water Velocities and Sediment Depths at Clark in May 2002. Error bars show turbulence (\pm the root-mean-squared [RMS]) at each point.

The Clark screening facility was visited on May 16, 2002; June 25, 2002; and September 19, 2002. Water velocities at this site complied with NMFS criteria during all surveys. All approach values were less than 0.4 ft/s, and sweep velocities were generally higher than approach velocities (Figures 6, 7, and 8). The water velocity in the bypass was always greater than the average sweep velocity, and in September, there was a clear increase in sweep velocity from upstream to downstream within the site. These conditions created a clear trajectory towards the bypass and would be expected to expedite fish passage through the site.

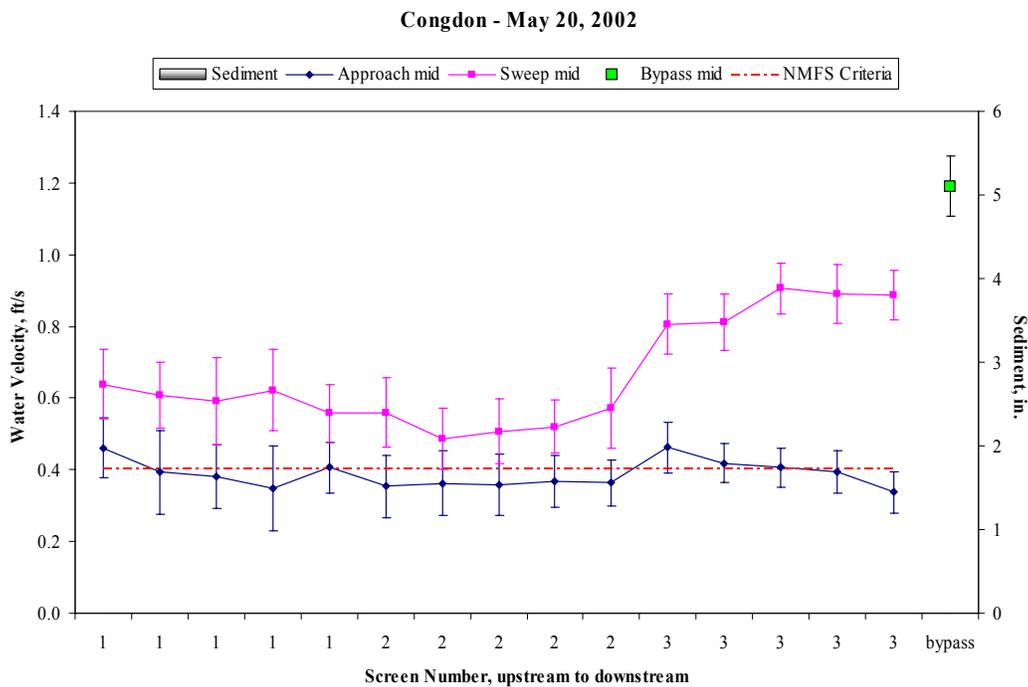
Figure 9. Water Velocities and Sediment Levels at Congdon in May 2002. Error bars show turbulence (\pm the root-mean-squared [RMS]) at each point.

The screen seals were in good condition. There was no sediment in front of the screens during any of the surveys. Submergence was at the high end of the criteria range throughout the survey period: 85% during May and June, and 83% in September. The depth of water flowing over the weir and through the outfall met NMFS criteria. Water ran freely through the bypass, though, as in previous years, water surged at the bypass outfall. This condition was not as severe as in 2001 when PNNL researchers observed water spraying at least a foot above the outfall pipe. A test conducted in 2000 concluded that the surging was not caused by an obstruction of the bypass. This surging water could be harmful to fish moving through the bypass; the PNNL researchers recommend the installation of an air pressure release tube to prevent the surges.

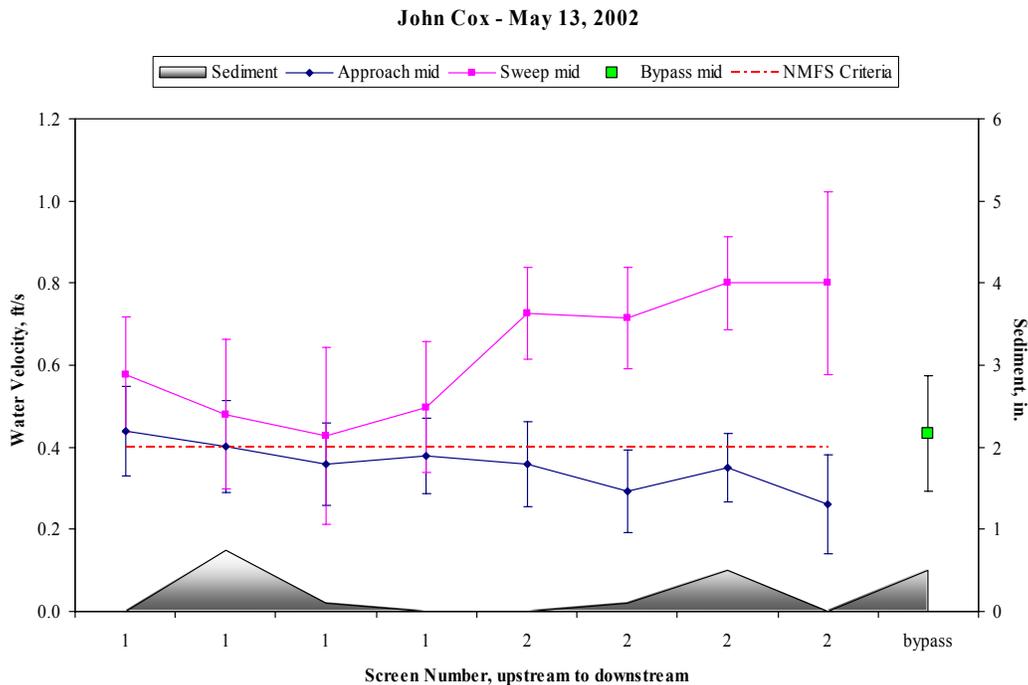
Figure 12. Water Velocities and Sediment Depths at John Cox in May 2002. Error bars show turbulence (\pm the root-mean-squared [RMS]) at each point.

The screens were vandalized sometime before the 2002 irrigation season and small holes in screen 2 were covered or filled with a black sealant. The screen seals appeared to be in good condition throughout the survey period, and the gap between the bottom seal and screen 2 noted in 2001 was not present in 2002. Submergence met NMFS criteria in May and June, and sediment accumulation was not a problem. Some small fish (~1 in.) were noted in the forebay in September. However, because the water level was below the rubber seals on the screens, they could not get through the bypass.

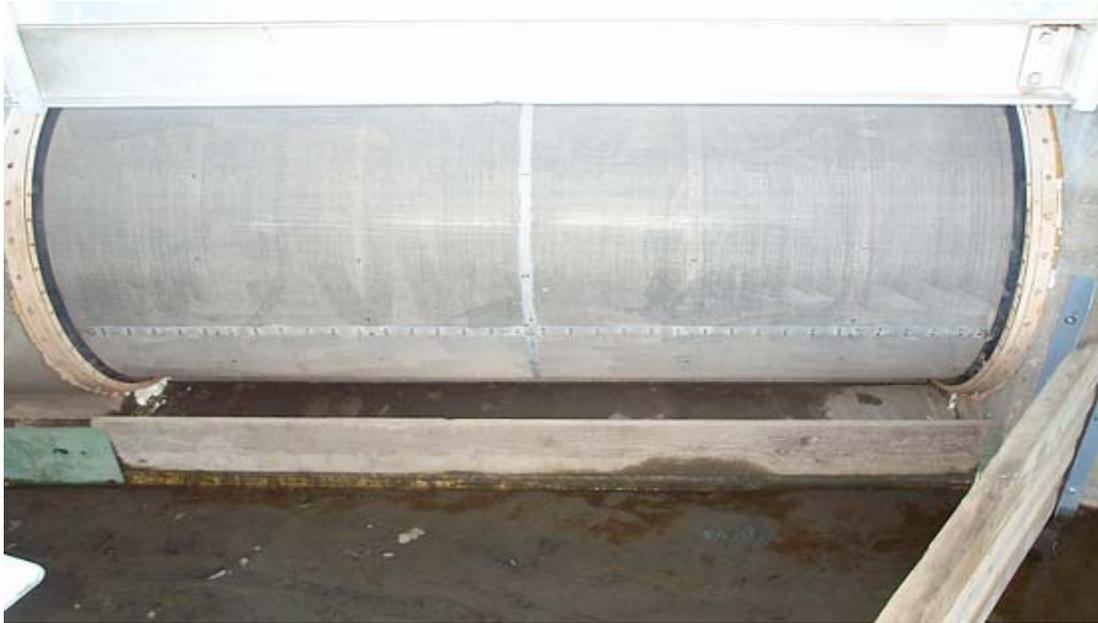
Figure 26. Screen 1 at Naches-Cowiche with Stoplogs in Front of the Screen (parallel) and Upstream of the Screen Bays (perpendicular to the direction of water flow). The upstream stoplogs were blown out by high flows early in the irrigation season.

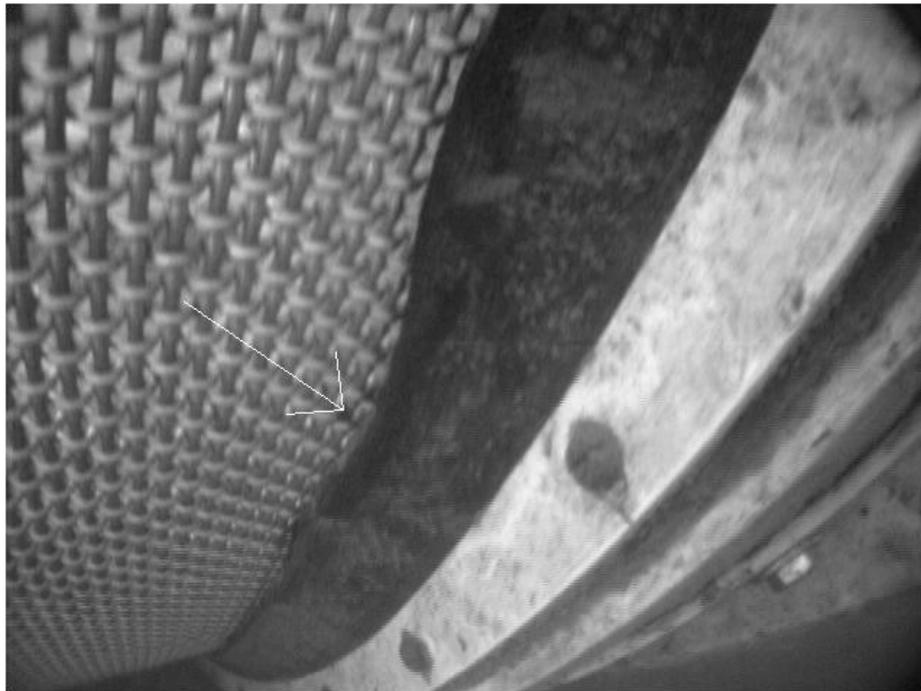
Figure 30. Damaged Seal at New Cascade, Downstream on Screen 8

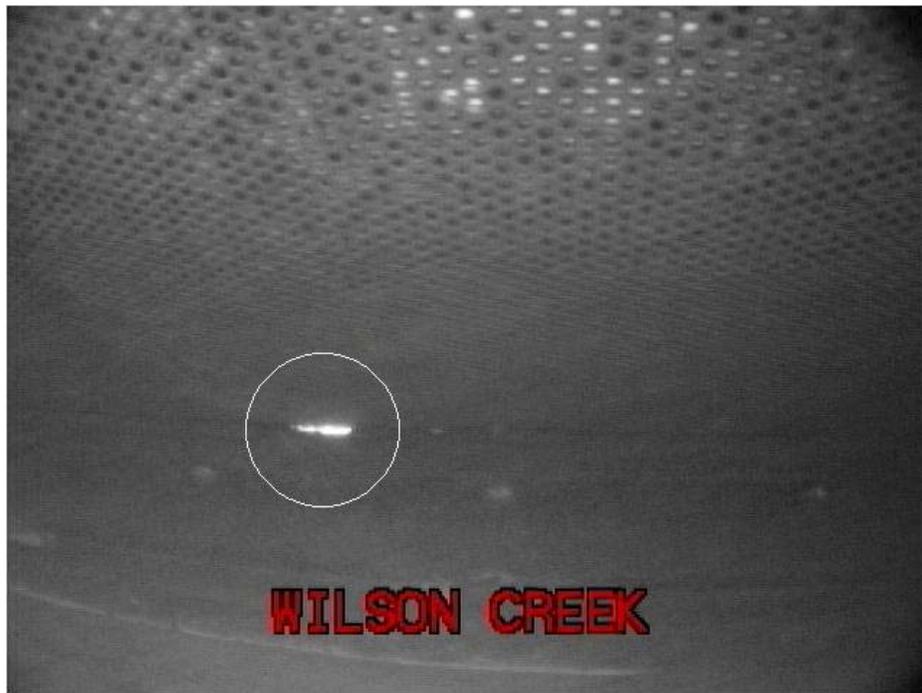
Figure 49. Gap Between the Bottom Seal and the Screen Observed at Wilson Creek in June 2002
