# Washington Phase II Fish Diversion Screen Evaluations in the Yakima River Basin

**Annual Report  
2003**

## Yakima River Basin Phase II Fish Screen Evaluations, 2003

May 2004

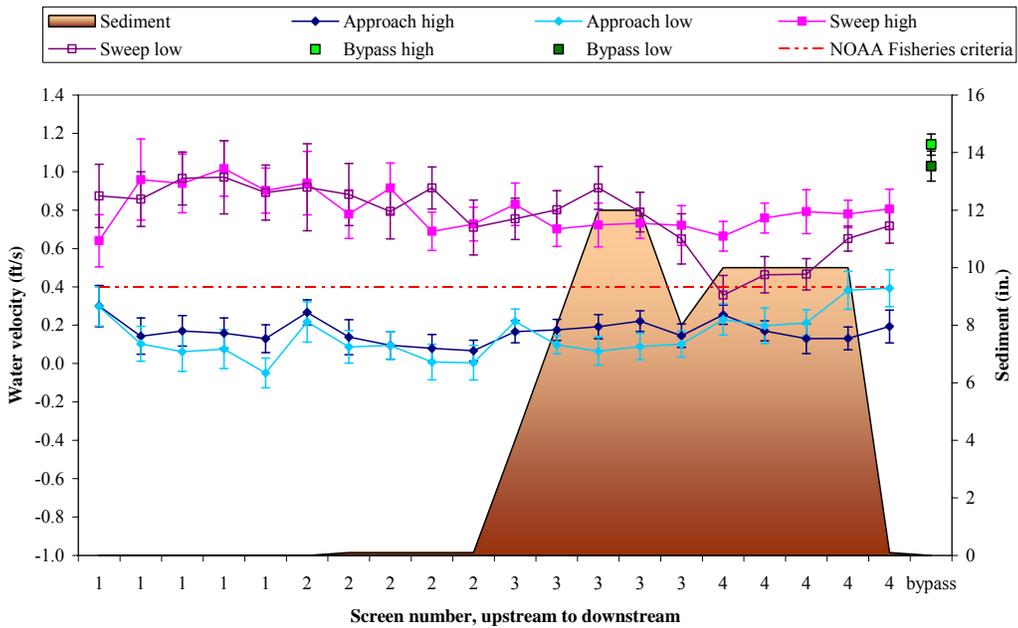
**Bachelor-Hatton - May 6, 2003**

**Figure 5.** Water Velocities and Sediment Accumulation at Bachelor-Hatton in May 2003. Error bars ( $\pm$  the root-mean-squared [RMS]) represent turbulence at each point.

Video surveys in all three months showed that the visible portions of the screen seals were in good condition. Approximately 12 in. of sediment had accumulated in front of screens 3 and 4 in May, which increased to a maximum of 15 in. in June. A fair amount of twigs and other debris were present in front of screen 4 and in the bypass during all surveys. Bypass conditions were good in May and June, and bypass outfall conditions met standards for safe fish passage in May and June. Flooding in early spring rerouted the stream away from the outfall. A small channel was dug to provide some flow of water to and from the outfall pipe, but water levels in this small channel may not stay consistently deep enough, and predation by birds or mammals could occur.

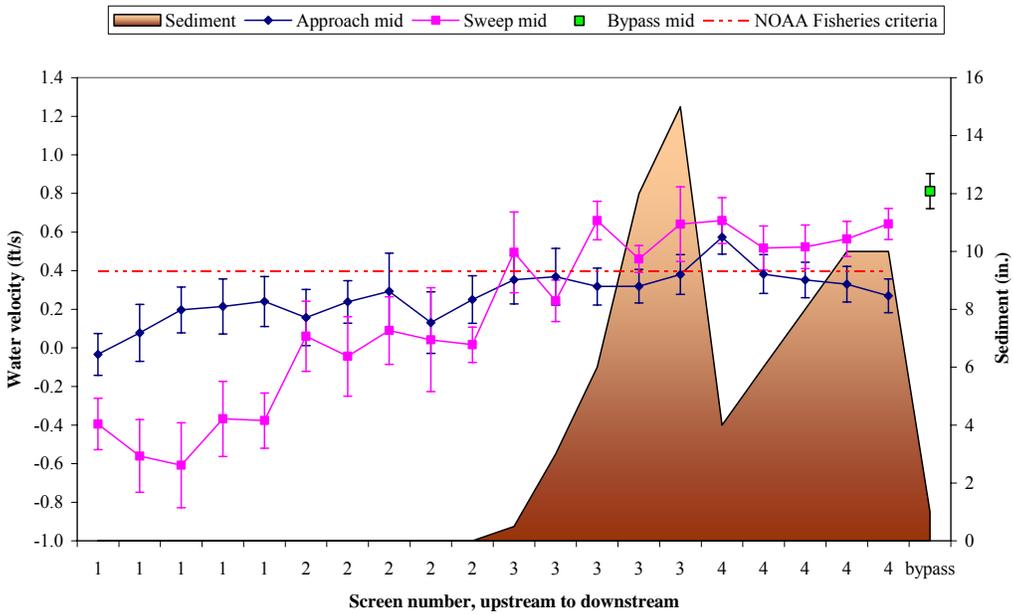
**Bachelor-Hatton - June 18, 2003**

**Figure 6.** Water Velocities and Sediment Accumulations at Bachelor-Hatton in June 2003. Error bars show turbulence ( $\pm$  the root-mean-squared [RMS]) at each point.

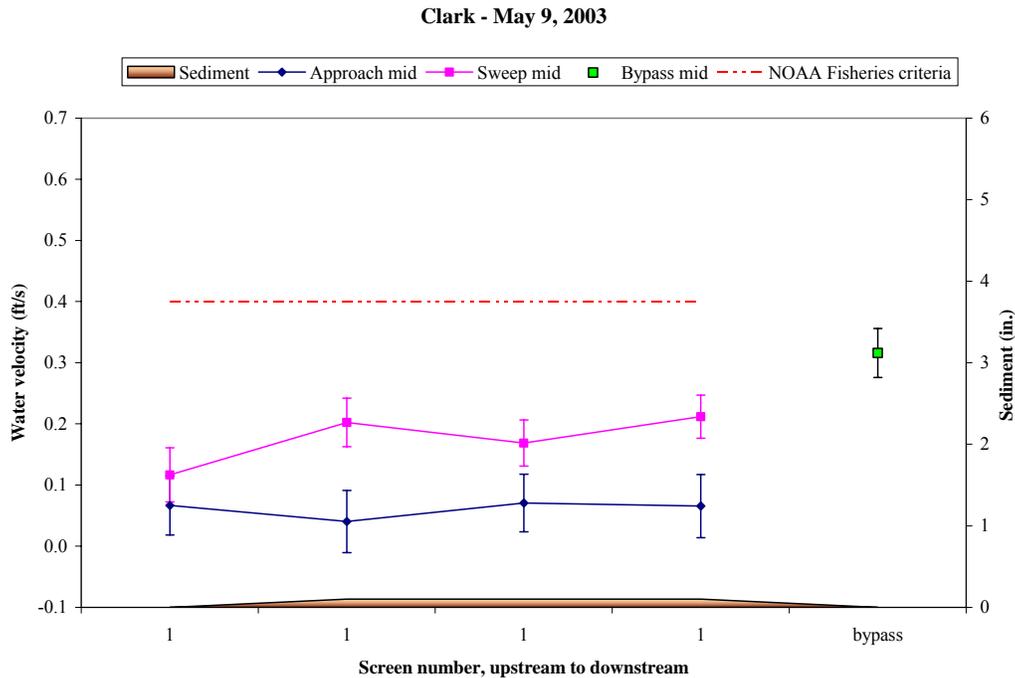
The Clark screening facility was visited on May 9, 2003; June 24, 2003; and September 19, 2003. Water velocities at this site complied with NOAA Fisheries criteria during all surveys. All approach values were less than 0.4 ft/s, and sweep velocities were always higher than approach velocities (Figures 7, 8, and 9). The water velocity in the bypass was always greater than the average sweep velocity, and except for September, there was a clear increase in sweep velocity from upstream to downstream within the site. These conditions created a clear trajectory towards the bypass and would be expected to expedite fish passage through the site.

The condition of the screen and seals was good throughout all surveys. Little sediment was present in front of the screens in May, and none was present in June or September. Screen submergence met

**Figure 7.** Water Velocities and Sediment Depths at Clark in May 2003. Error bars show turbulence ( $\pm$  the root-mean-squared [RMS]) at each point.

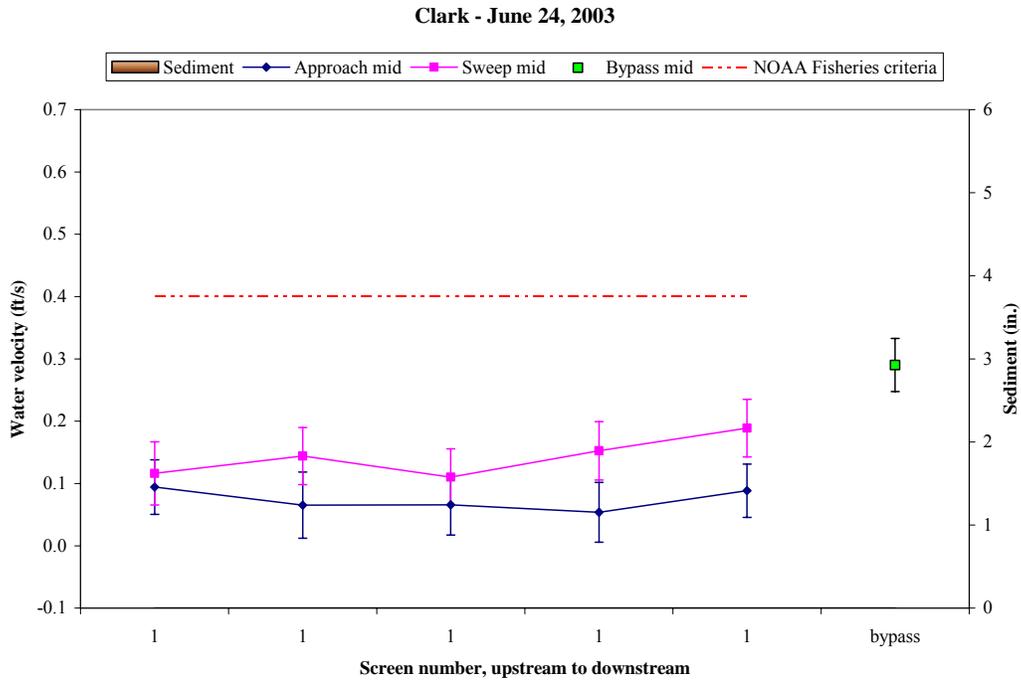
**Figure 8.** Water Velocities and Sediment Depths at Clark in June 2003. Error bars show turbulence ( $\pm$  the root-mean-squared [RMS]) at each point.

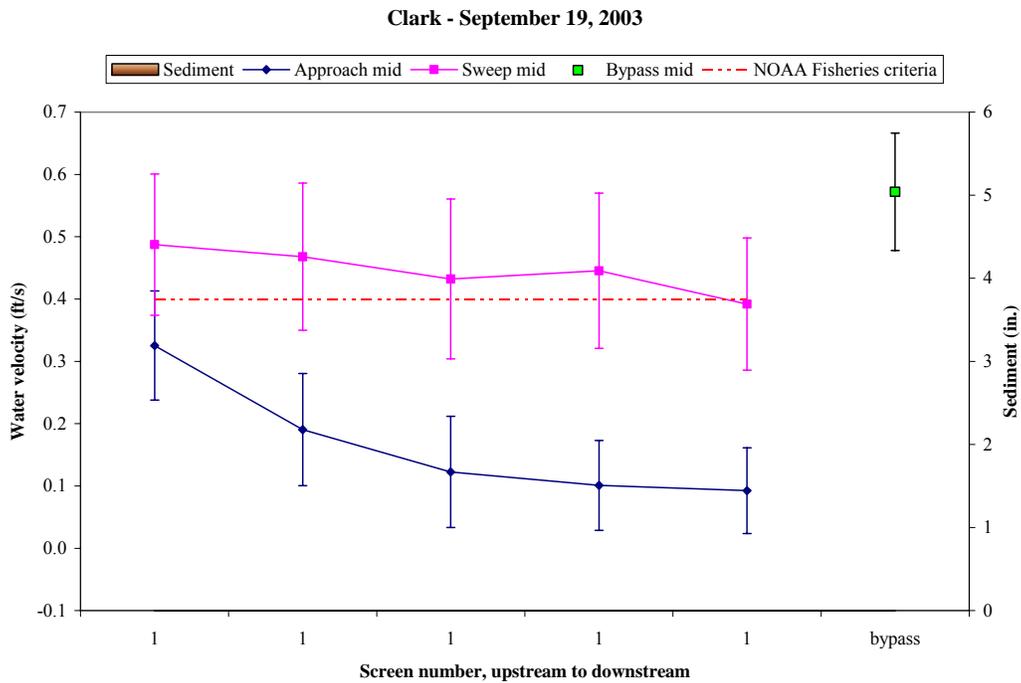
**Figure 9.** Water Velocities and Sediment Depths at Clark in September 2003. Error bars show turbulence ( $\pm$  the root-mean-squared [RMS]) at each point.

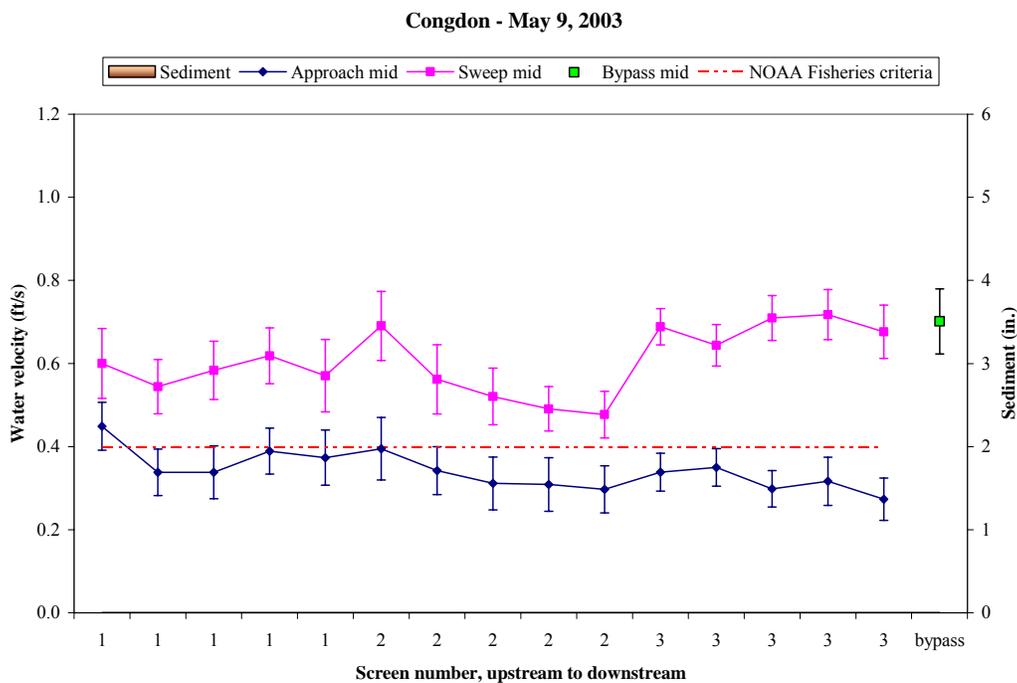
The screen seals were in good condition. There was very little sediment in front of the screens during all of the surveys. Submergence was at the high end of the criteria range throughout the survey period: 85% during May, 87% in June, and 83% in September. The depth of water flowing over the weir and through the outfall met NOAA Fisheries criteria. Water ran freely through the bypass, and the surging at the bypass outfall mentioned in previous years was not observed in 2003.

**Figure 10.** Water Velocities and Sediment Levels at Congdon in May 2003. Error bars show turbulence ( $\pm$  the root-mean-squared [RMS]) at each point.

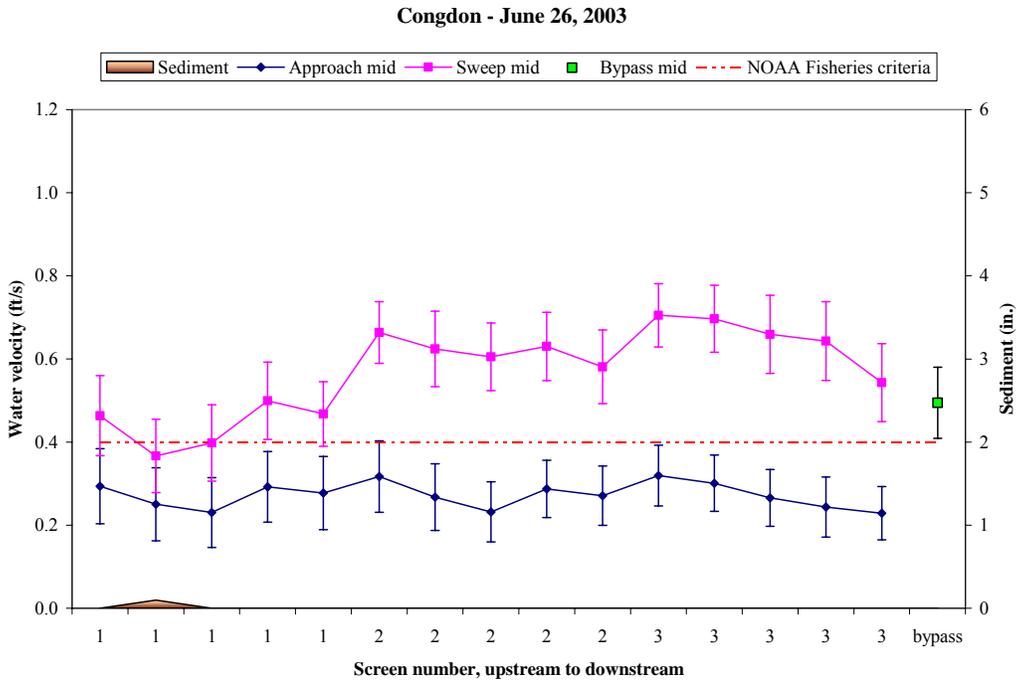
**Figure 11.** Water Velocities and Sediment Depths at Congdon in June 2003. Error bars show turbulence ( $\pm$  the root-mean-squared [RMS]) at each point.

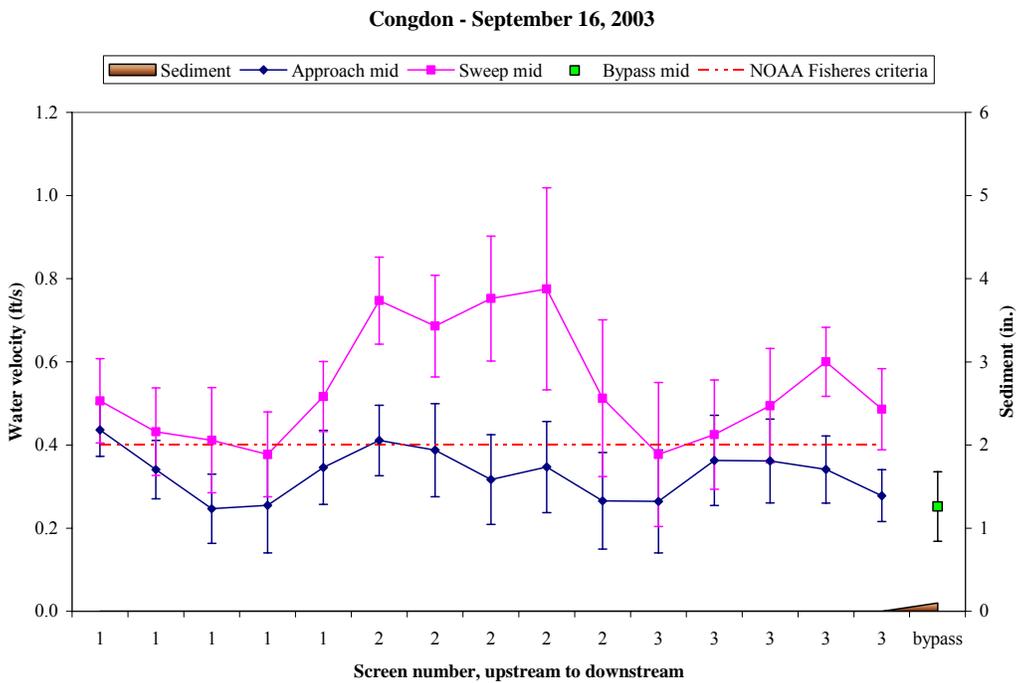
**Figure 12.** Water Velocities and Sediment Depths at Congdon in September 2003. Error bars show turbulence ( $\pm$  the root-mean-squared [RMS]) at each point.

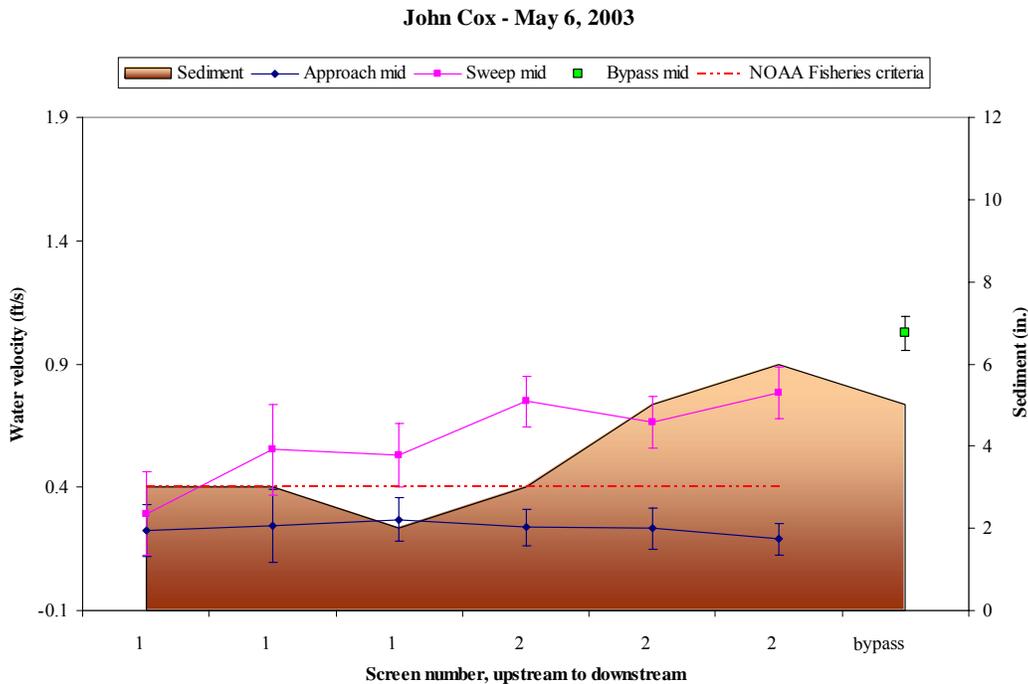
The screen seals appeared to be in good condition throughout the survey period, and the gap between the bottom seal and screen 2 noted in 2001 was not present in 2002. Submergence met NOAA Fisheries criteria in May and June, at 85% and 80%, respectively, though submergence had dropped to 61% in September. In June, there was a lot of woody debris in front of the screens and in September, there was enough sediment accumulation to cover the bottom seal and woody debris prevented flow measurements at the upstream end of screen 2.

**Figure 13.** Water Velocities and Sediment Depths at John Cox in May 2003. Error bars show turbulence ( $\pm$  the root-mean-squared [RMS]) at each point.

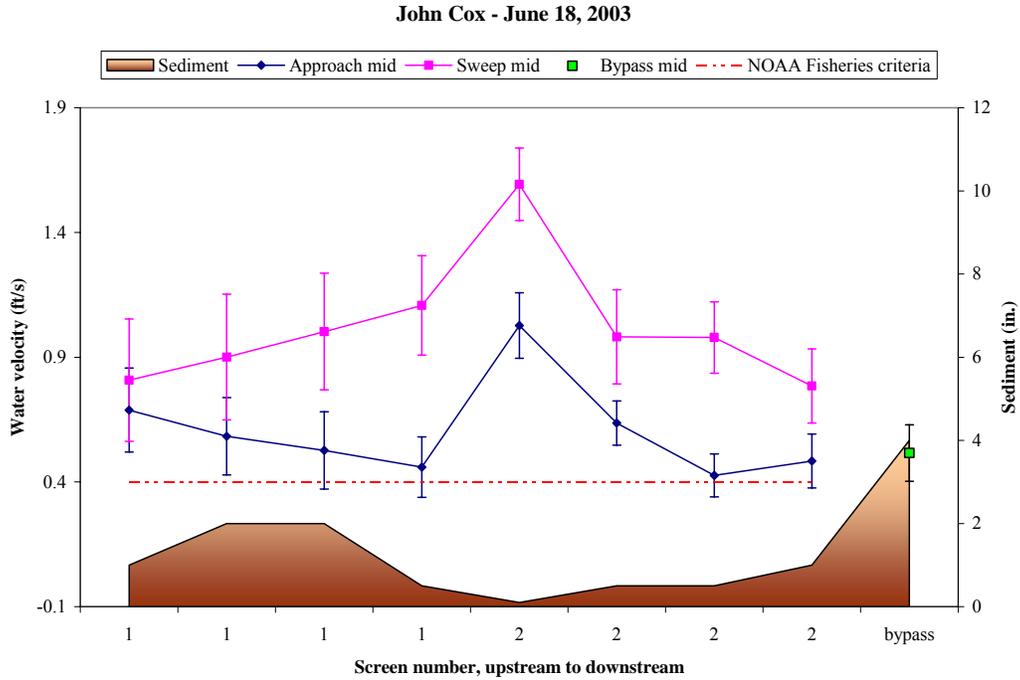
**Figure 14.** Water Velocities and Sediment Depths at John Cox in June 2003. Error bars show turbulence ( $\pm$  the root-mean-squared [RMS]) at each point.

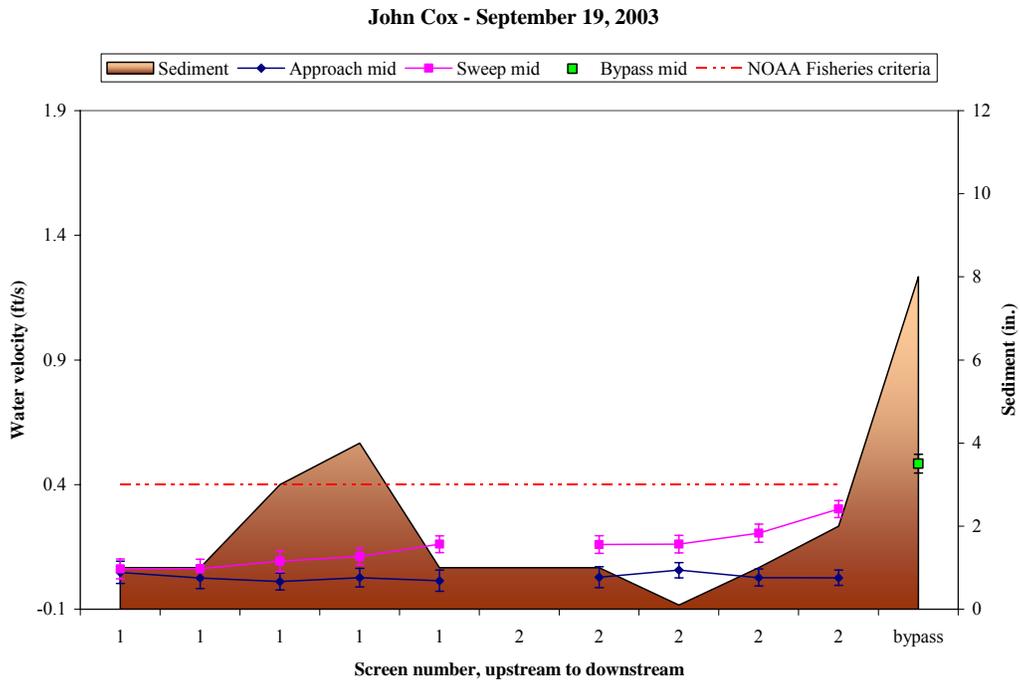
**Figure 15.** Water Velocities and Sediment Depths at John Cox in September 2003. Error bars show turbulence ( $\pm$  the root-mean-squared [RMS]) at each point.

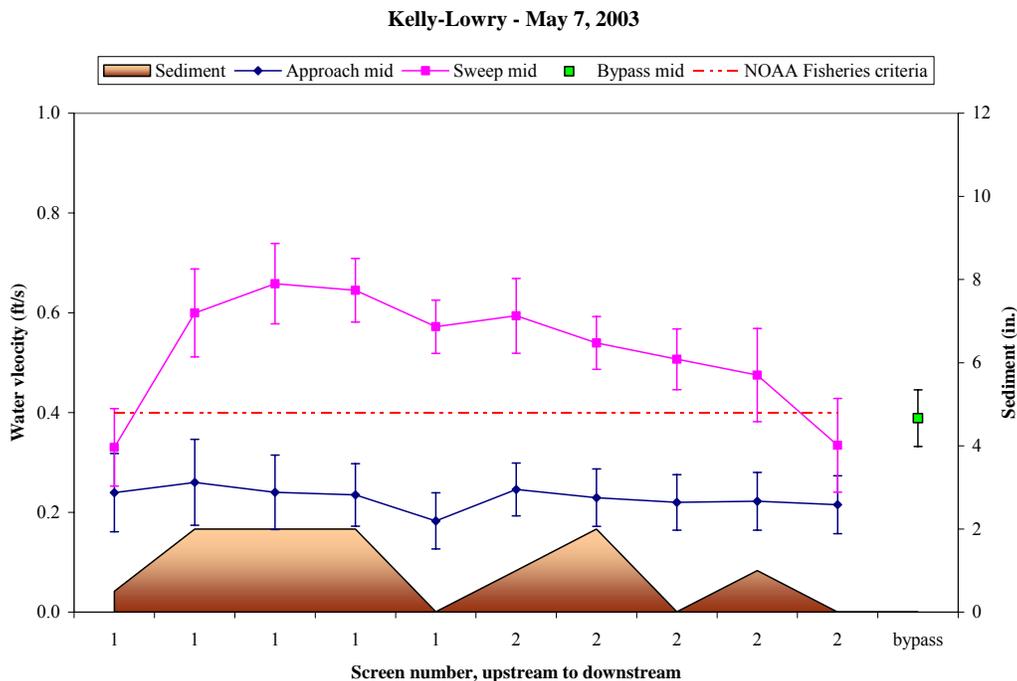
The screen seals all looked to be in good condition. A significant amount of debris had built up on the trash rack before the May survey and was present throughout the survey period. There was also a large pile of debris approximately 2 ft tall in the forebay in May. The gaps between the metal screen frames and the concrete wall noted in 2001 and 2002 were filled with spray-in insulation sometime before the May 2003 survey.

**Figure 16.** Water Velocities and Sediment Depths at Kelly-Lowry in May 2003. Error bars show turbulence ( $\pm$  the root-mean-squared [RMS]) at each point.

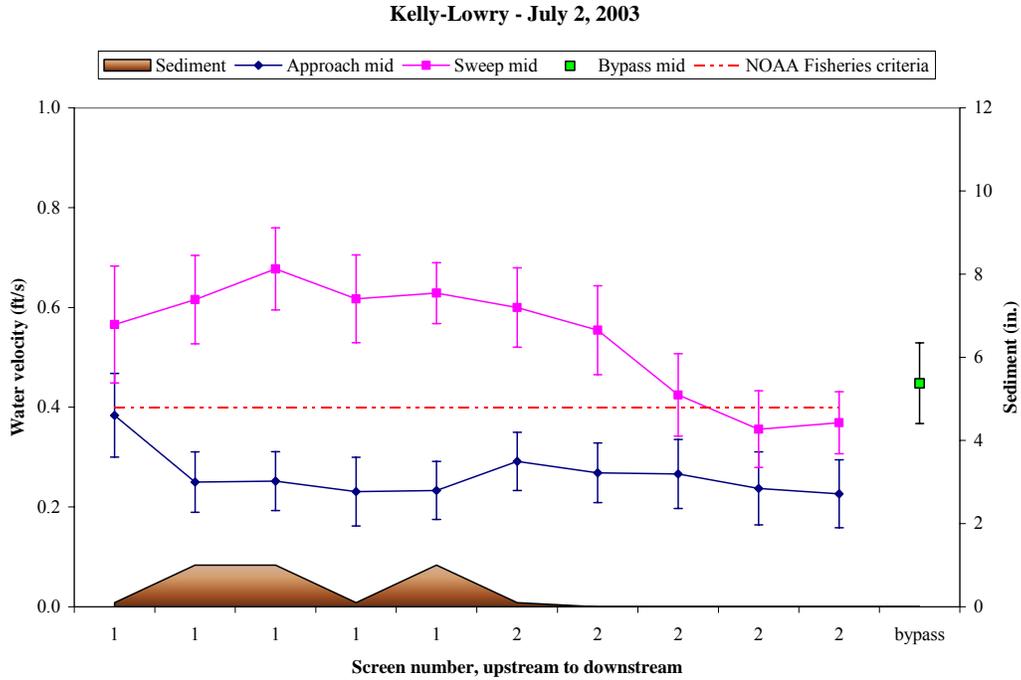
**Figure 17.** Water Velocities and Sediment Depths at Kelly-Lowry in July 2003. Error bars show turbulence ( $\pm$  the root-mean-squared [RMS]) at each point.

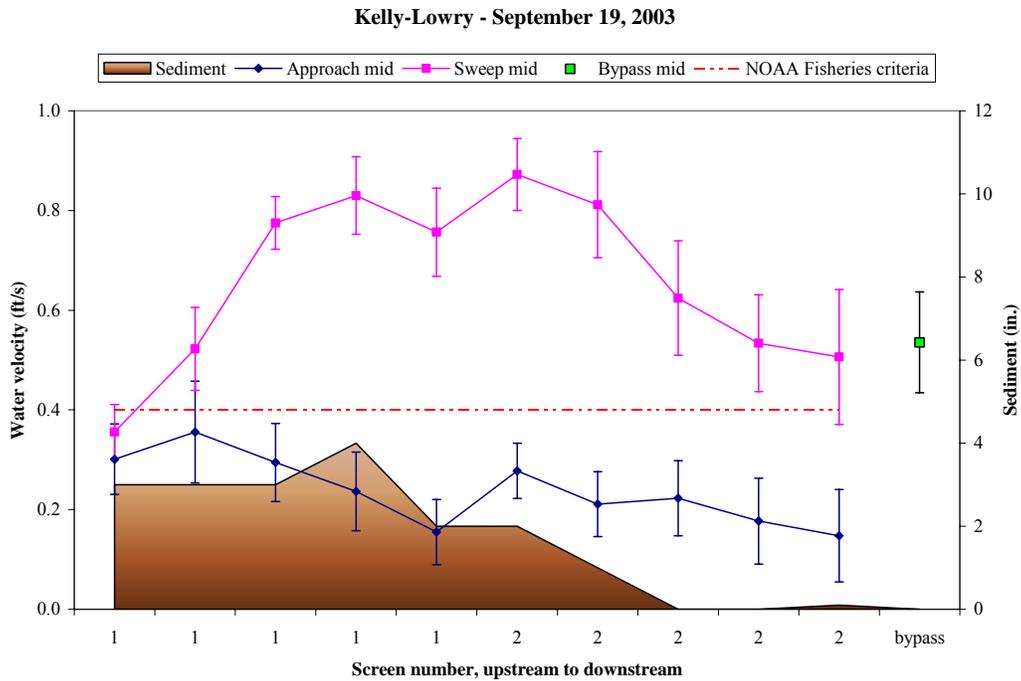
**Figure 18.** Water Velocities and Sediment Depths at Kelly-Lowry in September 2003. Error bars show turbulence ( $\pm$  the root-mean-squared [RMS]) at each point.

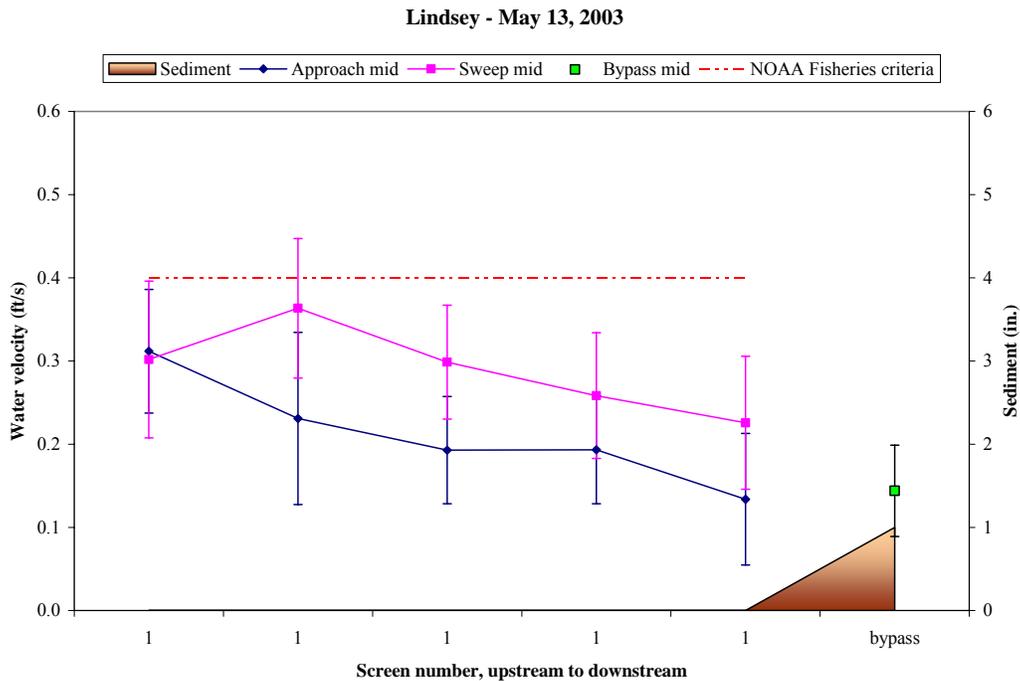
The screen seals were in good condition, and the drum moved leaf matter and other floating debris into the canal effectively. In May submergence was slightly below NOAA Fisheries criteria at 62% (criteria = 65% to 85%). Ray Gilmore was contacted on May 13 concerning the low submergence, although no operational changes were made to correct the condition. Notes in the logbook subsequent to our May site visit indicate submergence dropped to approximately 40% before the river level rose and changes in the operating conditions were made to increase the submergence level. Submergence met criteria in June and September at 85% and 66%, respectively. The gaps between the metal frame of the screen and the cement wall were filled with expanding foam insulation that will prevent entrainment of small fish in these gaps.

**Figure 19.** Water Velocities and Sediment Depths at Lindsey in May 2003. Error bars show turbulence ( $\pm$  the root-mean-squared [RMS]) at each point.

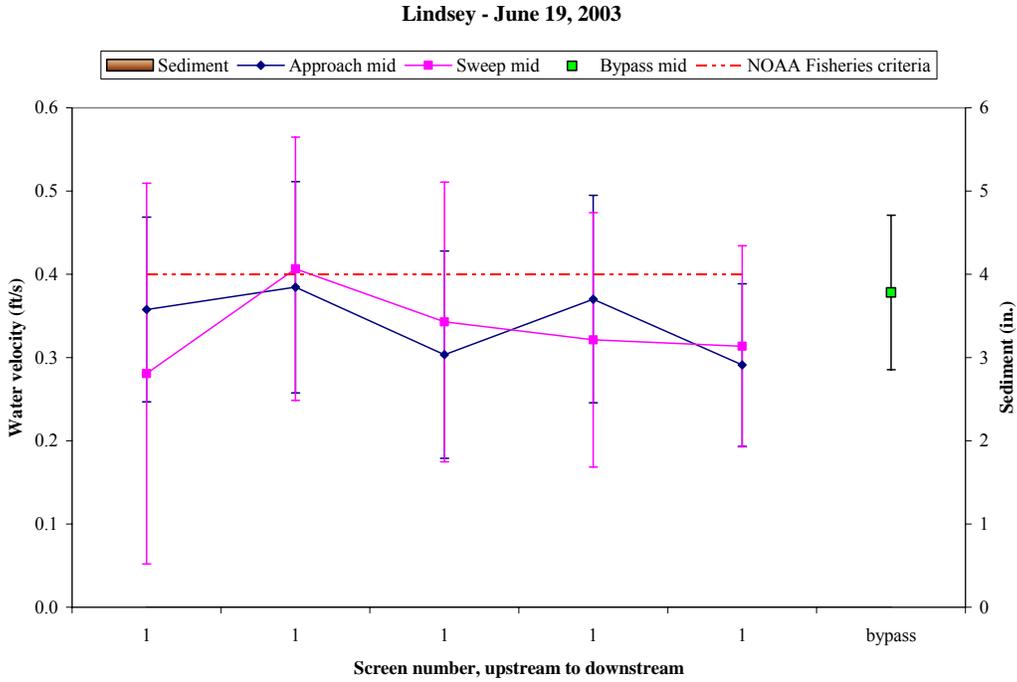
**Figure 20.** Water Velocities and Sediment Depths at Lindsey in June 2003. Error bars show turbulence ( $\pm$  the root-mean-squared [RMS]) at each point.

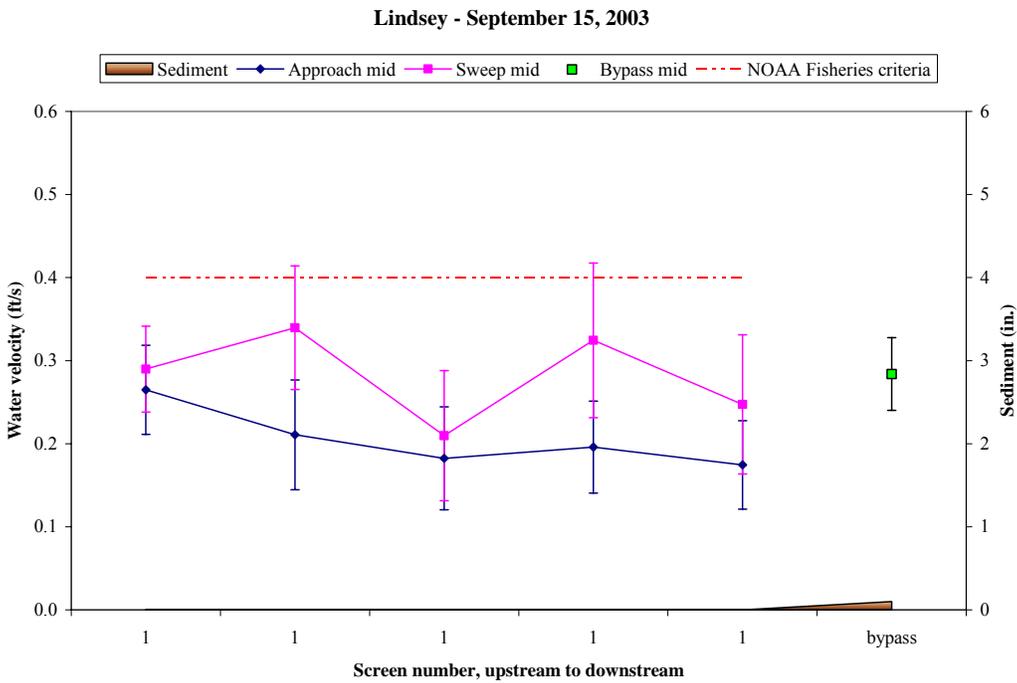
**Figure 21.** Water Velocities and Sediment Depths at Lindsey in September 2003. Error bars show turbulence ( $\pm$  the root-mean-squared [RMS]) at each point.

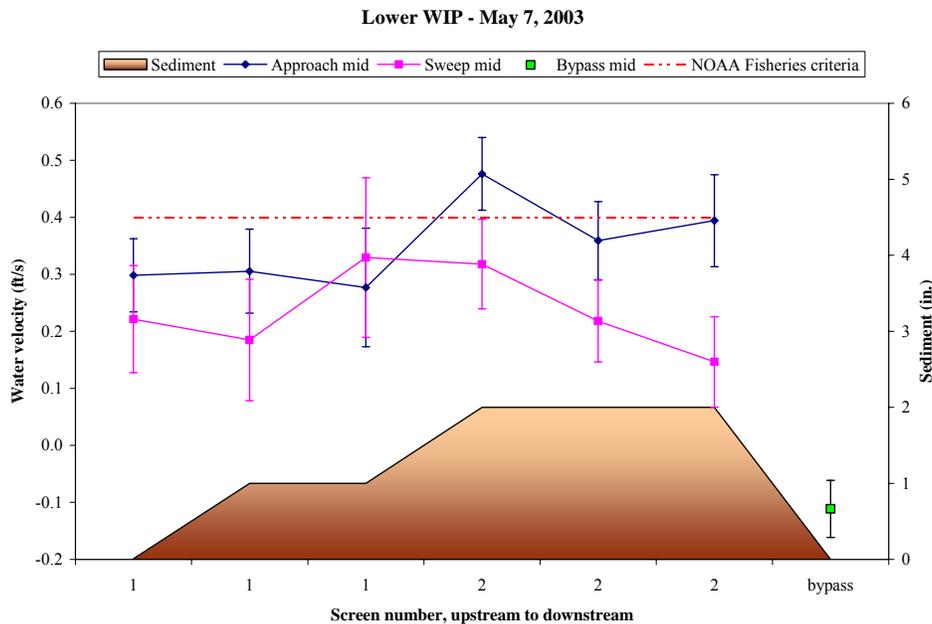
During May and July, an excessive amount of sand was present in the forebay, in front of the screens, and in the bypass. At the shallowest point in July there was only 4 in. of water over the sand. Submergence met criteria in May at 80%. In July and September, submergence was slightly outside criteria limits at 64% and 88%, respectively. Sediment deposits at the site were removed in August and September. In September, the bypass appeared to be backed up; there was no drop into the downwell, probably due to high stream flows. Bypass outfall conditions met NOAA Fisheries criteria during all surveys, although it was noted in June that if the water level in the stream was to drop fish could become trapped because the fish channel in the diversion dam was blocked.

**Figure 22.** Water Velocities and Sediment Depths at Lower Wapato Irrigation Project (WIP) in May 2003. Error bars show turbulence ( $\pm$  the root-mean-squared [RMS]) at each point.

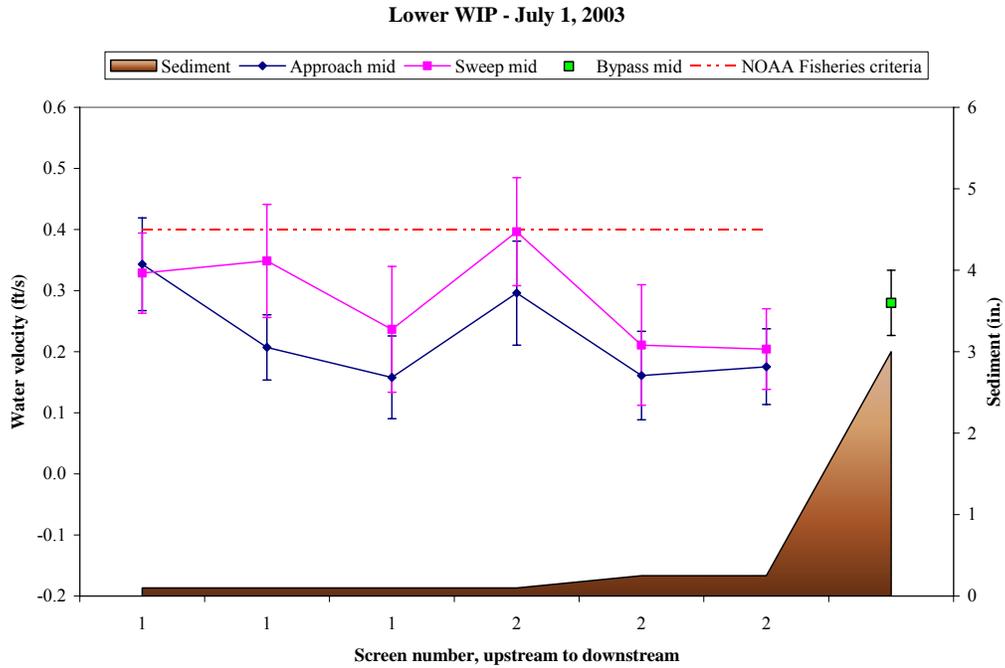
**Figure 23.** Water Velocities and Sediment Depths at Lower Wapato Irrigation Project (WIP) in July 2003. Error bars show turbulence ( $\pm$  the root-mean-squared [RMS]) at each point.

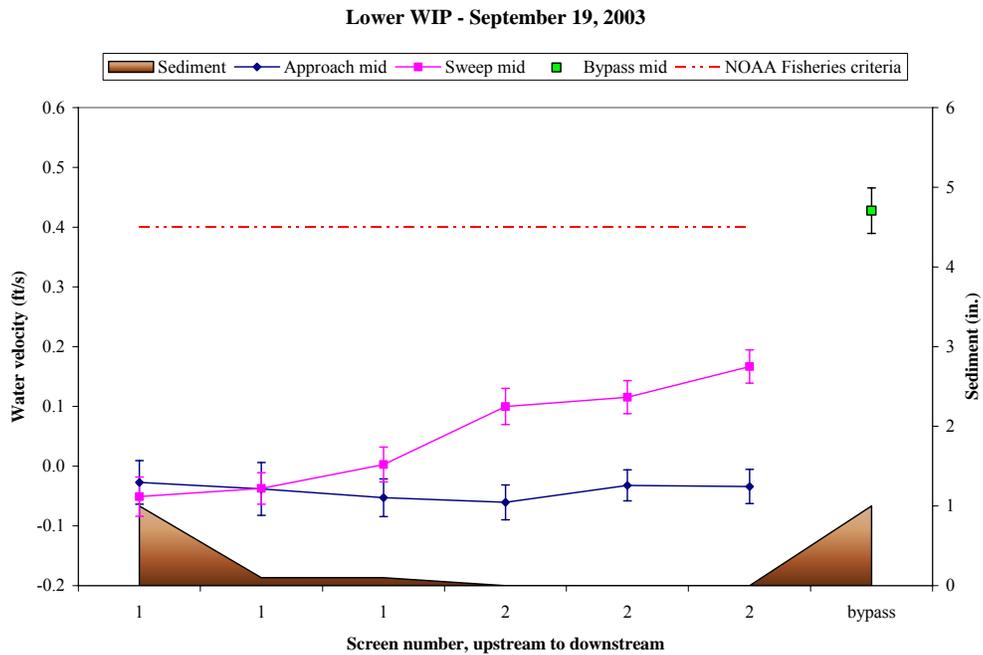
**Figure 24.** Water Velocities and Sediment Depths at Lower Wapato Irrigation Project (WIP) in September 2003. Error bars show turbulence ( $\pm$  the root-mean-squared [RMS]) at each point.

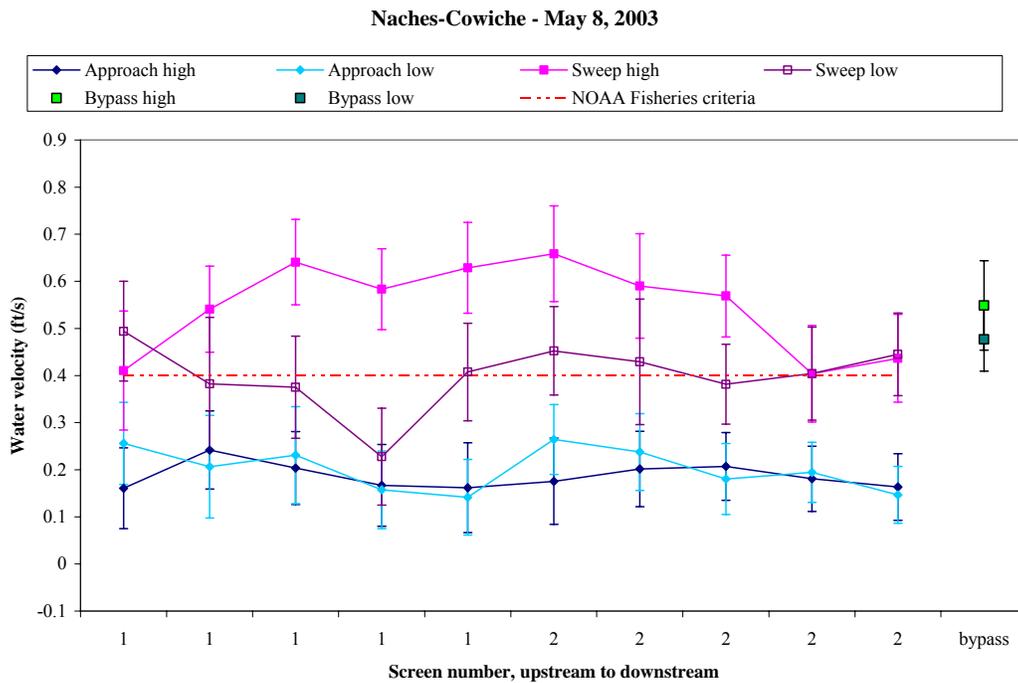
The stoplogs in front of the screens prevented an evaluation of the bottom seals with the video camera. All other visible seals were in good condition. During the June and September evaluations it was evident that debris had built up between the stoplogs and the screens. Submergence was within criteria during all visits and bypass conditions were generally good for safe fish passage. In June, the bypass outfall became plugged. It was cleaned out on the morning of June 26, and two dead fish were found. Fish in the screen facility have no way out if the outfall is blocked, although WDFW raises the weir to prevent movement through the bypass if blockage is suspected. In 2002, there was some concern that the design of the bypass outfall did not compensate enough for the shifting riverbed because it became filled with rock when flows were high. The outfall channel has been dug out several times in the past, only to get filled in again when the river level rose. Sometime before our September evaluation, ecology blocks were placed on three sides of the outfall channel in an attempt to stop rocks from being shifted into the outfall channel.

**Figure 25.** Water Velocities and Sediment Depths at Naches-Cowiche in May 2003. Error bars show turbulence ( $\pm$  the root-mean-squared [RMS]) at each point.

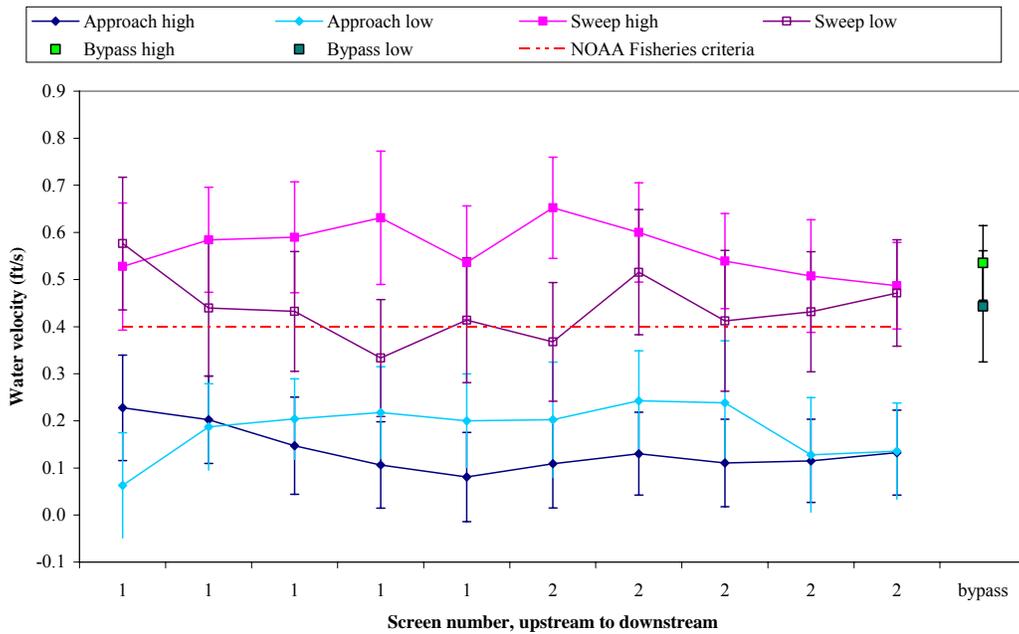
Naches-Cowich - June 26, 2003

Figure 26. Water Velocities and Sediment Depths at Naches-Cowiche in June 2003. Error bars show turbulence ( $\pm$  the root-mean-squared [RMS]) at each point.

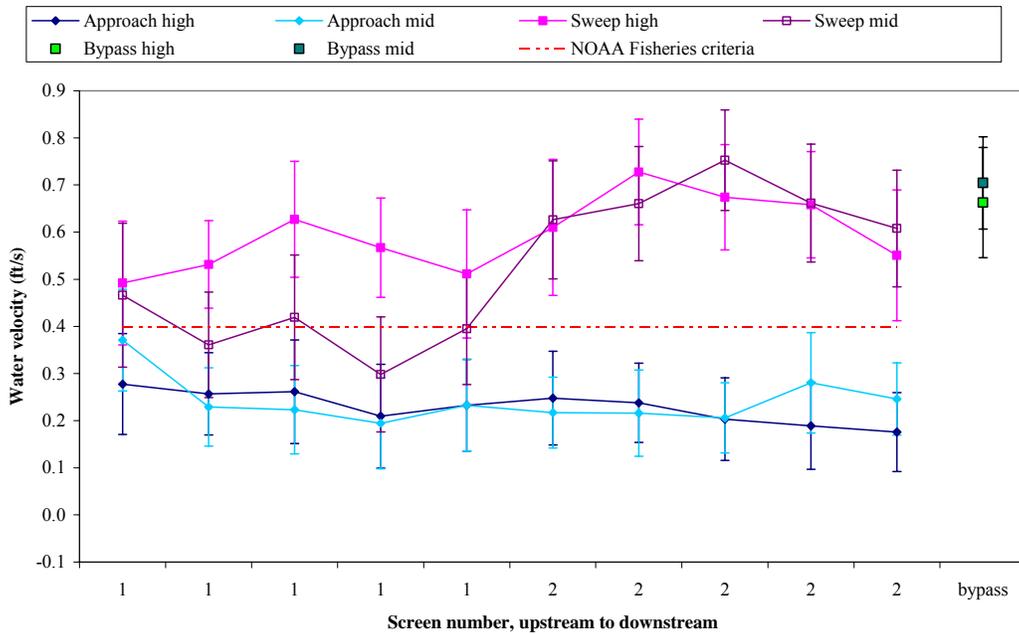
Naches-Cowiche - September 19, 2003

Figure 27. Water Velocities and Sediment Depths at Naches-Cowiche in September 2003. Error bars show turbulence ( $\pm$  the root-mean-squared [RMS]) at each point.

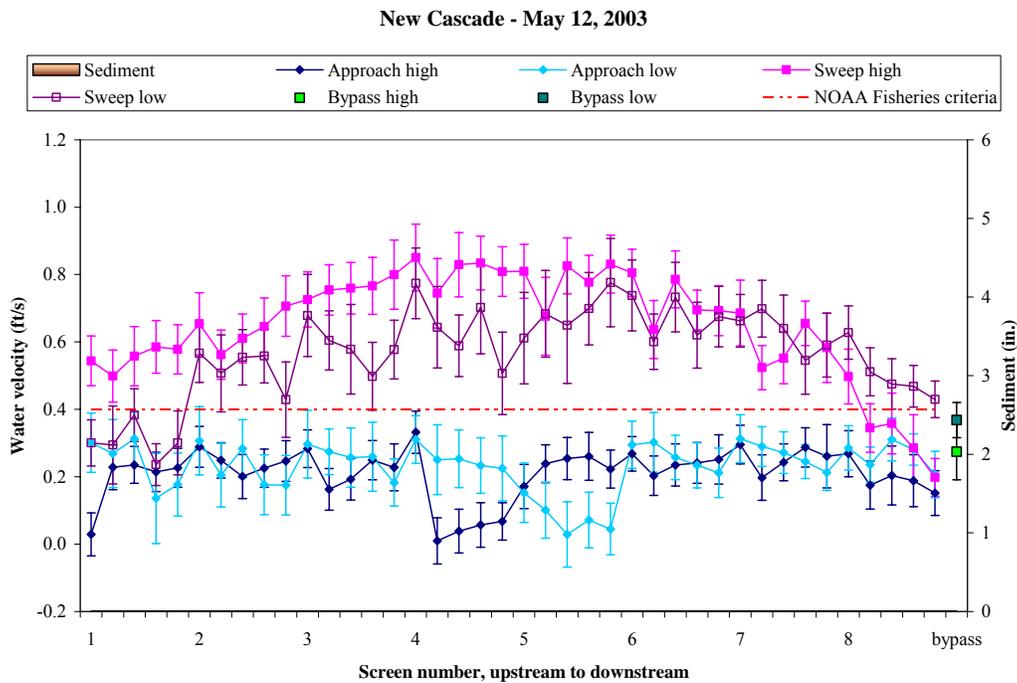
Submergence slightly exceeded criteria in May, June, and September, at 90%, 89%, and 88%, respectively. Ray Gilmore was notified on May 12 of the high submergence level. No changes were made in operating conditions. In the past this site has had problems with sediment buildup, especially in the downstream corners of the screen bays. However, very little sediment accumulation occurred during the 2003 season. All bottom seals were replaced in the fall of 2002, as were the left side seal on screen 1 and the right side seal on screen 8, which had been warped for several years. All seals appeared to be in good condition, and all cheeks were sealed with expanding foam insulation.

**Figure 28.** Water Velocities and Sediment Depths at New Cascade in May 2003. Error bars show turbulence ( $\pm$  the root-mean-squared [RMS]) at each point.

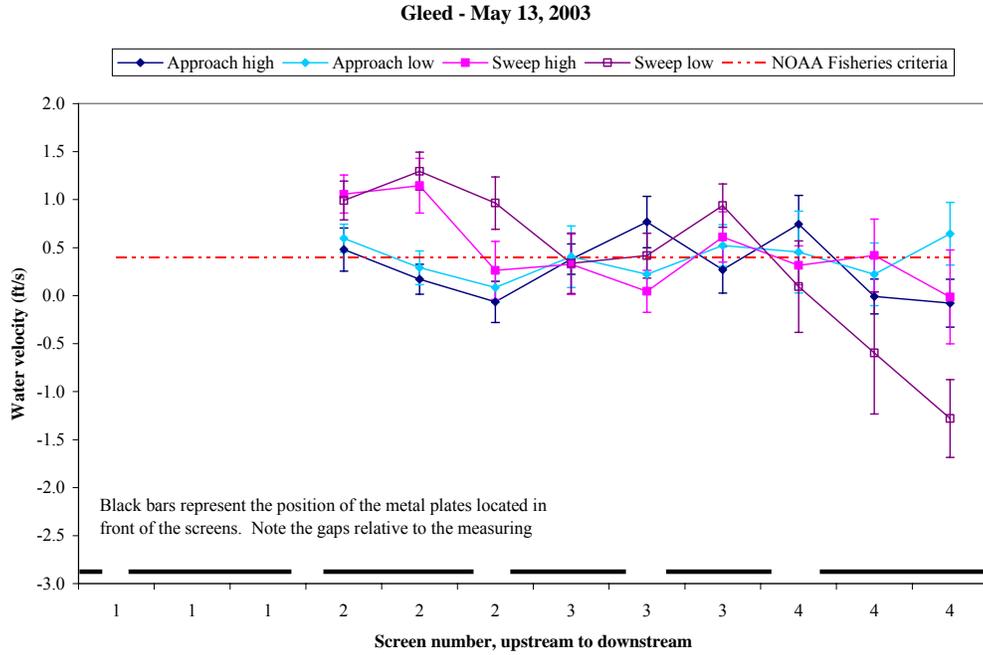
**Figure 68.** Water Velocities and Sediment Depths at Gleed in May 2003. Measurements were not taken in front of screen one because a sheet of plywood had been placed directly in front of the screen. Error bars show turbulence ( $\pm$  the root-mean-squared [RMS]) at each point.
