Walla Walla River Basin Fish Screen Evaluations

Nursery Bridge Fishway, Garden City/Lowden II, and Little Walla Walla Sites

Annual Report
2004

**Walla Walla River Basin Fish Screen Evaluations,
2004: Nursery Bridge Fishway, Garden City/Lowden II
and Little Walla Walla**

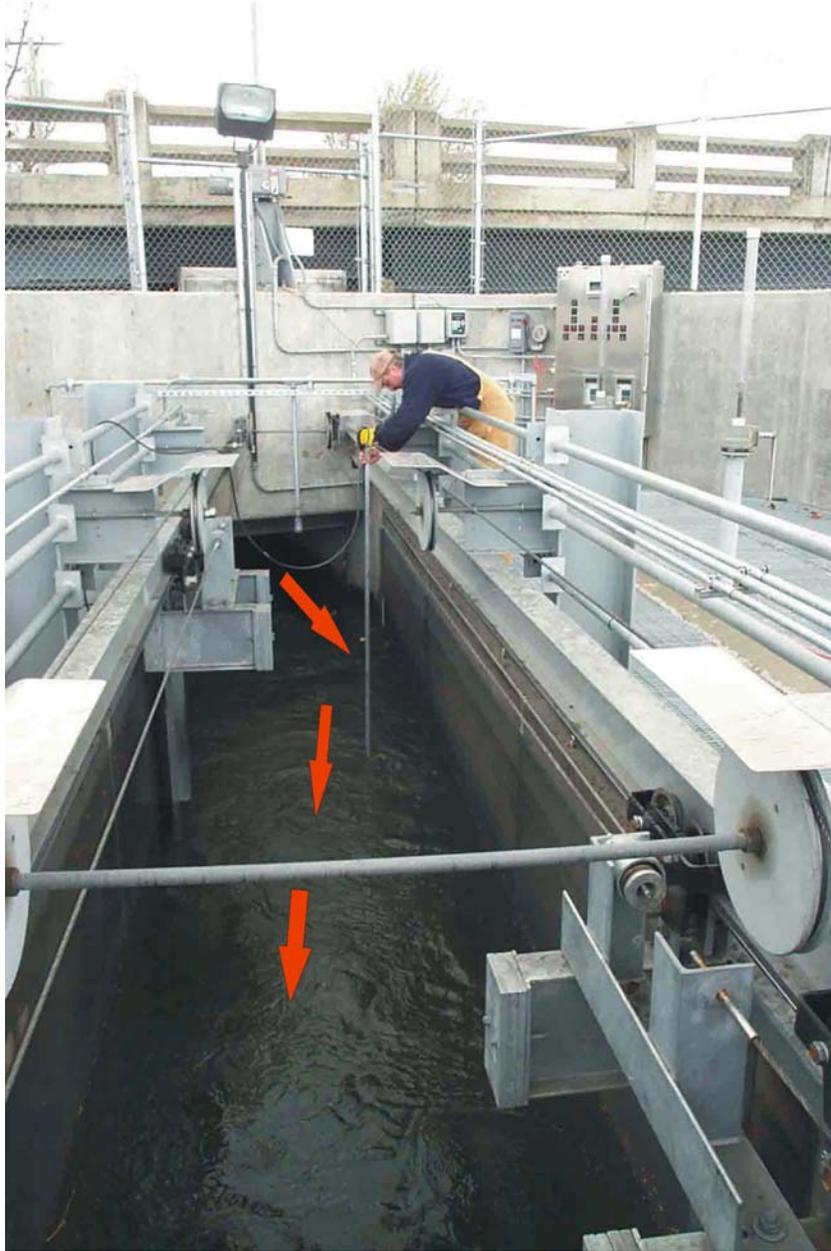
Figure 1-2. Nursery Bridge Fishway auxiliary water supply (AWS) screens.
The red arrows show the direction of water flow.

The evaluation of existing screen sites is important to ensure that the sites achieve the goal of protecting fish from entrainment into the irrigation systems (McMichael et al. 2004). The screens at the Nursery Bridge Fishway were evaluated during spring 2004 to determine whether conditions were conducive to safe fish passage and whether the site was operating within criteria developed by NOAA Fisheries. The Nursery Bridge Fishway is located on the east bank (river right) of the Walla Walla River near the town of Milton-Freewater, Oregon (Figure 1-1). The fish-screen facility is located at the upstream end of the ladder and is used to draw water through the auxiliary water supply (AWS) to increase attraction flow at the ladder entrances. This facility consists of two horizontal-bar screens facing each other with a channel in between (Figure 1-2).

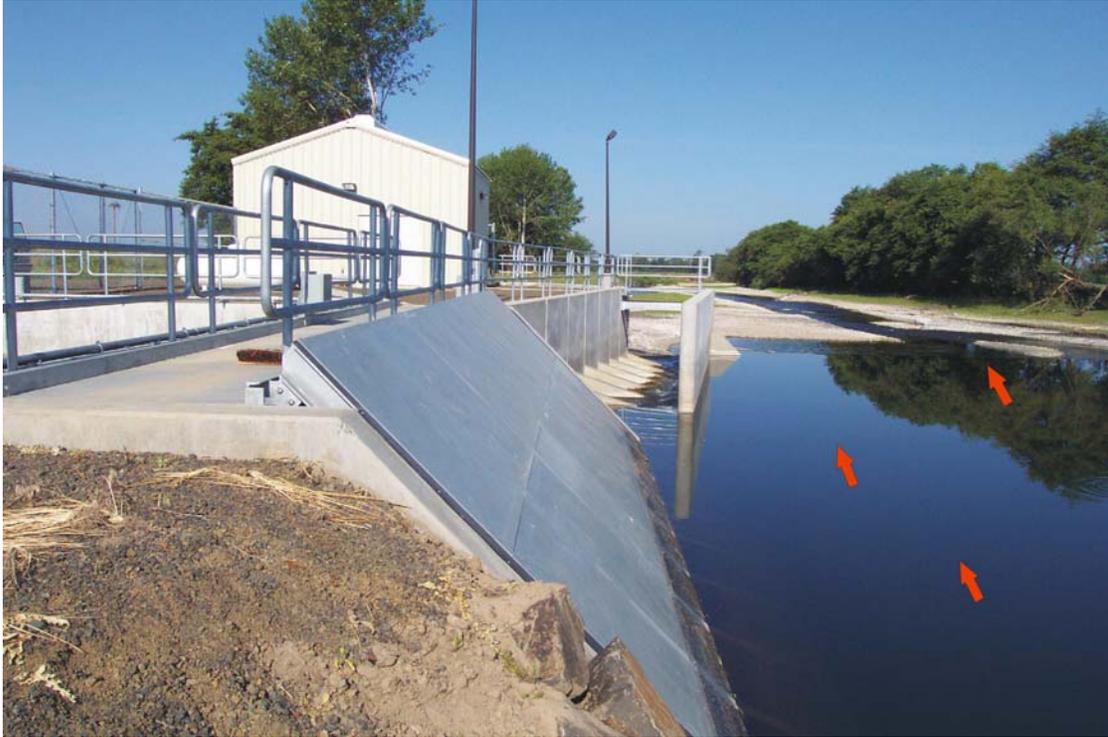
Figure 1-3. Garden City/Lowden II fish screens. The red arrows show the direction of water flow.

The Garden City/Lowden II site is located about 2 mi east of the town of Lowden off Highway 12 (Figure 1-1). The site has an inclined plate screen with eight 6-ft high × 4-ft wide screen panels (Figure 1-3). The site was evaluated in July 2004 to determine whether conditions were conducive to safe fish passage and whether the site was operating within criteria developed by NOAA Fisheries and also to determine whether any changes in the baffle settings were needed, based on measurements, to put the site within NOAA Fisheries criteria.

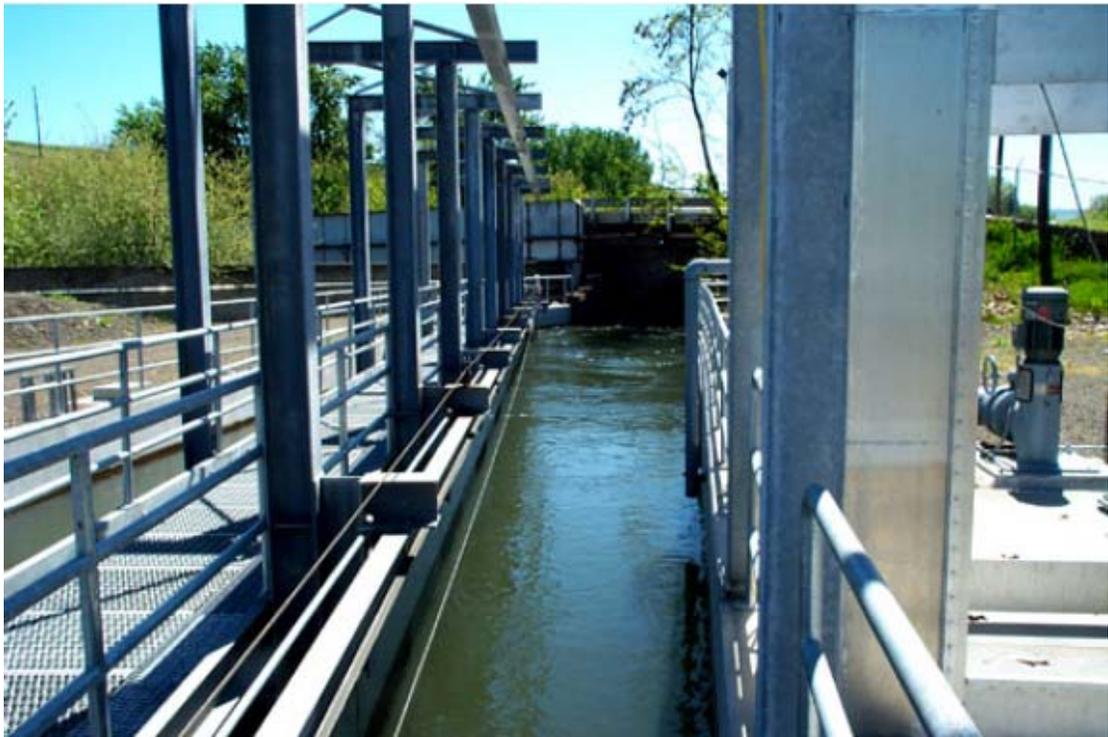
Figure 1-4. Little Walla Walla Screens.

The Little Walla Walla diversion is located at river mile 47 on the west bank of the Little Walla Walla River, within the city limits of Milton-Freewater, Oregon (Figure 1-1). The Little Walla Walla site was updated in 2000 by the construction of a set of 11 flat plate screens of stainless steel wedgewire design with 0.069-inch openings (Figure 1-4).

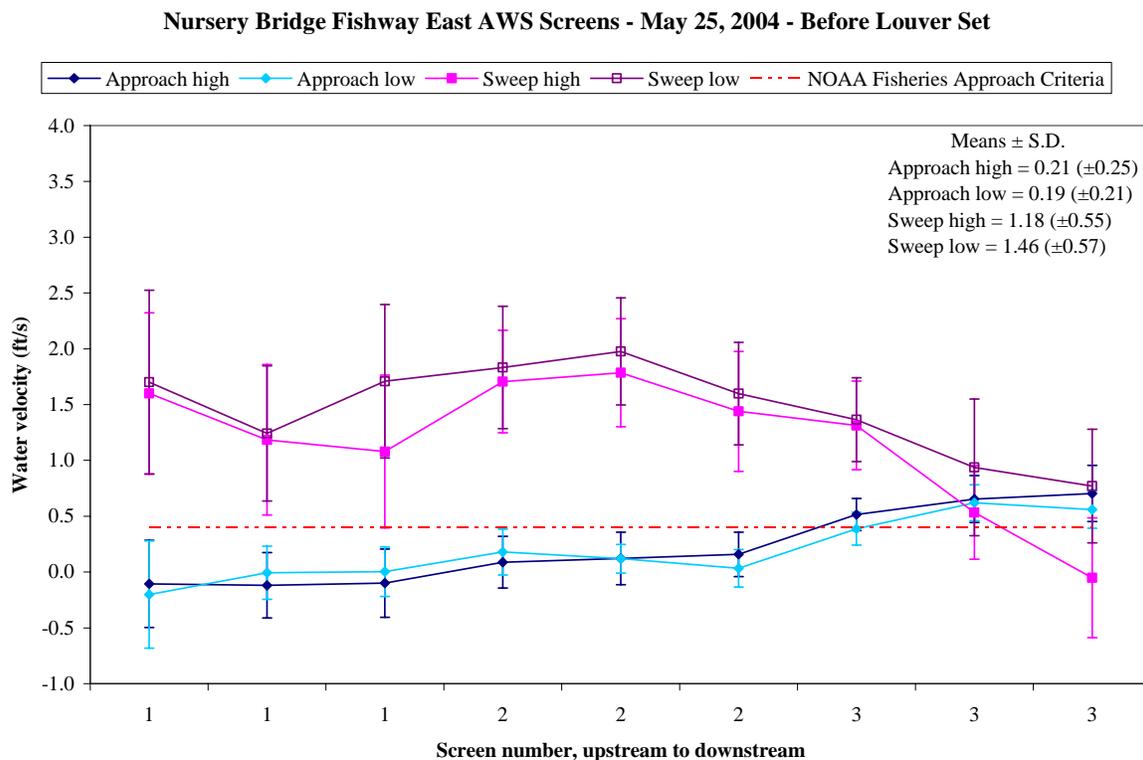
The Nursery Bridge site was evaluated May 25, 2004 to determine whether changes in louver settings would result in lower approach velocities that would bring the site into compliance with NOAA Fisheries screen criteria. For the purpose of PNNL's evaluations, a site is considered to be in compliance with NOAA Fisheries criteria if less than 10 percent of the measured approach velocities exceed 0.4 ft/s (McMichael et al. 2004). An entire set of velocity measurements at 0.2 and 0.8 of depth, in front of both sets of AWS screens (east and west) was taken before the louvers were moved. A cursory, on-site examination of the data showed approach velocities exceeded NOAA Fisheries criteria of 0.4 ft/s on the east screens at 5 out of 18 locations, all at the most downstream screen, and on the west screens at 9 out of the 18 measured locations, mostly at the lower depth (Figures 3.1 and 3.2).

Figure 3-1. Initial approach and sweep velocity measurements at the Nursery Bridge Fishway east AWS screen on May 25, 2004. The dashed line at 0.4 ft/s represents NOAA Fisheries criteria for approach velocities. The error bars (\pm the standard deviation) represent turbulence at each point. The text box shows the mean across all screens for the measured parameter.

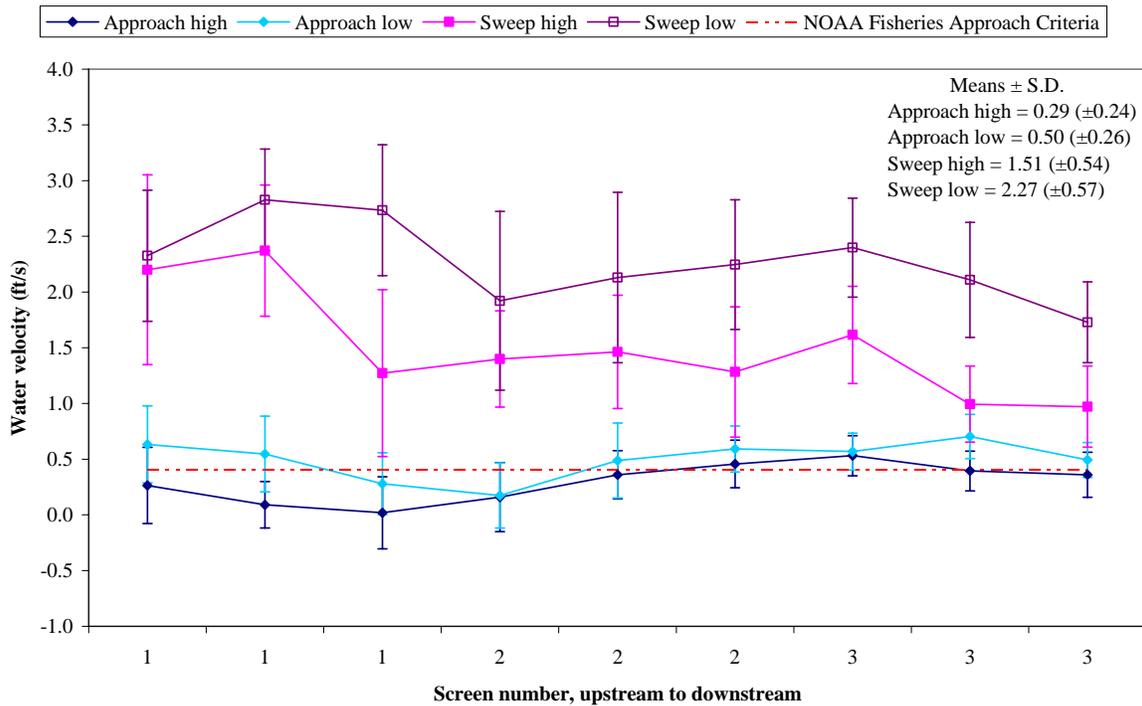
Nursery Bridge Fishway West AWS Screens - May 25, 2004 - Before Louver Set

Figure 3-2. Initial approach and sweep velocity measurements at the Nursery Bridge Fishway west AWS screen on May 25, 2004. The dashed line at 0.4 ft/s represents NOAA Fisheries criteria for approach velocities. The error bars (\pm the standard deviation) represent turbulence at each point. The text box shows the mean across all screens for the measured parameter.

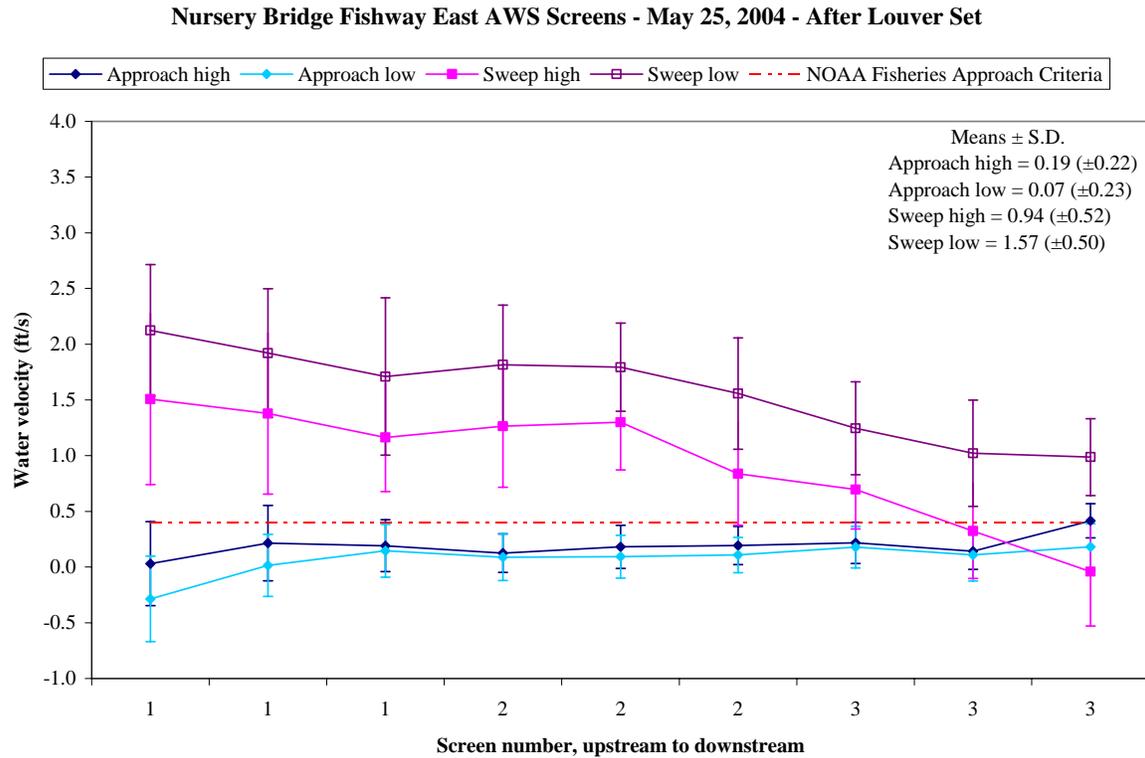
A second set of measurements was taken after the louvers were moved. The results showed that only one out of 18 measured locations on the east side exceeded 0.4 ft/s. On the west side, the number of points that exceeded criteria remained the same (Table 3.1, Figure 3-3, and Figure 3-4).

Figure 3-3. Approach and sweep velocity measurements at the Nursery Bridge Fishway east AWS screen after setting the louvers. The dashed line at 0.4 ft/s represents NOAA Fisheries criteria for approach velocities. The error bars (\pm the standard deviation) represent turbulence at each point. The text box shows the mean across all screens for the measured parameter.

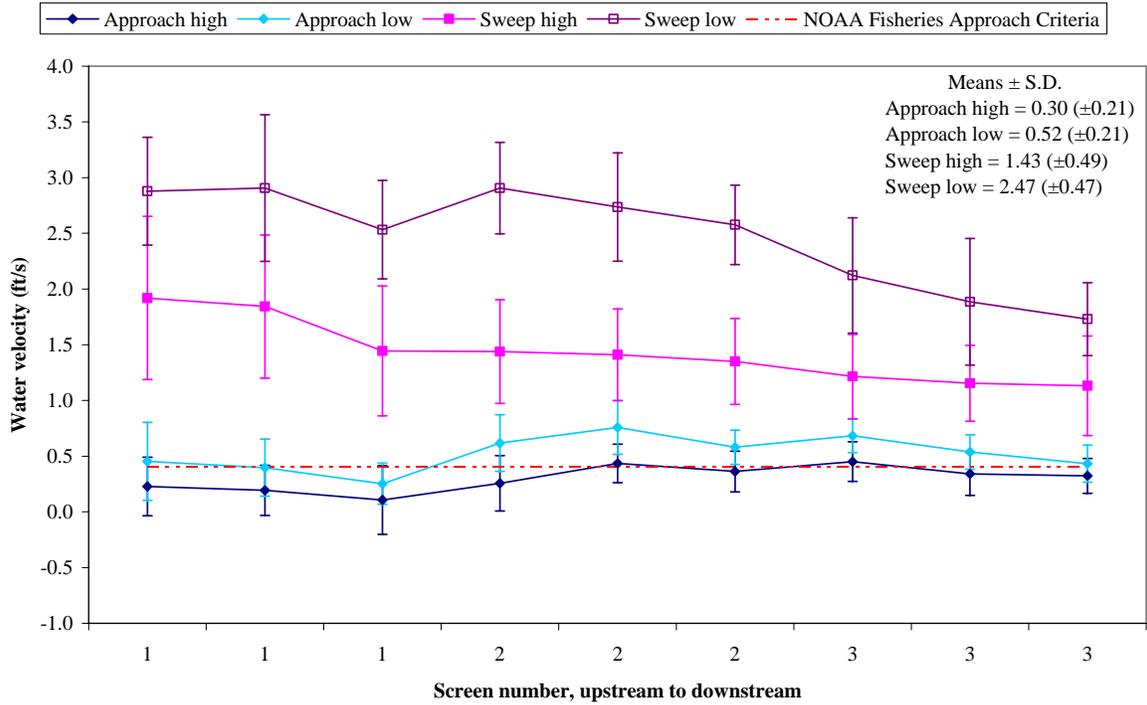
Nursery Bridge Fishway West AWS Screens - May 25, 2004 - After Louver Set

Figure 3-4. Approach and sweep velocity measurements at the Nursery Bridge Fishway west AWS screen after setting the louvers. The dashed line at 0.4 ft/s represents NOAA Fisheries criteria for approach velocities. The error bars (\pm the standard deviation) represent turbulence at each point. The text box shows the mean across all screens for the measured parameter.

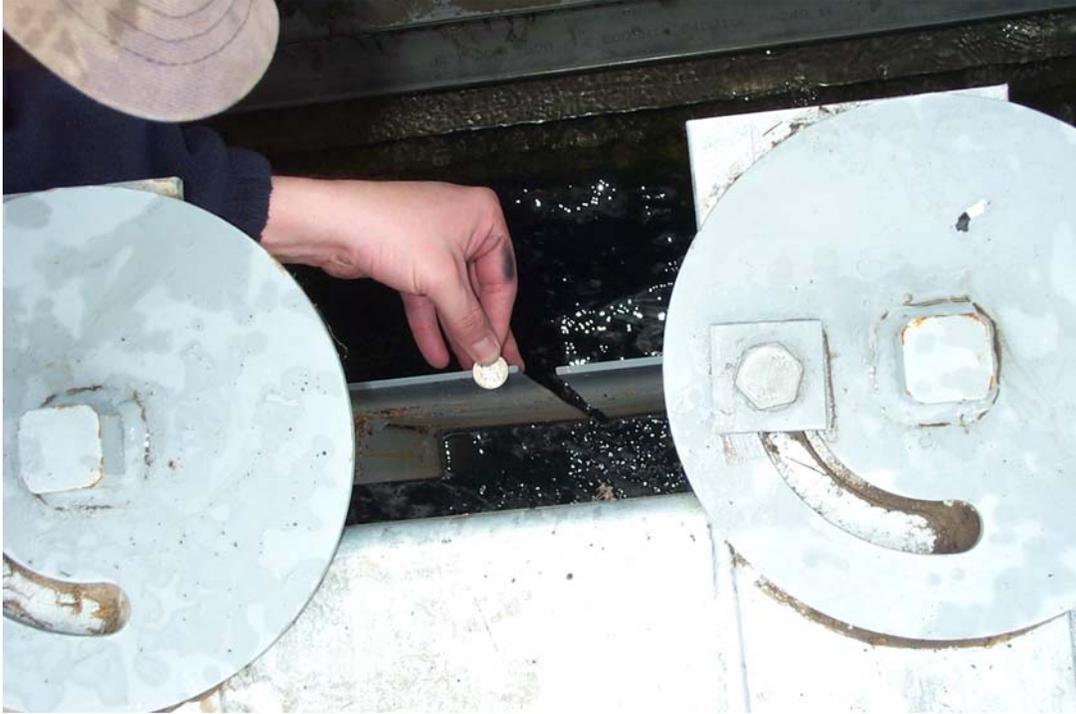
Changing the louver settings behind the screens did not change the flow patterns sufficiently to put the screens in compliance with NOAA Fisheries criteria for approach velocity, especially in front of the west screen. Two factors contribute to this problem. The first is the site design. The water enters the site at an angle toward the west screen, in essence hitting the west screen with more force (and higher velocities) than it would if the majority of the flow passing through the AWS screen area were parallel to the screen face. The second problem is the louver design/fabrication. Generally, louvers are designed to slightly overlap so that when completely closed, almost no water passes through them. The louvers at the Nursery Bridge Fishway do not overlap; they do not even meet. There is a gap approximately 0.9 in. wide (Figure

3-5) between the louvers when they are completely in the “closed” position. This gap allows water to flow through the screens even when the louvers are completely closed. Therefore, the approach velocity problems at this site cannot be fixed merely by closing the louvers. To conclude, the site was not constructed to operate within NOAA Fisheries criteria under all flow conditions, and to bring the site into compliance would require physical changes in the facility.

Figure 3-5. The louvers at Nursery Bridge Fishway auxiliary water supply screens had a gap the size of a nickel (approximately 0.9 in.) between them when fully closed.

The 2004 evaluation of the Nursery Bridge Fishway AWS screens indicates that the site was not constructed to provide fish safe and efficient passage. Initial approach velocities exceeded NOAA Fisheries criteria at 39% of the measured positions. Physical changes to the louvers and/or the structure will need to be made to put the site into compliance with NOAA Fisheries criteria,

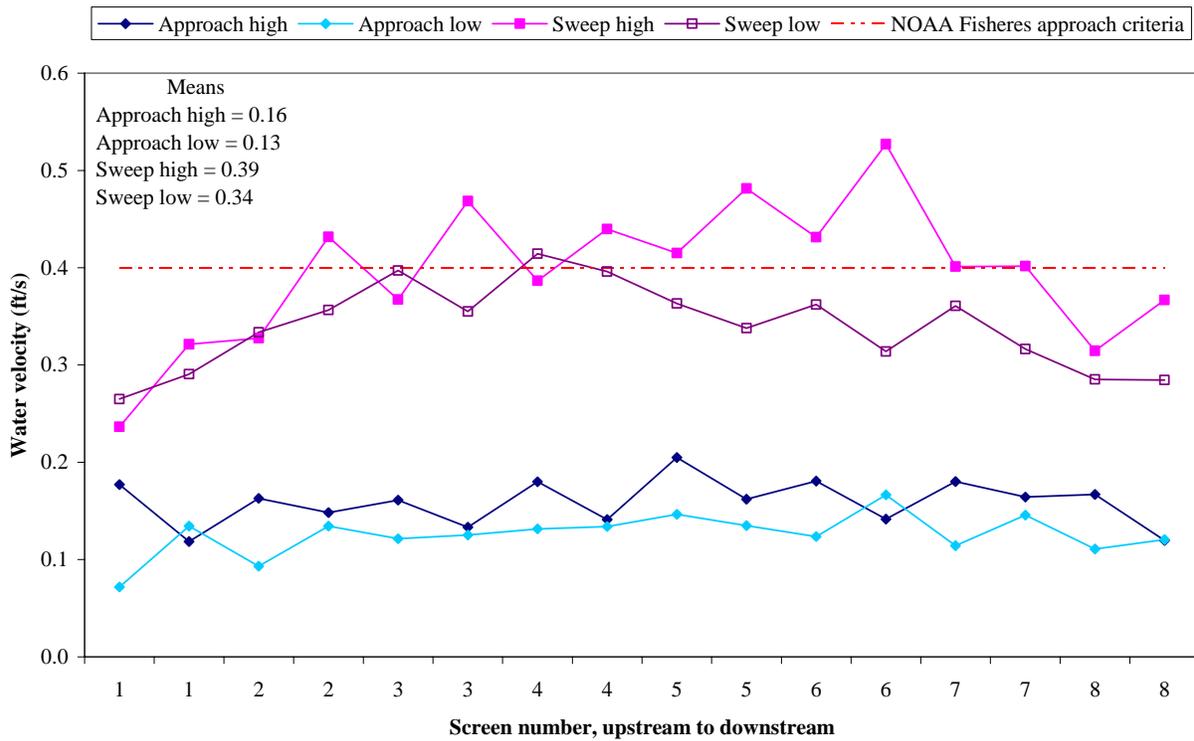
Garden City/Lowden II, July 19, 2004

Approach velocities were well within NOAA Fisheries approach criteria. Sweep velocities were generally greater than approach velocities (Figure 3-6). The sweep velocity increased slightly from upstream to downstream within the site, and velocities tended to be somewhat variable from point to point. The ratio of sweep to approach was 2.6, which should be sufficient to provide a clear direction for fish movement through the site.

Figure 3-6. Approach and sweep velocities at Garden City/Lowden II fish screens on July 19, 2004. The dashed line at 0.4 ft/s represents NOAA Fisheries criteria for approach velocities. The text box shows the mean across all screens for the measured parameter.

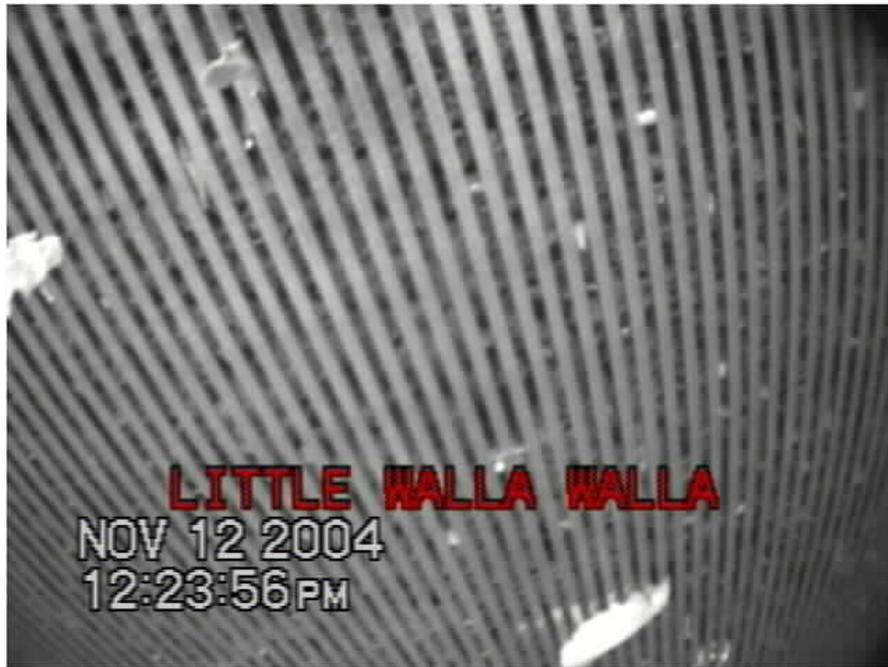
The Little Walla Walla fish screens were evaluated November 12, 2004 to determine how a buildup of algae on the screens affected water velocities. A visual examination of the screens did not reveal any indication of algae growth; in fact the screen surfaces appeared very clean. A video survey showed that the algae had built up in between the vertical bars of the screens where the brushes do not penetrate (Figure 3-7) and that the algae buildup in the screens was heavier at the bottom than at the top. At the time of the survey there was approximately 7 inches of headloss across the screens.

Figure 3-7. Little Walla Walla screens; note the clean exterior of the bars and the algae buildup in between the vertical bars.

The Little Walla Walla site met NOAA Fisheries criteria for approach velocities and appeared to be designed, constructed, and operated to effectively provide for safe fish passage through the site. The algae buildup in the screens did not appear to have any negative consequences in terms of fish passage.

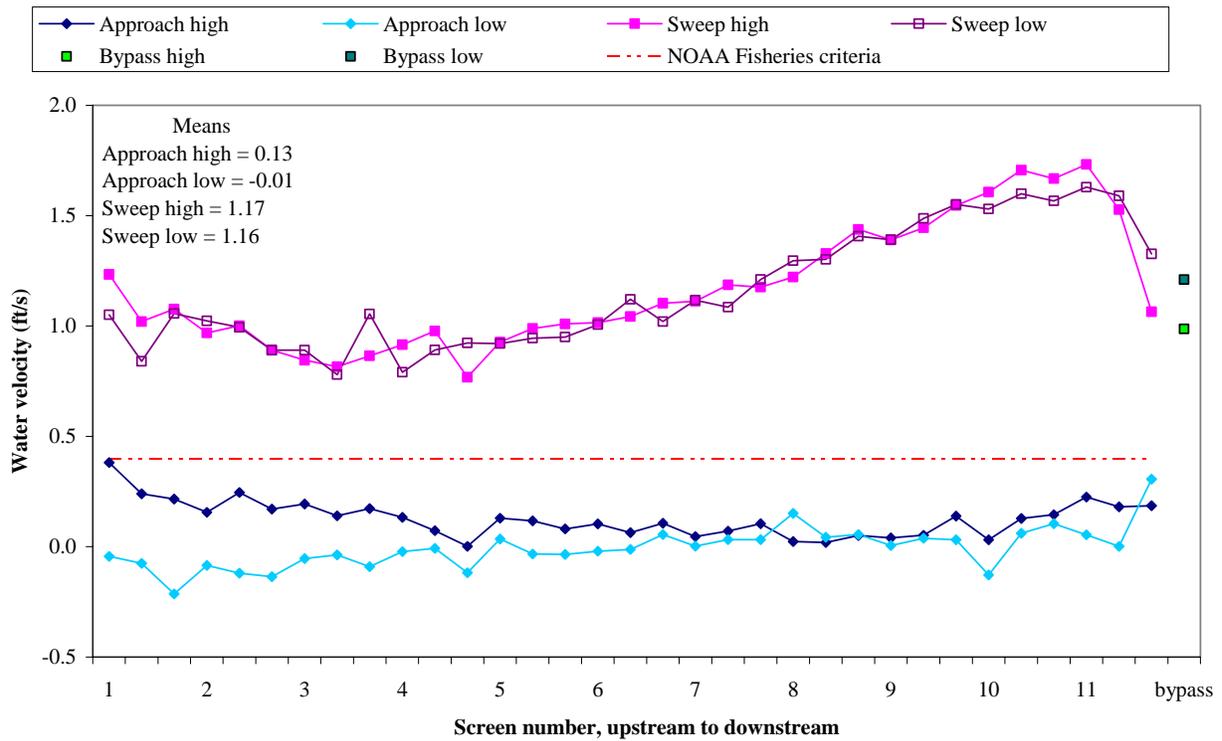
Little Walla Walla - November 12, 2004

All approach velocities met NOAA Fisheries criteria of < 0.4 ft/s (Figure 3-8). Sweep velocities were always higher than approach velocities. Sweep velocities increased slightly towards the bypass, although average bypass velocity was lower than the average sweep velocity. Based on these results, it appears that the algae growth and resulting head differential across the screens is a problem with potential consequences for irrigators, but not for fish. It is unclear from these results what the pattern of water velocities would be if the screens were cleaned out.

Figure 3-8. Approach and sweep velocities at the Little Walla Walla fish screens on November 12, 2004. The dashed line at 0.4 ft/s represents NOAA Fisheries criteria for approach velocities. The text box shows the mean across all screens for the measured parameter.
