A FISHERIES EVALUATION OF THE DRYDEN FISH SCREENING FACILITY

Annual Report 1994

Pacific Northwest National Laboratory

Project No. 85-062
Contract No. DE AI79-93BP00029

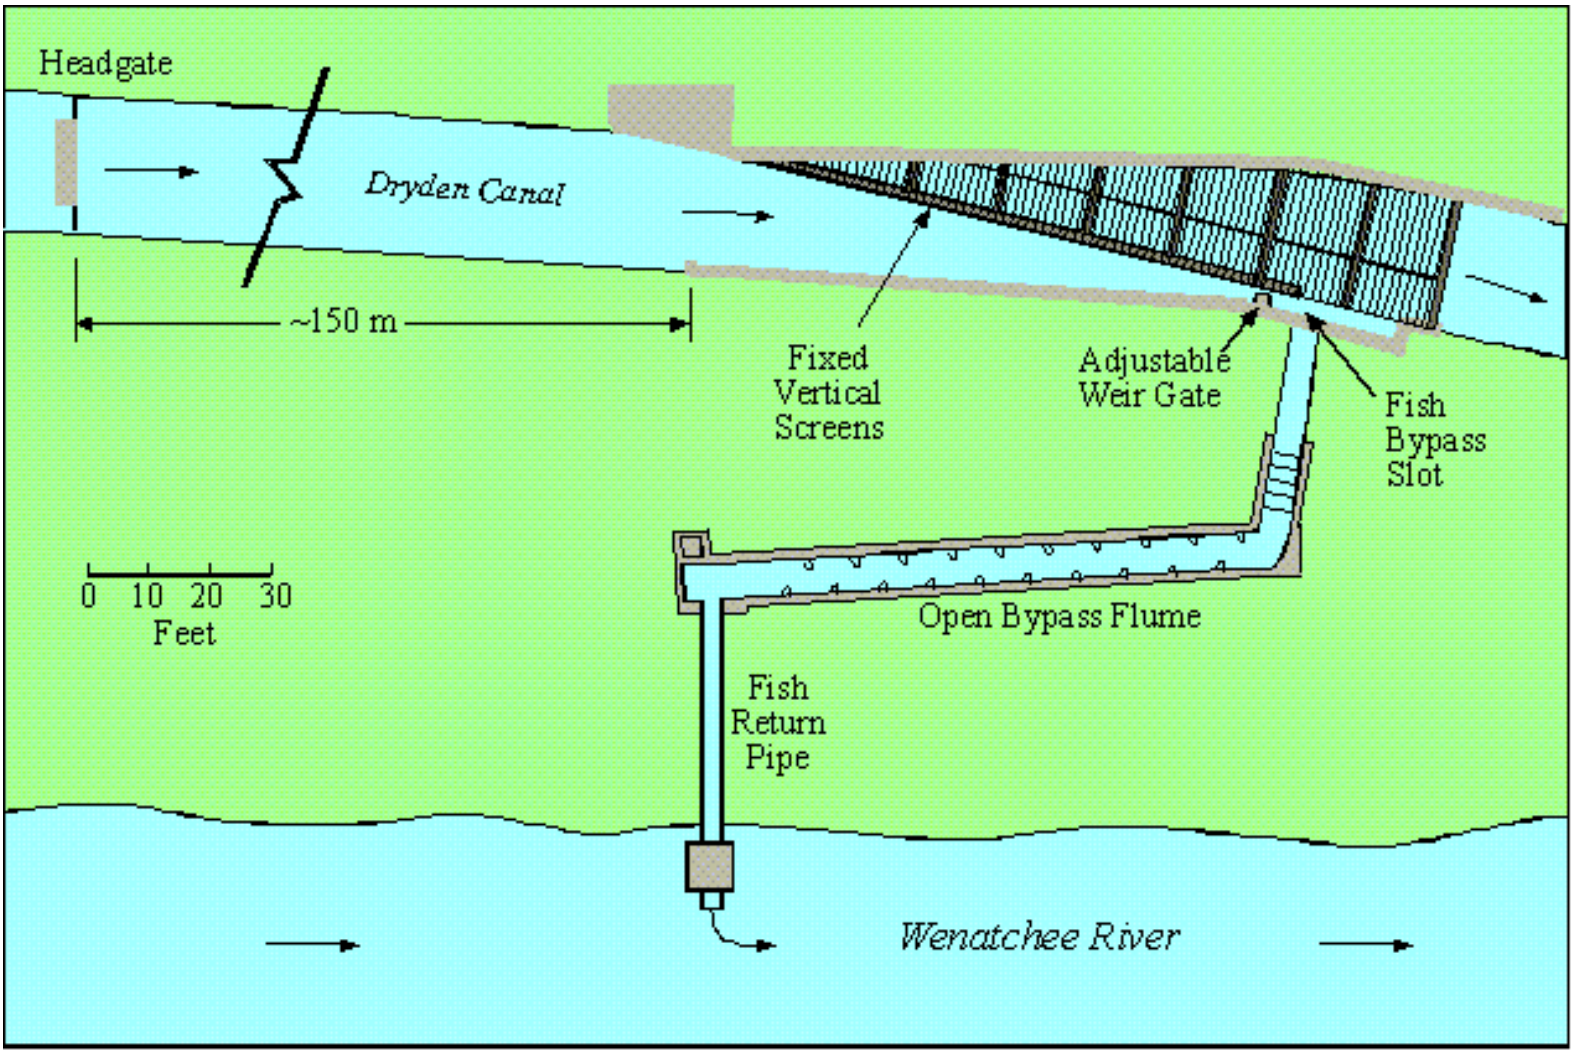
Figure 3. Flow Control Structure and Fish Bypass System in the Dryden Fish Screening Facility

The bypass weir gate was found out of adjustment several times during visits to the site. Low bypass flows can contribute to migration delays. High bypass flows can cause excessive turbulence in the bypass flume. Fish may also get washed into and trapped inside the flume baffles. The bypass weir crest gate is supposed to be maintained at a level 20 in. below the forebay elevation. Although there is a staff gage to measure the canal surface elevation in the forebay, there is no staff gage or operator aid with which to set the adjustable weir. A simple way to accurately set the weir crest would be to construct a "paper" table correlating the height of the weir gate (as measured by the length of weir gate shaft exposed above the collar) to canal surface elevation.

Entrainment of air in the lower section of the fish return pipe occurred during low river stages. The anti-surging vent seemed to be effective at eliminating most of the air trapped in the pipe during high river flows, as little boiling near the pipe terminus was observed. However, at lower flows that occurred when conducting the bypass descaling test, trapped air forced water to splash about five ft upwards from the top of the bypass pipe. This event occurred at regular intervals every few minutes.

A large log wedged in the entrance to the fish bypass almost prevented the bypass descaling test. The log was subsequently removed by reducing the bypass flow. Similar problems were experienced with large woody debris during previous tests in April and May. Floating objects that are thrown or drift into the canal could damage the cleaning brush mechanism or cause injury to fish if the objects become lodged in the fish bypass.

Efforts should be made to ensure that bypass flow is always set at 20 cfs at the Dryden Screens. Flow regulation could be achieved by using automated headgate valves. It may be necessary to add a check structure to ensure proper forebay elevation. Automated head gates would also prevent overtopping of screen panels if the cleaning brush system failed. If manual headgates valves are used, bypass flow regulation could be improved if a staff gage was added to the bypass weir gate and a table was added to the operating criteria showing the correct valve setting based on canal forebay surface elevation. Regardless of how flow regulation is achieved, it is important to stress the need for maintaining a 20 cfs flow through the fish bypass. A surface water elevation gage should also be added behind the screens so that head differential can be monitored easily.

Annual inspection of the headgate structure, screen surface, seals, cleaning bush, and bypass pipe/flume is highly recommended. The bypass system, including primary pipe, open baffle flume, and secondary pipe should be inspected before the canal is filled with water. Partial blockages from sticks or other debris in the bypass pipe could occur without causing descaling or injuries to fish. However, over time small blockages could grow and cause injury or migration delays. Screen operators should be trained to look for signs of blockage and check for normal flow in the bypass as part of their daily screen inspection. It is also advisable to periodically clean the bypass pipe by passing a device (slightly smaller than the diameter of the pipe) through the pipe to detect and dislodge debris in the pipe. The success of fish enhancement and restoration programs within the Columbia Basin will depend on screening facilities that do not delay, injure, or entrain salmonid fry or smolts during rearing or migration.

The headgates and bypass trash rack should be inspected at regular intervals to minimize flow constraints by debris, especially when there is a lot of floating debris in the river. Large debris must be removed and not allowed to enter the canal, where it could potentially damage the profile bar panels or brush assembly, or become lodged in the fish bypass. In addition, large debris should be removed from along the canal upstream of the screening facility to prevent it from being thrown into the canal.

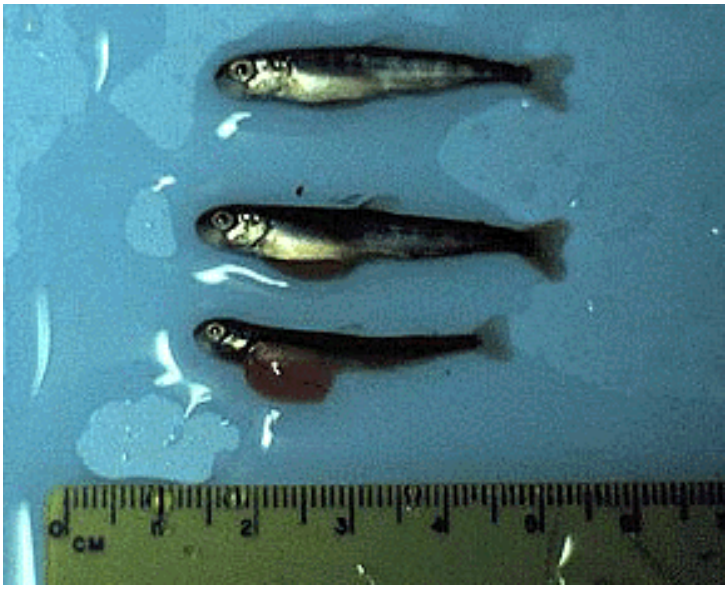
Figure 15. Picture of Wild Chinook Salmon (*Oncorhynchus tshawytscha*) Fry Caught on the Inclined Plane During Integrity Test at the Dryden Fish Screening Facility, May 1994

Other species captured in the fyke net behind the screens included 5 dace (*Rhinichthys spp.*), 2 whitefish (*Prosopium spp.*) and 10 wild chinook fry (Table 5). Wild chinook salmon fry caught in the fyke net ranged from 36 to 42 mm in FL while salmon fry caught on the inclined plane ranged from 27 to 49 mm in FL (Figure 14). Head width of rainbow trout fry (test fish) recovered ranged from 3.11 to 3.58 mm. Head width measured on the 10 wild chinook salmon fry captured in the fyke net ranged from 4.26 to 4.34 mm. A total of 768 wild chinook fry were captured on the inclined plane during the integrity test. Using the entrainment formula, an estimated 6% of the salmon fry were entrained in the canal. Wild chinook salmon fry caught on the inclined plane ranged in age from alvins with yolk sacs to more advanced fry (Figure 15). A large proportion of the wild chinook salmon fry were in various stages of yolk sac absorption. All captured wild chinook salmon fry were returned unharmed to the fish bypass.

Based on the screen integrity tests and previous laboratory studies by other researchers, a 3.175 mm (0.125 in.) profile bar screen is too coarse to protect chinook salmon fry or early life stages of other smaller salmonid and resident fish species. The newest screening criteria adopted by the WDFW calls for 1.75 mm (0.069 in.) profile bar for protecting salmon and steelhead fry (Appendix A). Therefore, the replacement the existing 3.175 mm (0.125 in.) profile bar at Dryden Screens with profile bar with 1.75 mm or smaller openings is recommended.

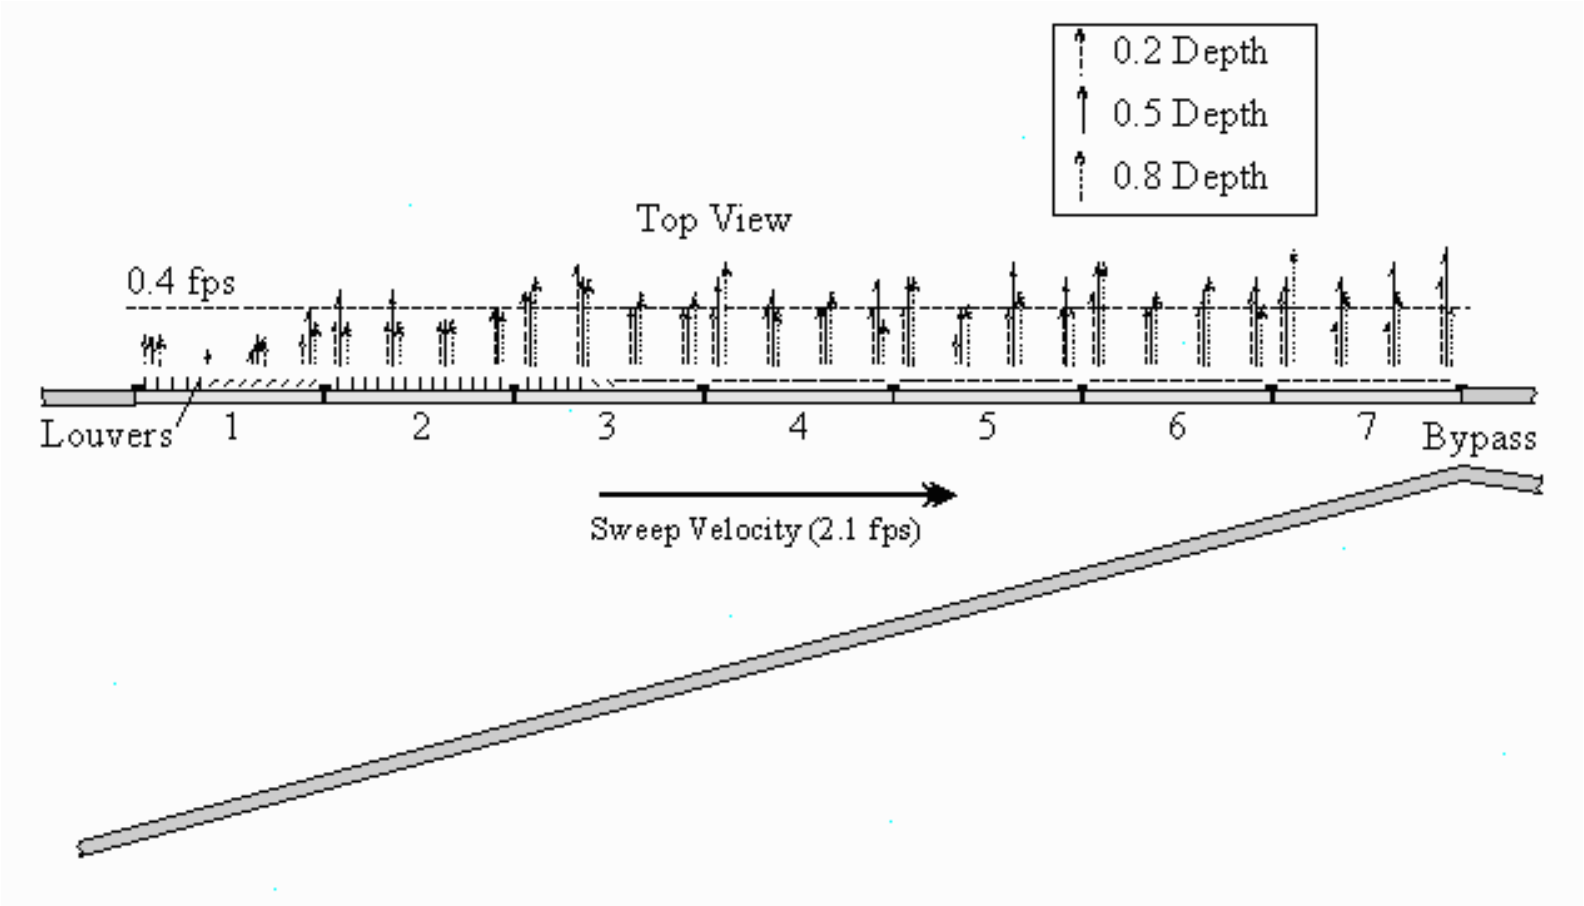
Figure 16. Water Velocity Profiles Through and Across the Screen Face of the Profile Screen Panels at the Dryden Fish Screening Facility, Measured on April 12, 1994

Velocity measurements through the screen panels is summarized in Table 6. Very little water passed through screen panel 1, and velocity through screen panel 2 was less than velocity through screen panels 3-7. Adjustable vertical louvers (13 behind each screen panel) were in the full "open" position behind screen panels 1, 2, and the upstream half of screen panel 3. The louvers were completely closed on the downstream half of screen panel 3 and on screen panels 4-7 (Figure 16).

Approach velocity measurements showed velocities exceeding the 0.4 ft/sec recommended screening criteria at the downstream screen sections, despite the louvers being in the fully closed position. The lowest approach velocities occurred at the two upstream panels. The installation of wider louvers behind the downstream screens (panels 4-7) may be needed to produce uniform flow through all screen sections and prevent velocities from exceeding approach velocity criteria when the canal is full.
