Washington Phase II Fish Diversion Screen Evaluations in the Yakima River Basin

**Annual Report
1997**

DOE/BP-00029-5

February 1998

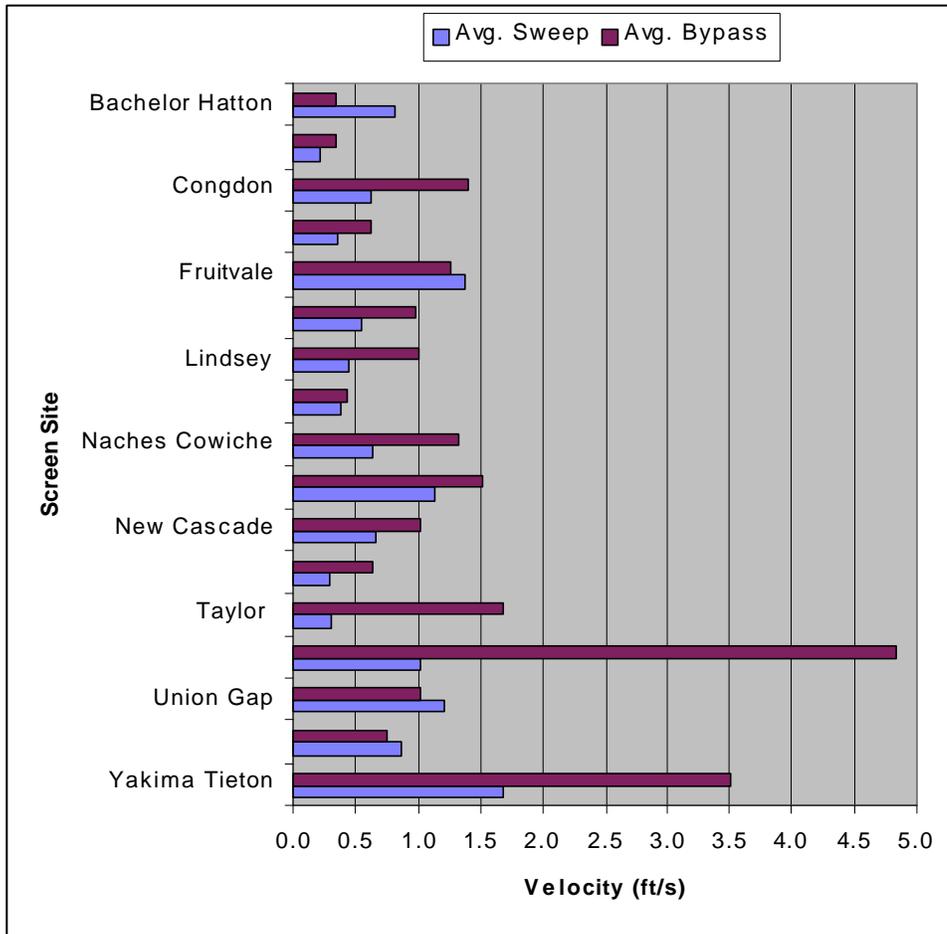
Figure 7. Average Sweep and Bypass Velocities by Site.

Bypass flows were usually faster than the average flow past the screens (Figure 7). Only three of nineteen sites had average bypass velocities less than their average sweep velocities, i.e., Bachelor Hatton, Union Gap, and Upper WIP. One explanation was that at Bachelor Hatton, large accumulations of sediments (up to 11 inches in depth) were observed in the bypass during all three evaluations. At Union Gap, the weir gate was never observed in the full open position. However, it was being operated according to the operating criteria that recommend that 1 foot of water flow over the weir. At Upper WIP, while the weir gate was always in full open position, sedimentation was present and rocks blocked flows from the outfall pipe.

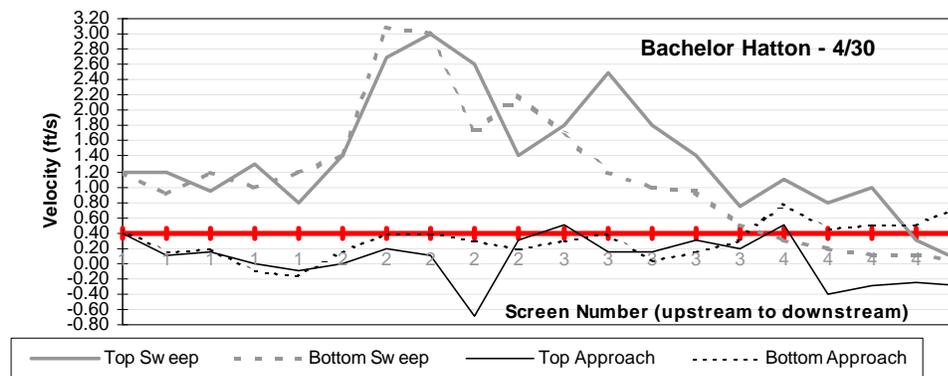
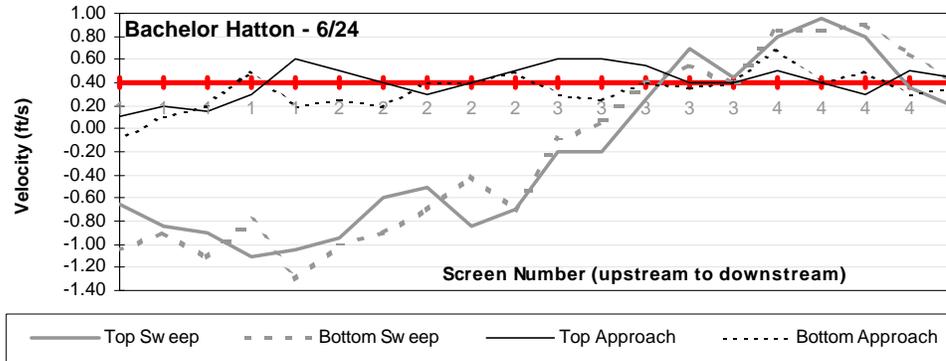
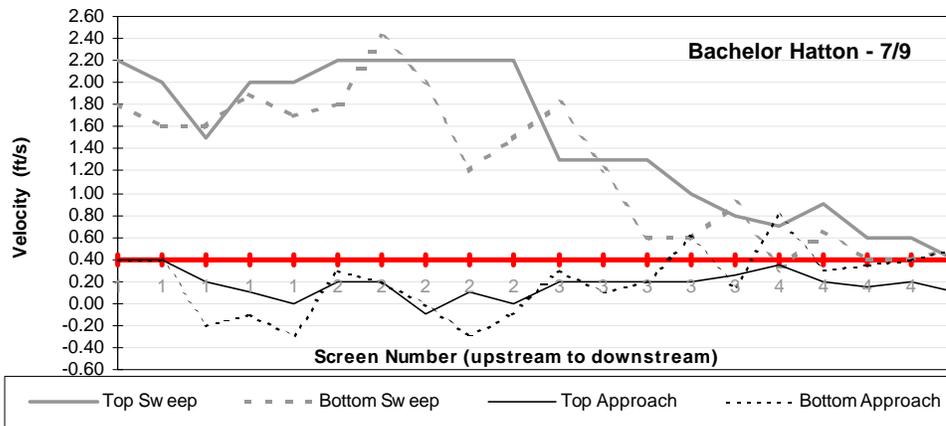
Bachelor Hatton flows showed a general trend during the entire evaluation period, as sweep velocities were quite distinct from approach velocities in front of Screens 1 through 3, but merged together in front of Screen 4 (Figures 16-18). During the June evaluation, an eddy in front of Screens 1 and 2 produced negative sweep velocity values. Approach velocities during the three evaluation periods were relatively consistent. Average approach values were less than 0.4 fps except for the June top approach, which averaged 0.41 fps. Maximum approach flows at this site were 0.8 fps, in front of Screen 4 on 4/30 and 7/9/97. Of all approach velocity measurements taken at Bachelor Hatton, 12.5% exceeded criteria.

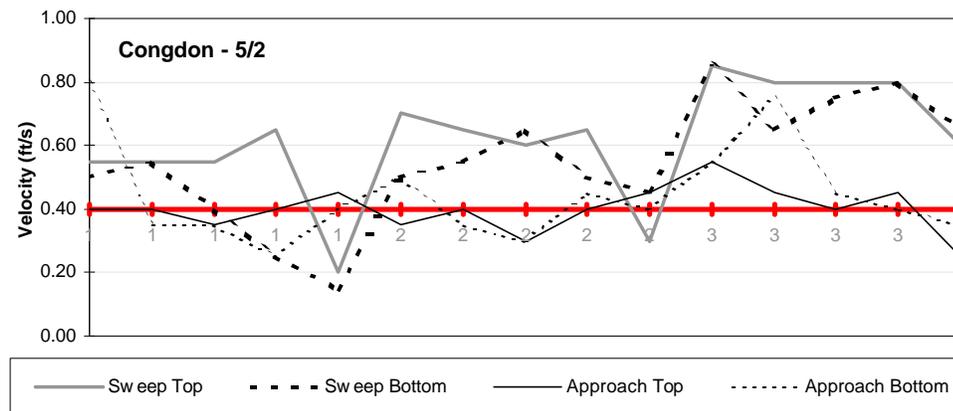
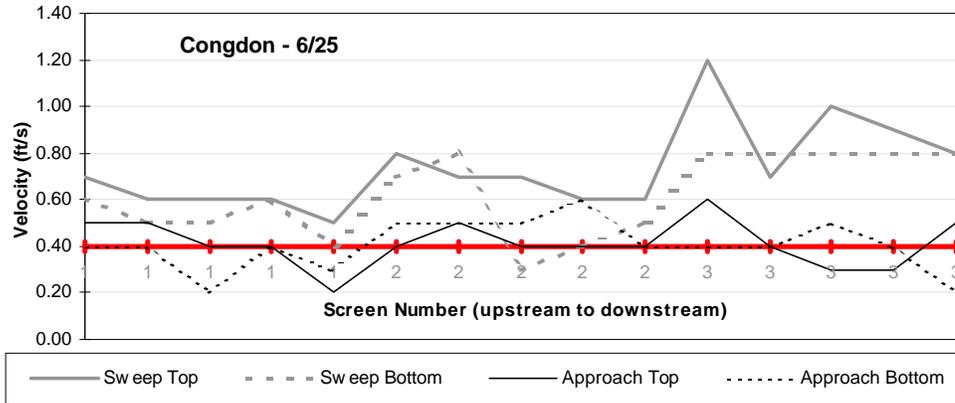
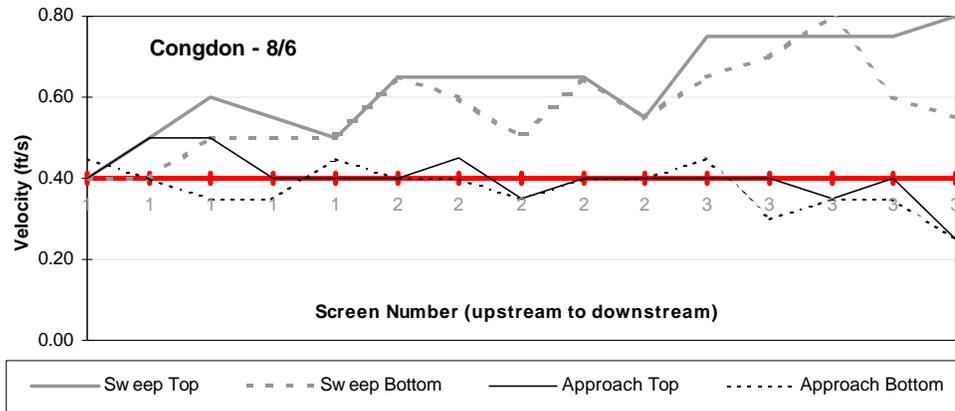
Some trends in approach velocities were evident at this site. For example, top sweep velocities were usually greater at the middle of each screen than at the ends (Figures 22-24). Bottom sweep velocities showed a similar pattern, but were not as pronounced. Approach velocities were much more constant. Sweep velocities were generally greater than approach velocities, but there were exceptions, mainly in front of Screens 1 and 2. High approach velocities were common at this site as 31.1% of all approach velocities measured exceeded the 0.4 fps criteria. High approaches were measured during all three evaluations and occurred in front of all three screens.

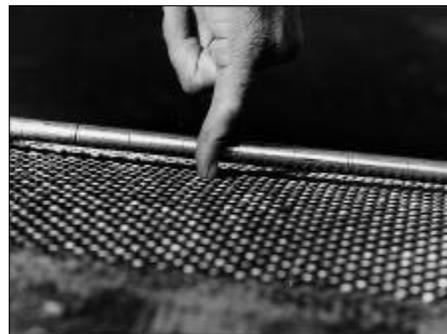
Figure 25. Flat Spot in Screen 2 at Congdon

Underwater video observations at Congdon revealed a small gap (approximately 0.5 in) where Screen 3 and its bottom seal contacted. Above-water evaluations indicated that all three screens had potential gaps along the bottom seal. Screen 2 had two of the largest flat spots. The depressions occurred between the internal metal bands that gave the screen its shape (Figure 25).

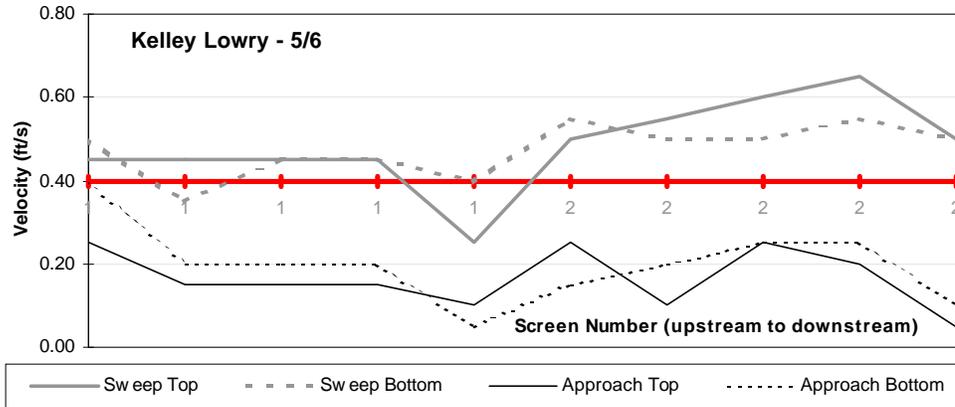
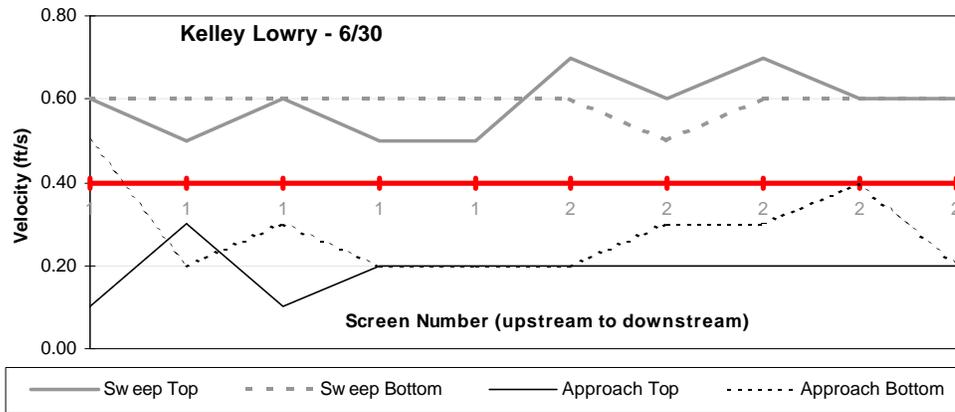
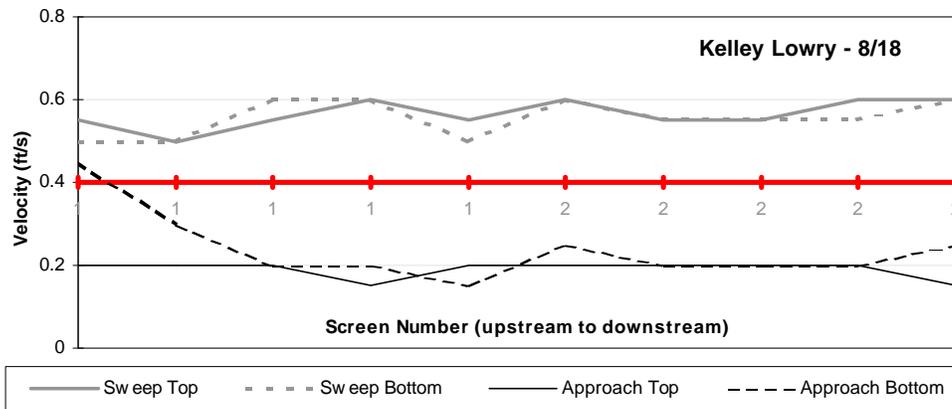
Water velocities were quite consistent from one evaluation to the next at this site (Figures 26-28). Sweep velocities were fairly constant, and fast enough to encourage fish to move toward the bypass. Velocities noticeably increased at the bypass entrance and continued to increase toward the weir. Sweep velocities were always greater than

their corresponding approach velocities. Most approach velocities met criteria. Only 3.3% of all measurements exceeded 0.4 fps. These instances both involved a bottom approach value at the upstream end of Screen 1.

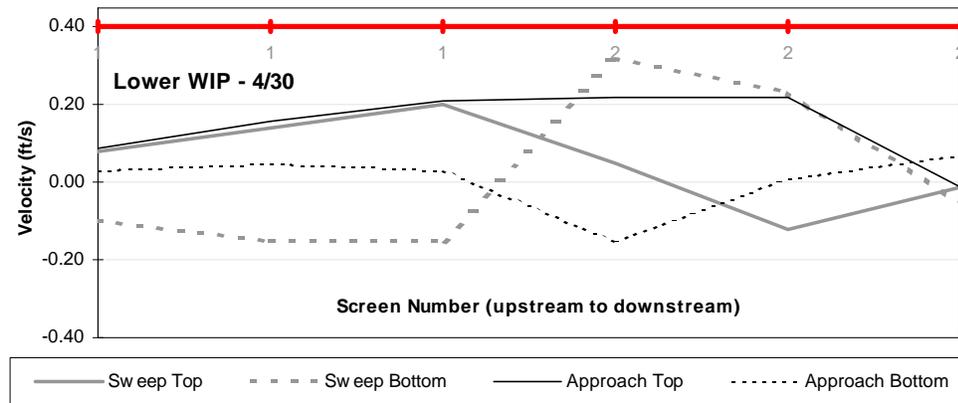
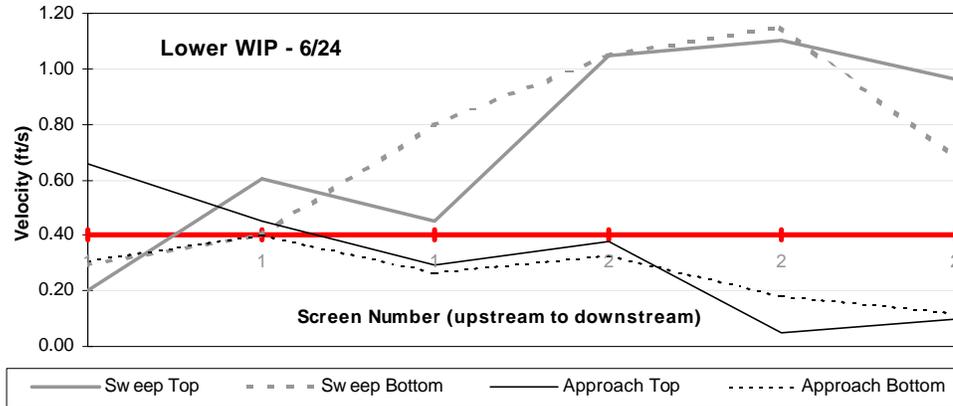
There were no obvious patterns for sweep or approach velocities except that velocities were generally greater in June than in April (Figures 32 and 33). Sweep velocities varied and were not always greater than corresponding approach velocities. The criterion for approach velocities was not met for 8.3% of the total approach measurements. The high approach velocities occurred at the upstream end of Screen 1.

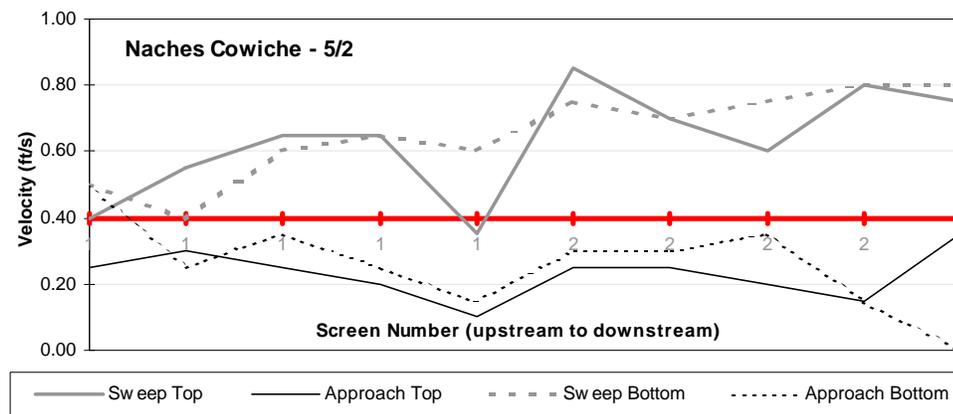
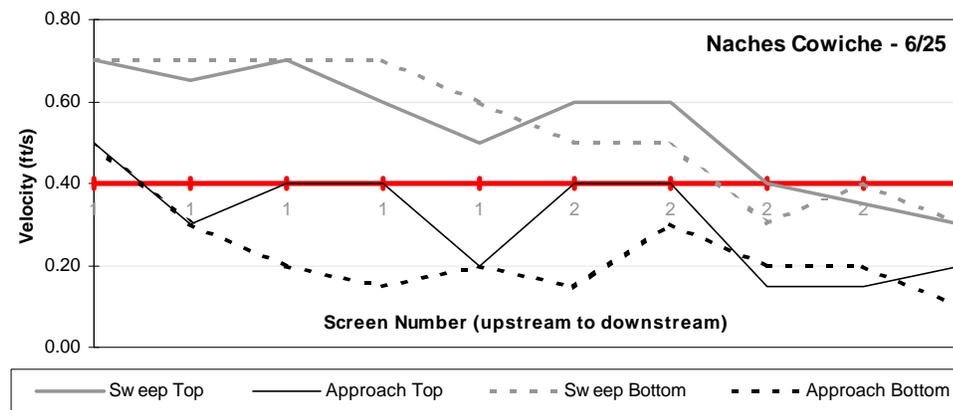
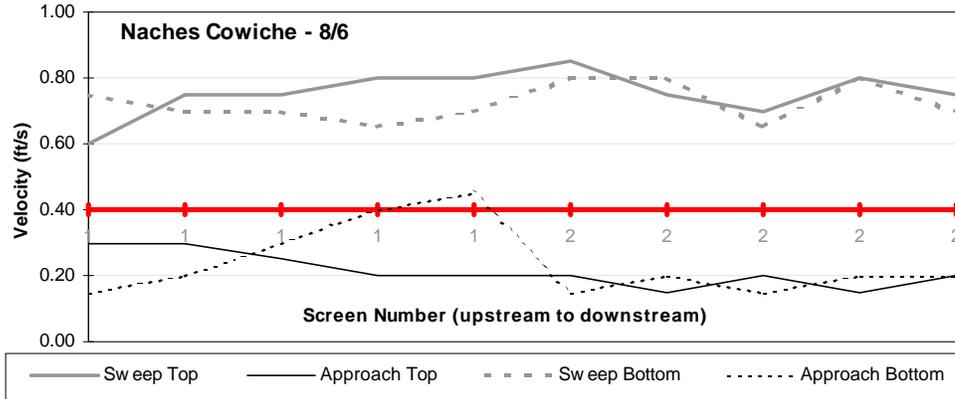
Sweep velocities were varied between visits. They increased toward the bypass except during the second evaluation (Figures 34-36). Sweep velocities were usually higher than approach velocities. The only exception occurred when a bottom approach velocity exceeded the criteria at the upstream end of Screen 1 on 5/2/97. Approach velocities exceeded criteria for 6.6% of all measurements.

Bypass flows were good during the first and third evaluations. However, water was moving very slowly in the bypass (0.2 fps) when it was measured in June. The bypass ramp was raised too high for water to flow over it. Small amounts of water were seeping around the edges of the ramp, but fish could not pass over the weir. Also, the submergence level of 86.7% slightly exceeded criteria. After these data were recorded in June, WDFW personnel arrived, noted the slow flows, and made adjustments to the ramp that corrected the problem.

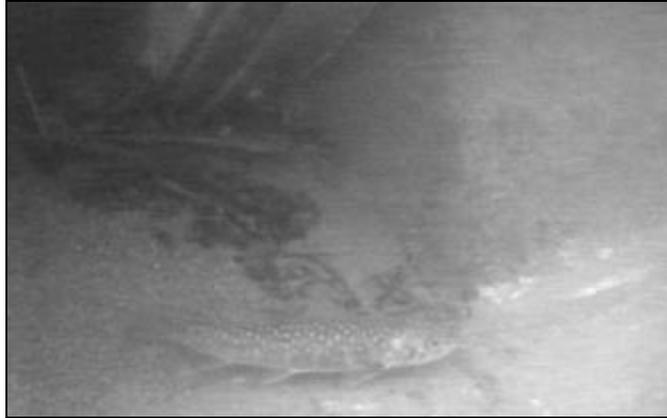
Figure 37. Trout at Naches Cowiche, 8/6/97

A net was set behind the screens on 8/6/97. Only one small sculpin, *Cottus* spp., (21-mm FL, 4-mm head width) was captured. Still, many fish were observed at this site. On the evening of August 6, more than 15 fish were seen swimming in the aftbay. One school was comprised of at least 12 redbreast shiners, *Richardsonius balteatus*. Other fish observed were several 6- to 12-inch trout, including one char, possibly a brook trout, *Salvelinus fontinalis*, as under-water video in front of the screens confirmed the presence of at least one brook trout (Figure 37).

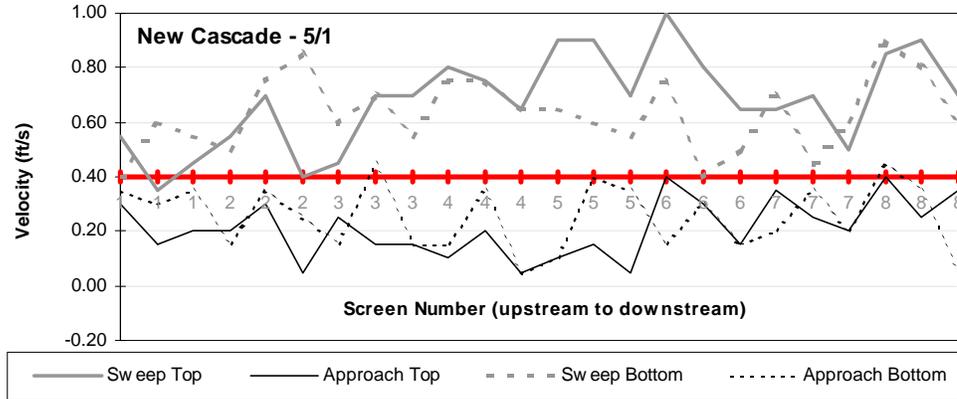
Figure 38. Water Velocities at New Cascade, 5/1/97

These flows were very inconsistent from one sample location to another, but do give a general representation of what was happening in front of the screens (Figure 38). Sweep velocities increased gradually toward the bypass and were greatest inside the bypass. Sweep velocities were always greater than their respective approach velocities. Only 4.2% of the approach measurements were greater than 0.4 fps.

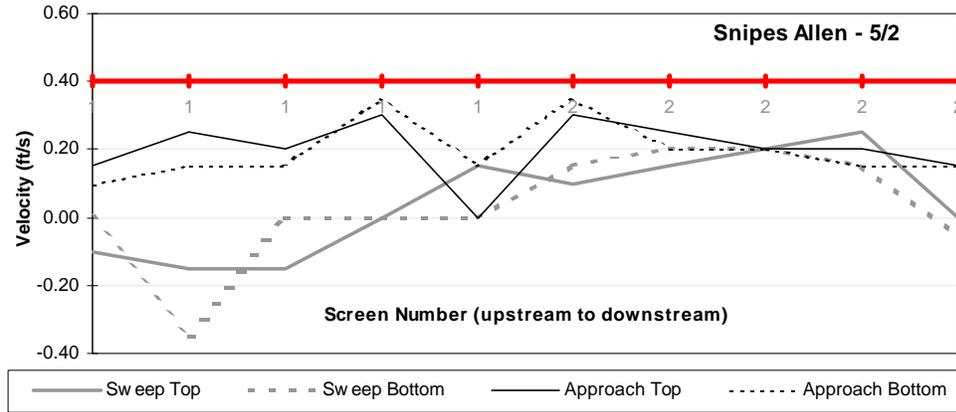
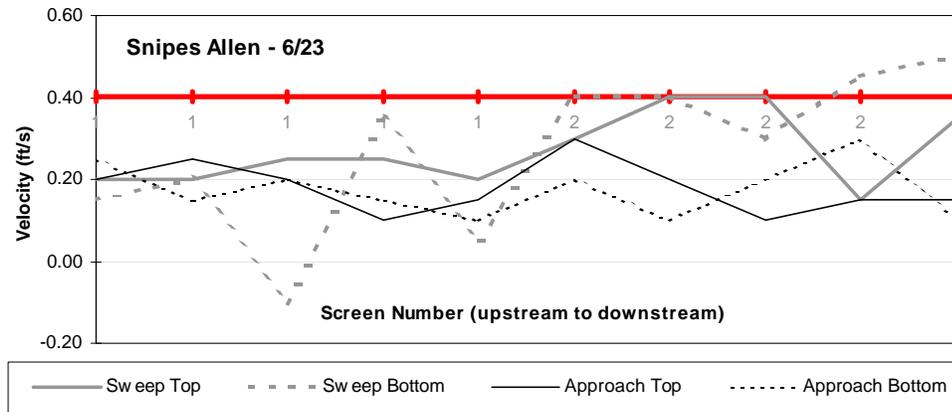
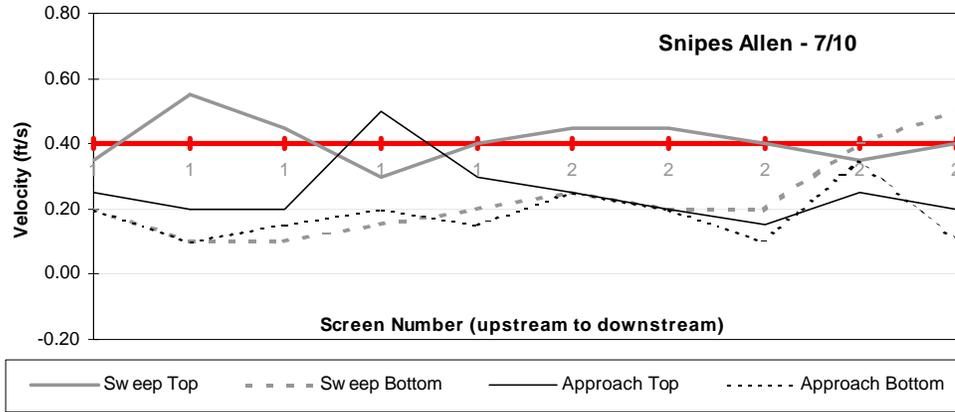
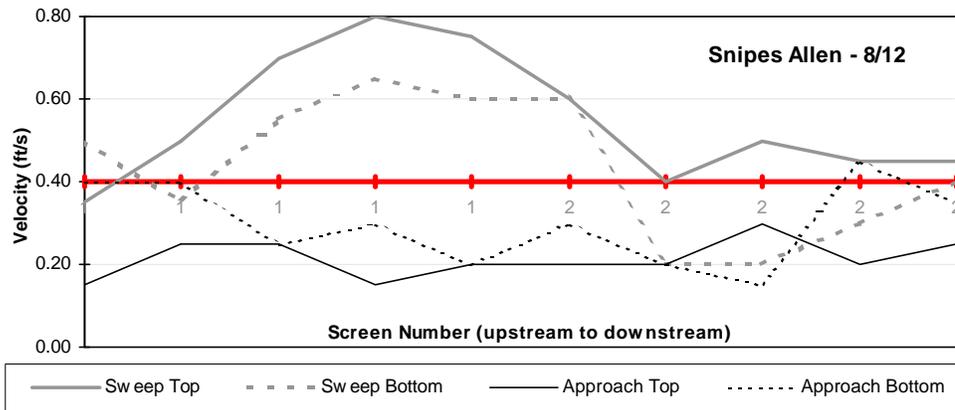
Velocities varied widely among site visits (Figures 39-42). Most bottom sweep velocity measurements increased toward the bypass, but this was not always the case for top sweep velocities. No obvious patterns were noted for approach and sweep velocities. Approach velocities often exceeded sweep velocities, in no particular pattern. During the first site visit, sweep velocities were negative in front of Screen 1.

This was confirmed as there was some backflow of water from the river into the bypass due to flooding events. Net bypass flow was measured as 0.0 fps in May. Therefore, at this site fish bypass under high flows must be active (i.e., fish cannot passively drift through the bypass). Only 3.3% of all approach measurements throughout the summer exceeded the criteria.

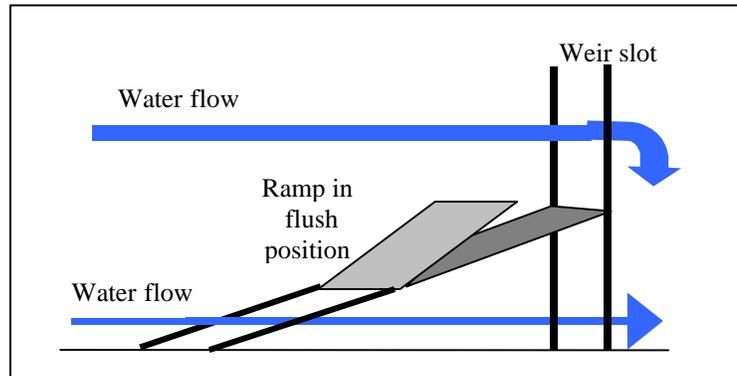
Figure 44. Snipes Allen Bypass Configuration on 5/2/97 and 6/23/97

During the May and June evaluations it was noted that the bypass weir ramp was in an odd position compared to the other sites evaluated. It appeared to be in the flushing position. The bottom section of the ramp had been flipped backwards so that the ramp handle was resting on the top section of the ramp (Figure 44). Fish could swim underneath the ramp or over the top.

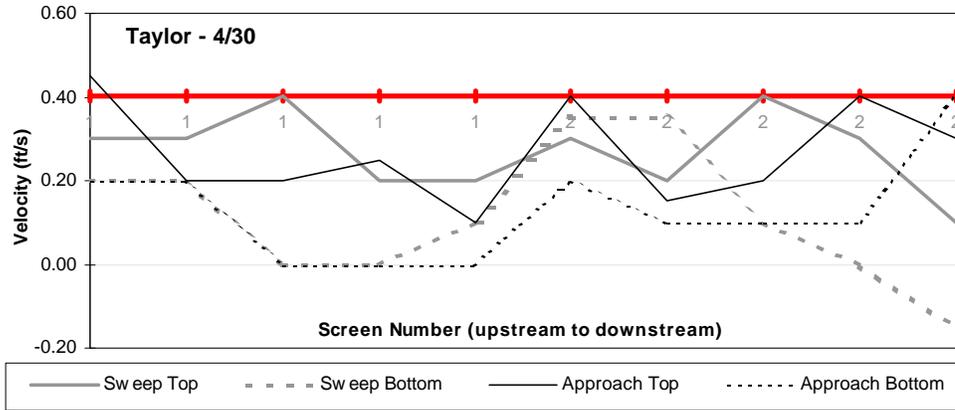
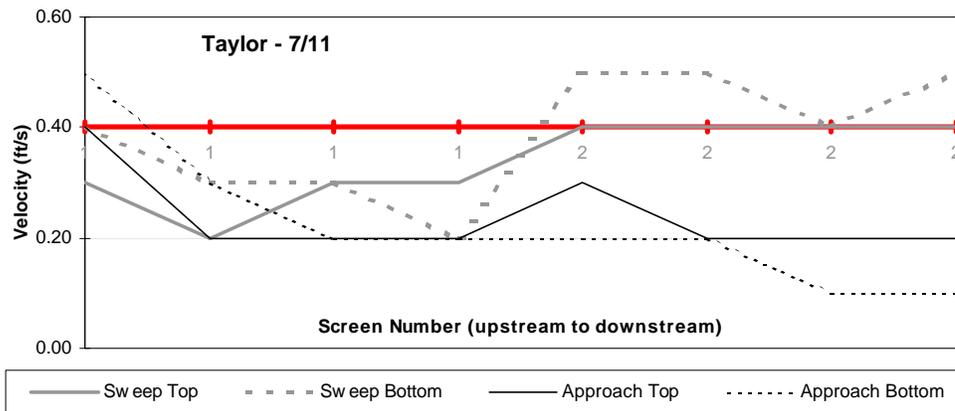
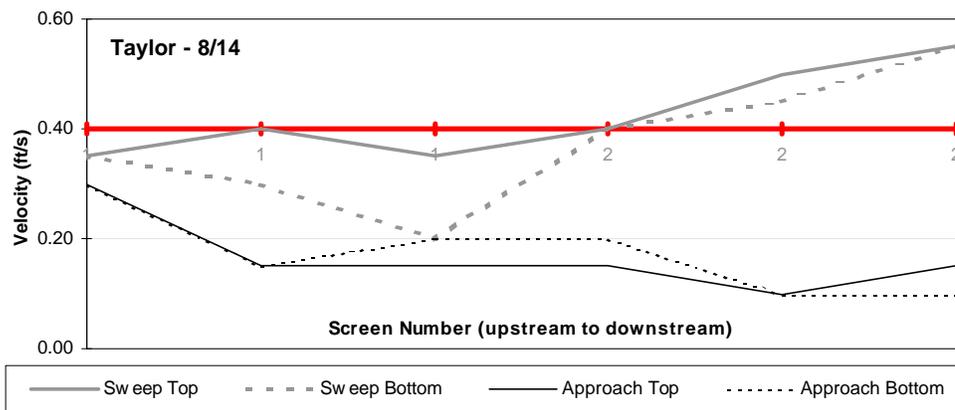
Sweep velocities at the Taylor site were generally slow, averaging only 0.3 fps (Figures 45-47). This could only partly be attributed to flood conditions at the site that caused negative flow in the fish bypass during April. Water levels in the river were not at flood stage in June or August, but sweep velocities were still low. Approach velocities often exceeded these low sweep velocities even though 95.8% of the approach velocity measurements were at or below 0.4 fps.

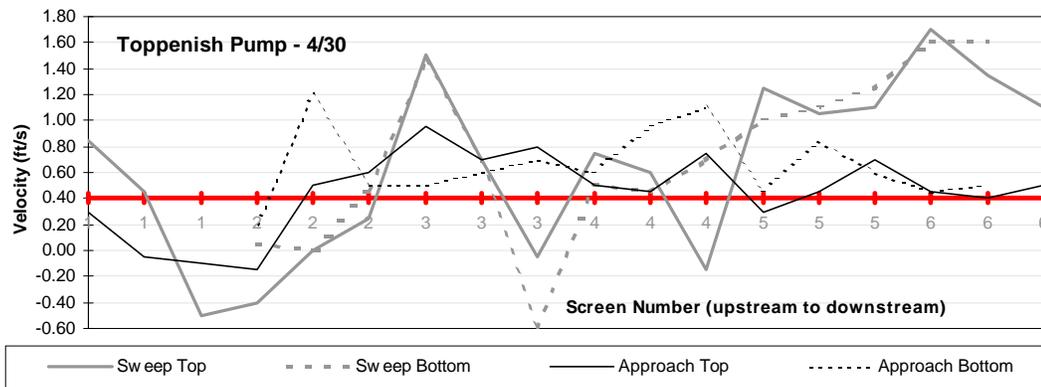
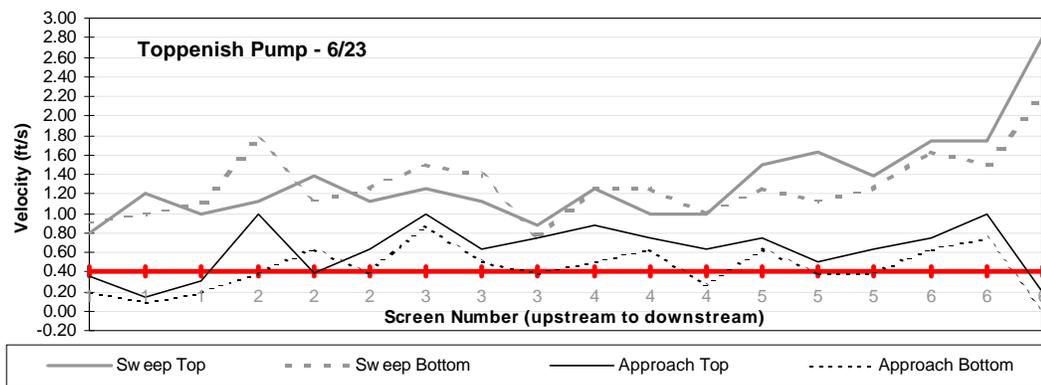
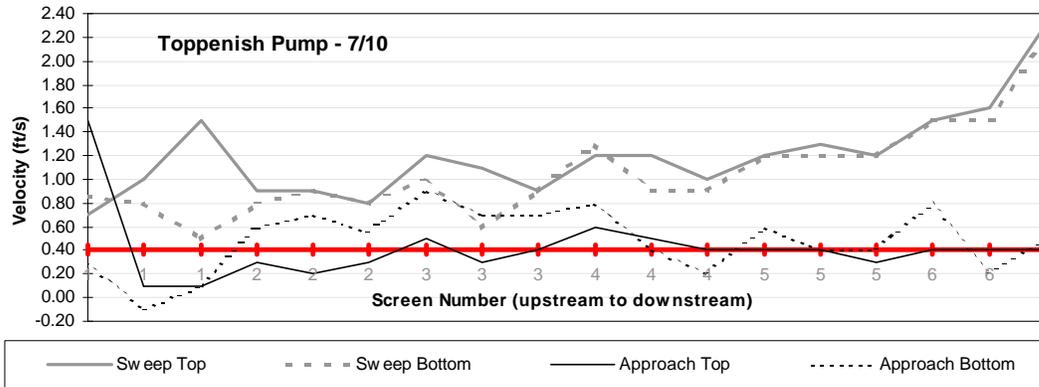
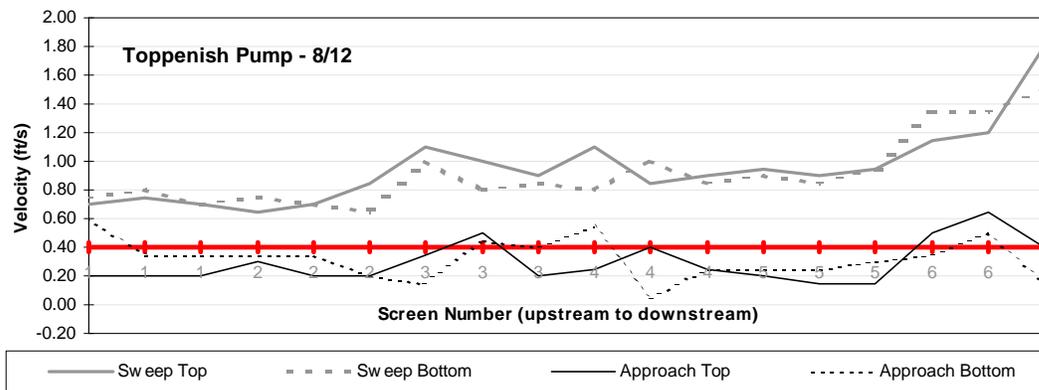
Approach velocities at Toppenish Pump were consistently high; 43% of all approach velocity values exceeded 0.4fps (Figures 48-51). Except during the first evaluation, sweep velocities usually exceeded approach velocities. The sweep velocities were relatively constant, but picked up speed in front of Screens 5 and 6 and on into the bypass.

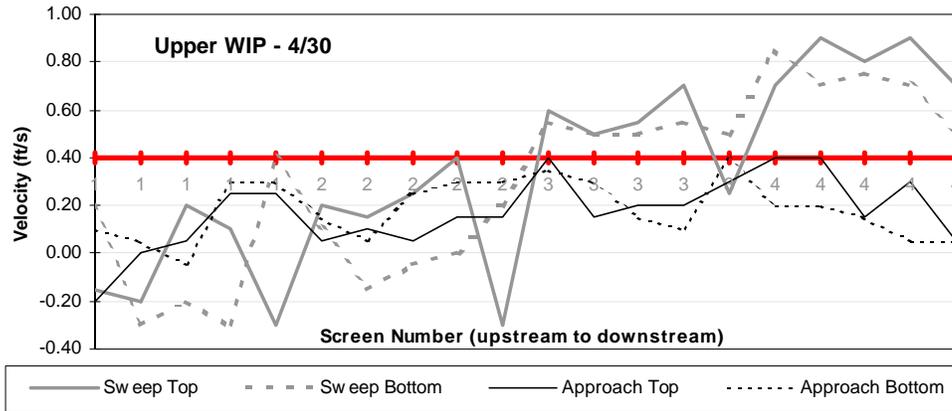
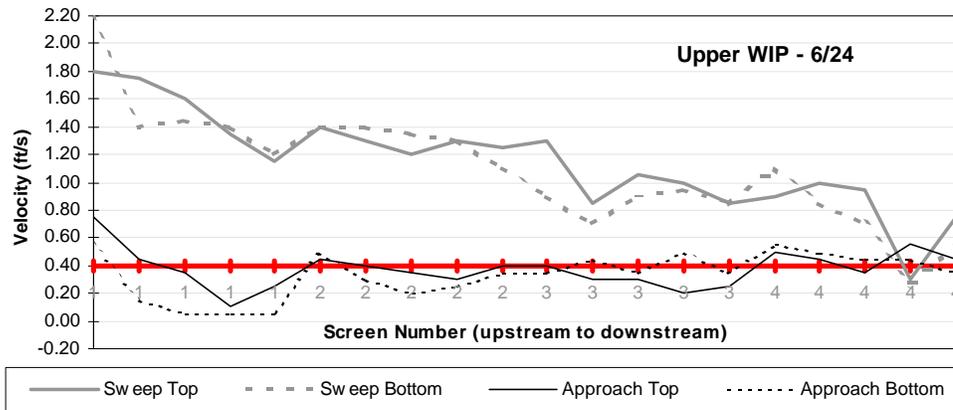
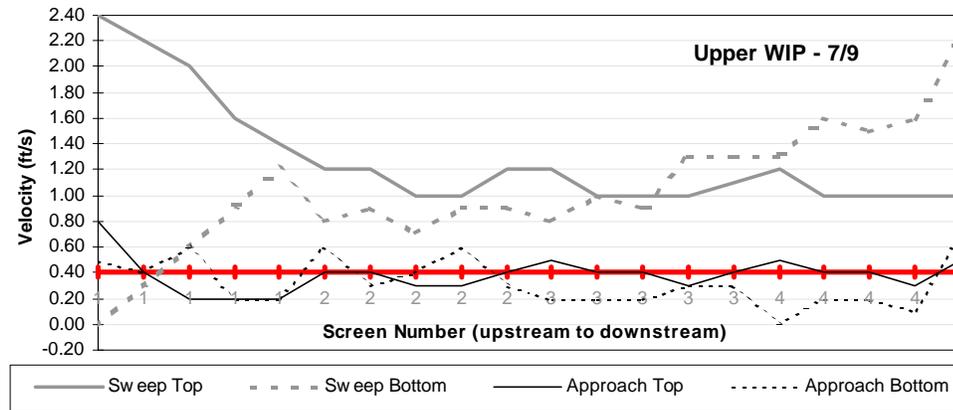
Sweep and approach velocities were inconsistent between evaluations (Figures 54-56). In April, sweep velocities were low in front of Screens 1 and 2 and did not exceed approach velocities. Sweep velocities were higher in front of Screens 3 and 4 and distinguishable from the approach velocities. In June, sweep and approach velocities were distinct except near the bypass where sweep velocities were dramatically lower. In August, sweep velocities were generally higher than approach velocities, but the two sweep values (top and bottom) differed. As top sweeps decreased toward the bypass, bottom sweeps increased. Of all approach measurements recorded at this site, 17.5% were greater than 0.4 fps. These exceedences occurred only during June and July. There was no pattern across the screens.

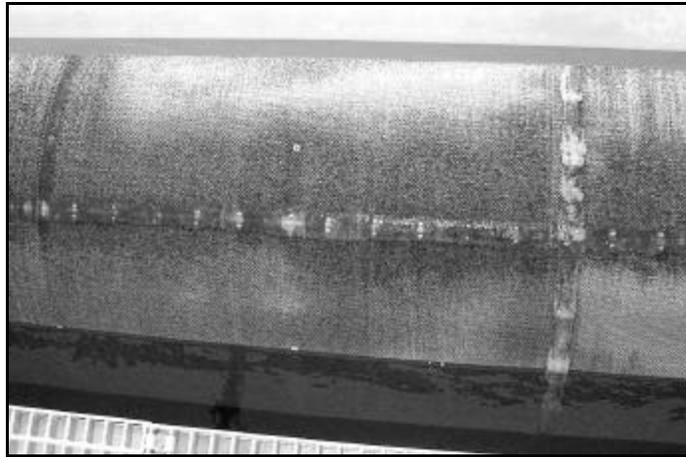
Figure 58. Evidence of Poor Bottom Seal Contact on an Upper WIP Drum Screen, as Indicated by the Presence and Absence of Algae Growth.

The drum screens show obvious patterns that indicate where the screen is and is not rubbing against the bottom seal. The presence and absence of algae growth on the wire mesh is the indicator (Figure 58).

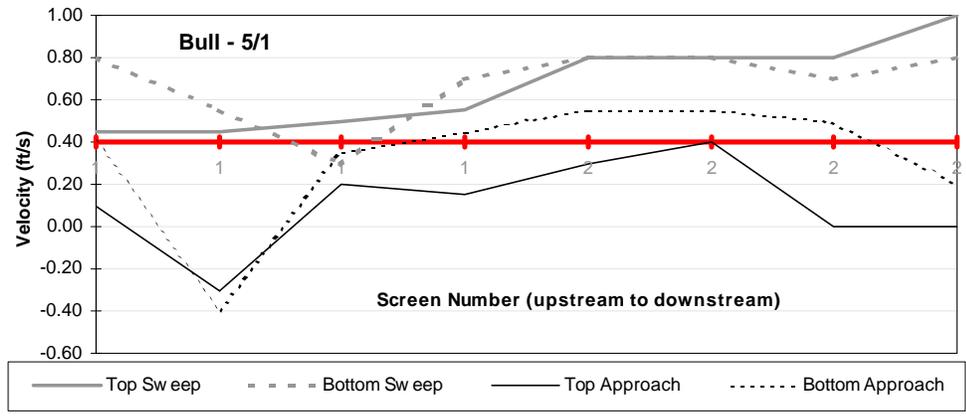
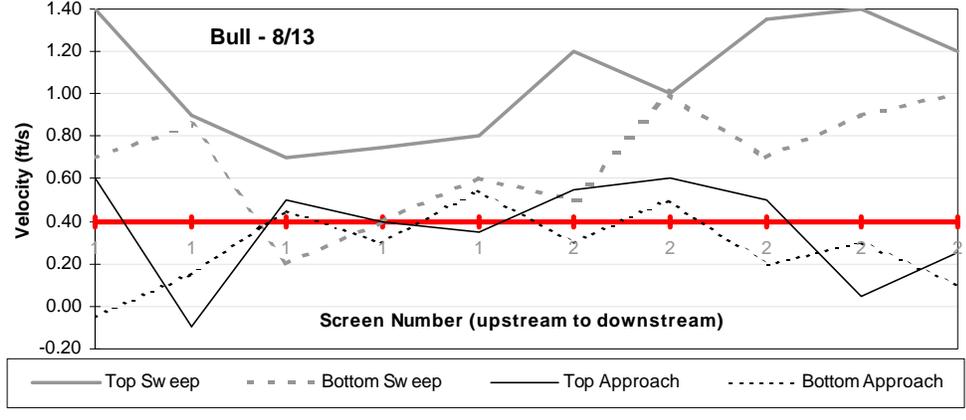
Sweep and approach velocities at Bull were quite consistent (Figures 59 and 60). Sweep velocities averaged 0.78 fps and approach velocities averaged 0.27 fps. However, 36.1% of all approach velocities measured at this site were greater than 0.4 fps. High approaches occurred across the entire length of the screen. Sweep velocities did not increase toward the bypass.

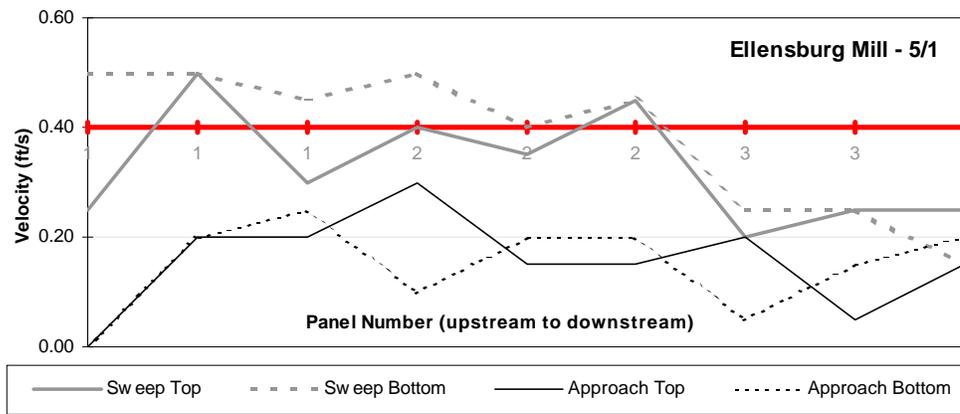
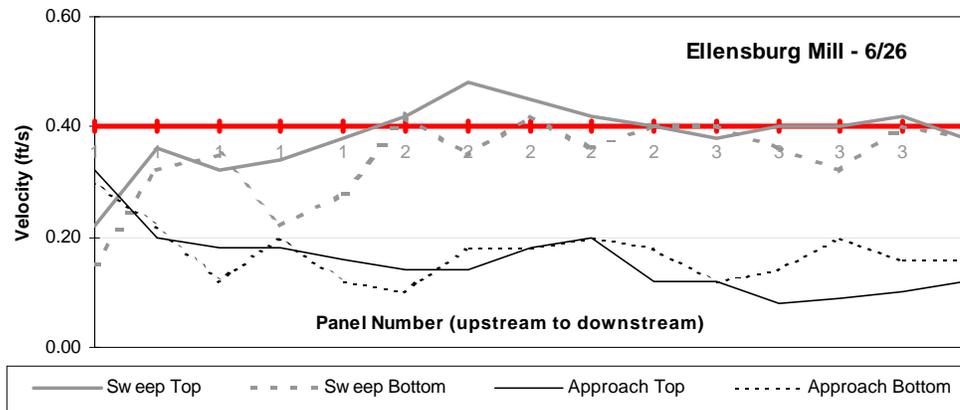
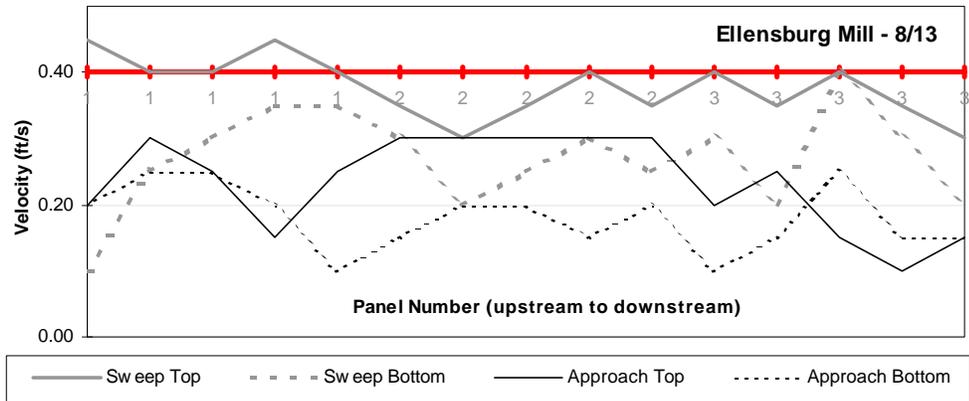
Water velocities in front of the Ellensburg Mill screen covered a wide range of values during the three site evaluations (Figures 61-63). Sweep velocities were never very high, although they did exceed approach velocities in most cases. Exceptions were during the third evaluation in August and involved low bottom sweep velocities. Sweep velocities did not noticeably increase closer to the bypass. Approach velocities never exceeded the 0.4 fps criteria, but flow readings indicated that water moved faster at the bottom center of each panel than near the ends at the same depth.

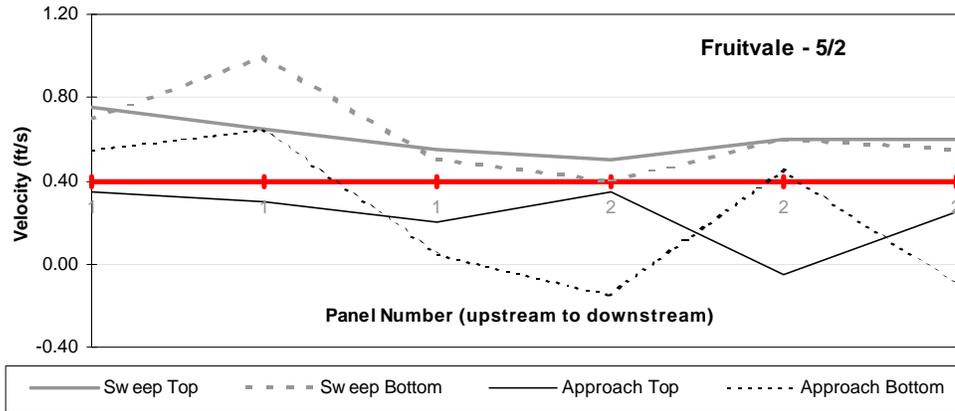
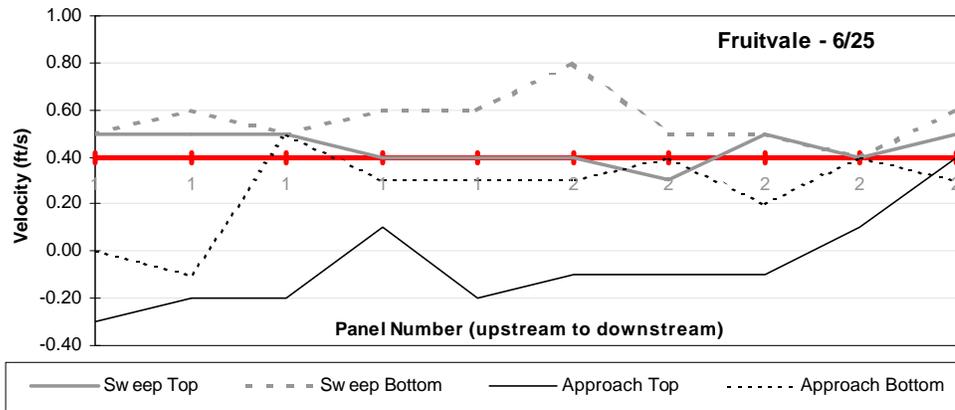
Keeping in mind the incidence of electromagnetic interference, velocities were generally good at this site (Figures 64 and 65). Sweep velocities exceeded approach velocities, except for several times when approach velocities exceeded criteria. Approach velocities were greater than 0.4 fps in 12.5% of the measurements. In June, most of the top approach velocity values were negative values. While there were some eddies, most of these negative readings should be attributed to electromagnetic interference.

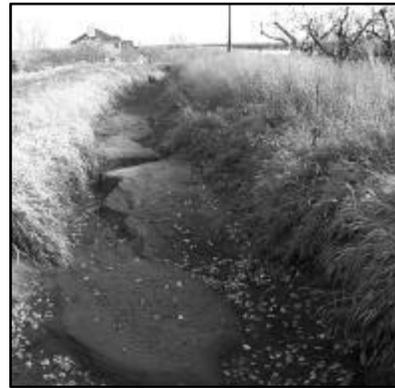
Figure 66. Sedimentation in the Canal at Fruitvale, 11/20/97

A post-season evaluation was conducted on 11/20/97. This site was completely dry and the forebay had been cleared of silt but several inches of silt were accumulated between the screen and the louvers. The irrigation canal contained great amounts of sediment (Figure 66). The bypass ramp had been left in a flushing position. The last logbook entry was on 10/8/97. It did not document any of the winterization process.

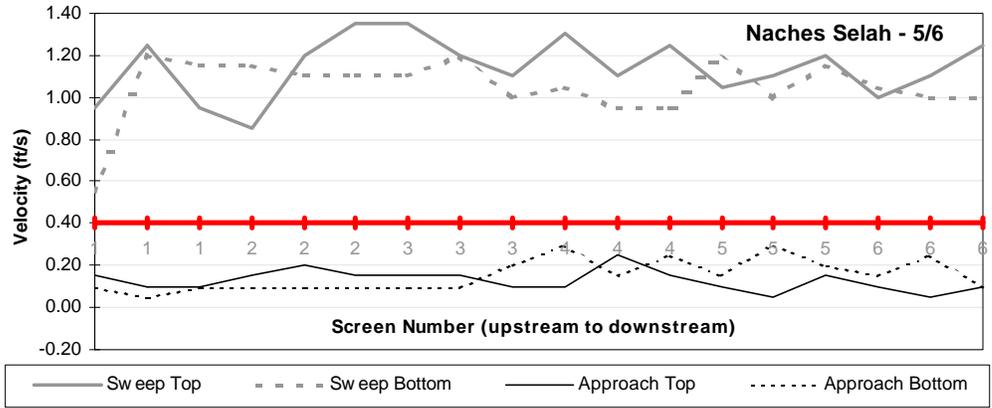
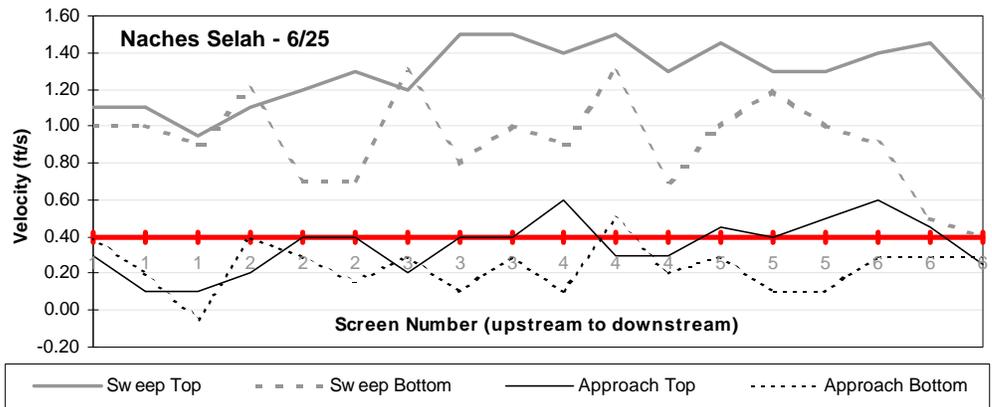
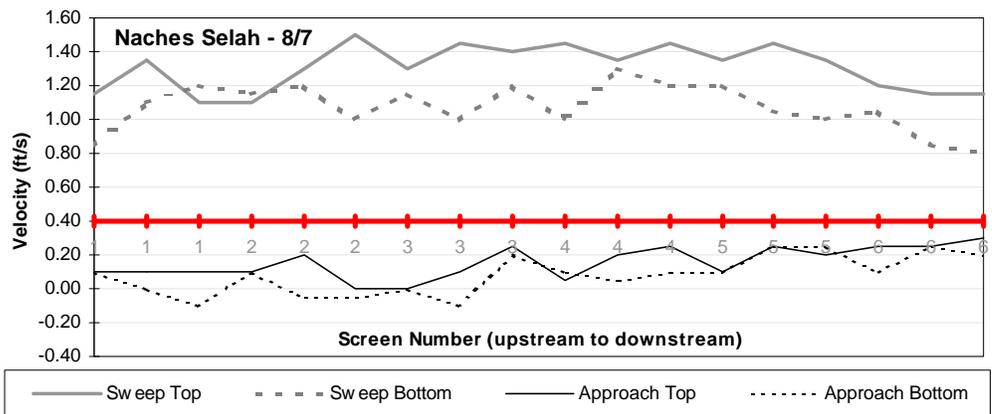
Water rapidly swept past the Naches Selah screen (average = 0.96 fps). Sweep velocities fluctuated and did not show any marked trends across the length of the screen, although top sweep values were almost always greater than bottom sweep values (Figures 67-69). Approach velocities also showed marked variation between sampling sites, but most (94.5%) were less than 0.4 fps. Sweep velocities were always greater than their corresponding approach velocities.

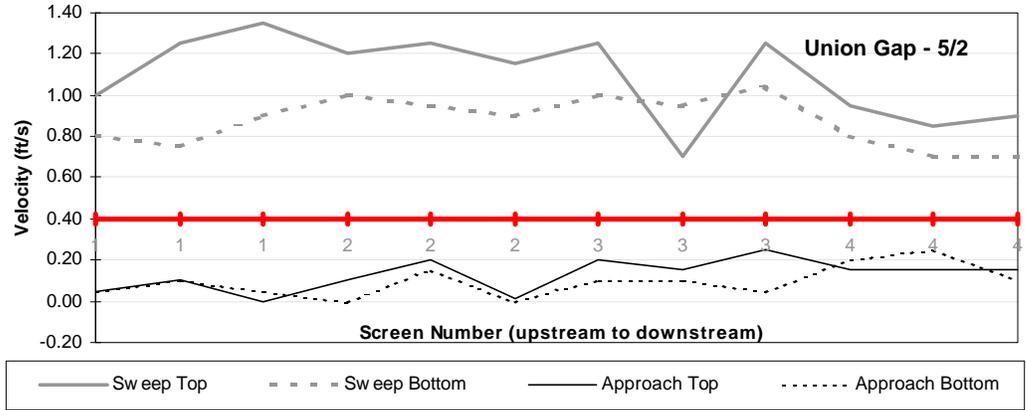
Figure 71. Water Velocities at Union Gap, 5/2/97

Sweep velocities at Union Gap were always greater than approach velocities (Figures 71-73). Top sweep velocities were generally greater than bottom sweep velocities, but both tended to decrease near the bypass entrance. Bypass flows were always slower than the average sweep velocity in front of the screens.

Approach velocities were greater than 0.4 fps for only 2.3% of all approach velocity measurements. Approach velocities were not constant across the length of the screen. Some patterns suggest that approach velocities were greatest at the center of the screens and slower near the ends of the screens (Figure 71).

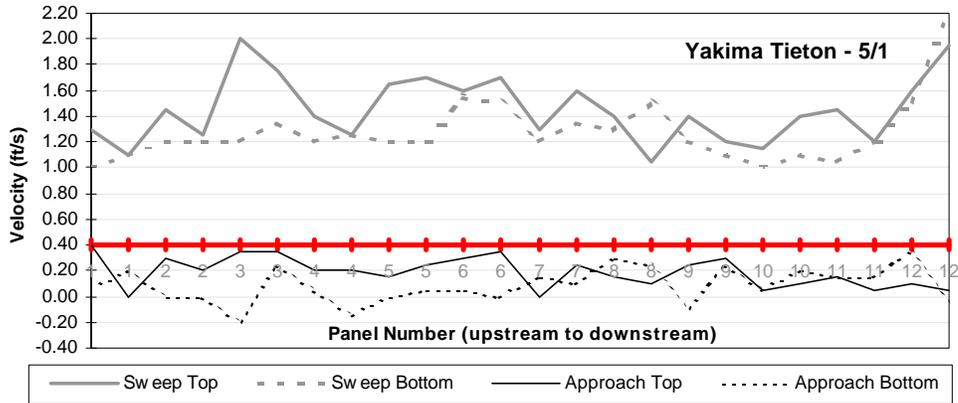
Figure 74. Water Velocities at Yakima Tieton, 5/1/97

Sweep and approach velocities did not overlap at Yakima Tieton (Figures 74-76). Sweep velocities were sufficiently fast enough to move fish to the bypass and showed a marked increase at the bypass entrance. Top approach velocities were greater than 0.4 fps along the upstream half of the screen in June and August (10.5% of all approach measurements).

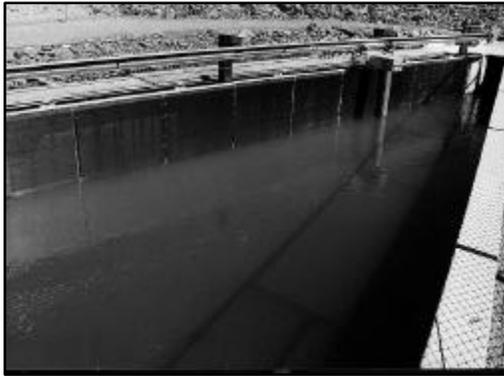
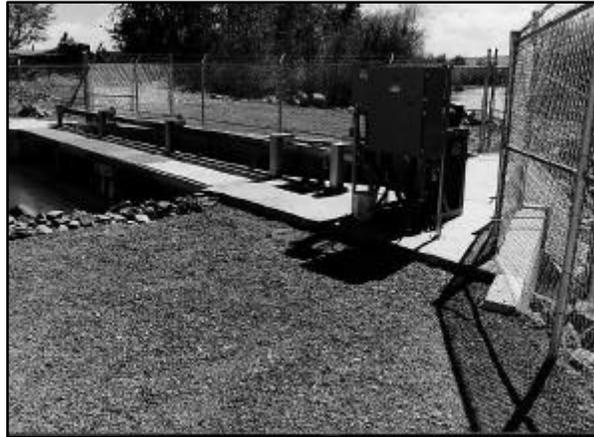
2. Ellensburg Mill

The Ellensburg Mill canal diversion is located on a side channel of the Yakima River about 2 miles west of the city of Ellensburg, Washington. The current Ellensburg Mill fishscreen facility (improved during the 1996/97 construction period) replaces a drum screen that did not meet design criteria for the protection of juvenile and adult anadromous fish during canal diversions.

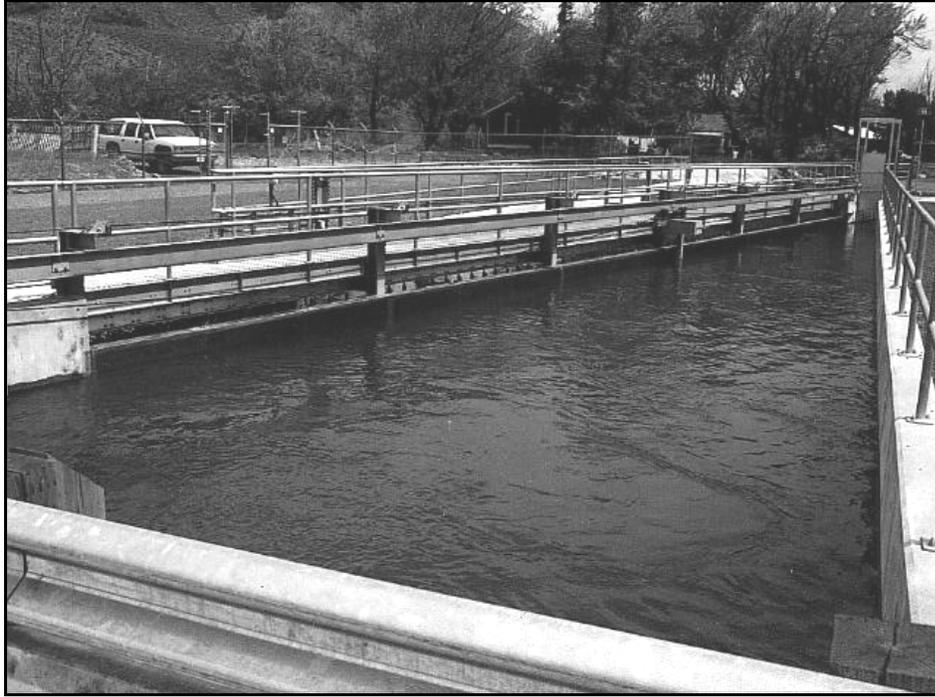
4. Naches Selah

Woody debris was also observed in the bypass at Naches Selah and in front of screens at Gleed. The debris at Naches Selah could be considered good cover for predators, but the water velocities at Gleed are high and therefore not conducive to fish lying in wait, making predation unlikely.
