**WASHINGTON PHASE II FISH DIVERSION
SCREEN EVALUATIONS IN THE
YAKIMA RIVER BASIN, 1999**

DOE/BP-00000652-4

Washington Phase II Fish Diversion Screen Evaluations in the Yakima River Basin, 1999

Pacific Northwest National Laboratory
Richland, Washington

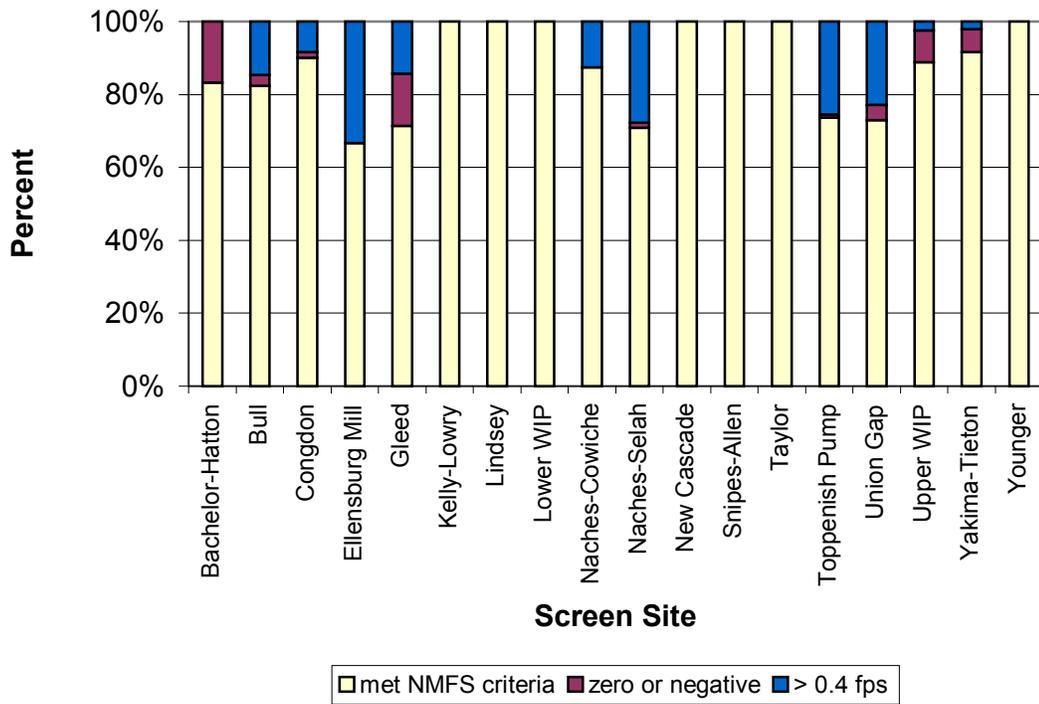
Overall, 89% of all approach velocity measurements met criteria (compared to 86% in 1997 and 93% in 1998). However, approach velocities were always within criteria at only 9 of 18 screen sites screen sites evaluated (Table 2 , Figure 2). Areas of screen (i.e., top, bottom, upstream, downstream) that exceeded these criteria were dependent on factors at the individual sites.

Figure 2. Percentage of measurements at Yakima Basin Phase II screen sites that met or did not meet NMFS approach velocity criteria of ≤ 0.4 fps in 1999. Zero/negative flows were generally created by eddies in front of the screens.

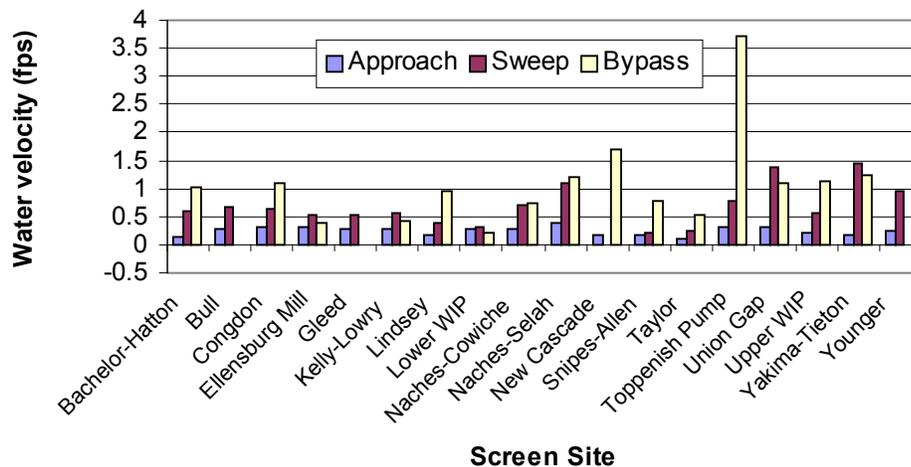
Averaging velocities for each screen site presented a clearer picture of the flows at these sites (Table 3; Figure 3). Considering only averages, sweep velocity was typically greater than approach velocity. All ratios were ≥ 1.5 , except at Bachelor Hatton and Gleed. Sweep velocities at these sites were negative due to large eddies created by high flows. Mean top sweep velocities were generally greater than mean bottom sweep velocities. Mean top and bottom approach velocities were more evenly mixed.

The ratio of sweep velocities to approach velocities at the flat plate screens was generally greater than at drum screens. This characteristic also retained approach velocities < 0.4 fps. This condition is likely to minimize the time it takes for fish to reach the bypass. Five sites had average bypass velocities less than their average sweep velocities. Bypass flows were usually faster than the average flow past the screens (Figure 3).

Figure 3. Mean approach, sweep, and bypass velocities (fps) at Phase II fish screen facilities in the Yakima Basin in 1999.

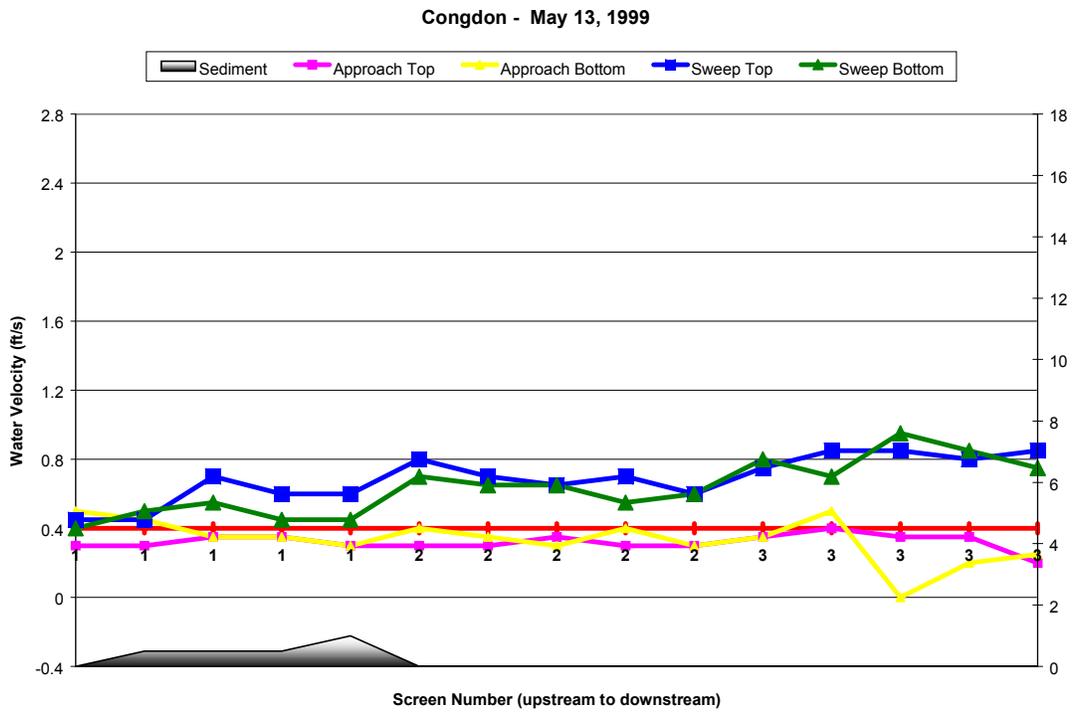
The Congdon screen site was evaluated 5/13/99 and 7/14/99. Ninety-two percent of the recorded approach velocities met NMFS criteria at the Congdon site. The remaining 8% of the recorded velocities were > 0.4 fps. In general, sweep velocities were greater than approach velocities and increased near the bypass (Figure 7 and Figure 8). The only places sweep velocities were less than approach velocities or where approach velocities exceeded criteria were in front of Screen 1 (farthest upstream) in July and September.

Figure 7. Water velocities and sediment depths at Congdon, 5/13/99.

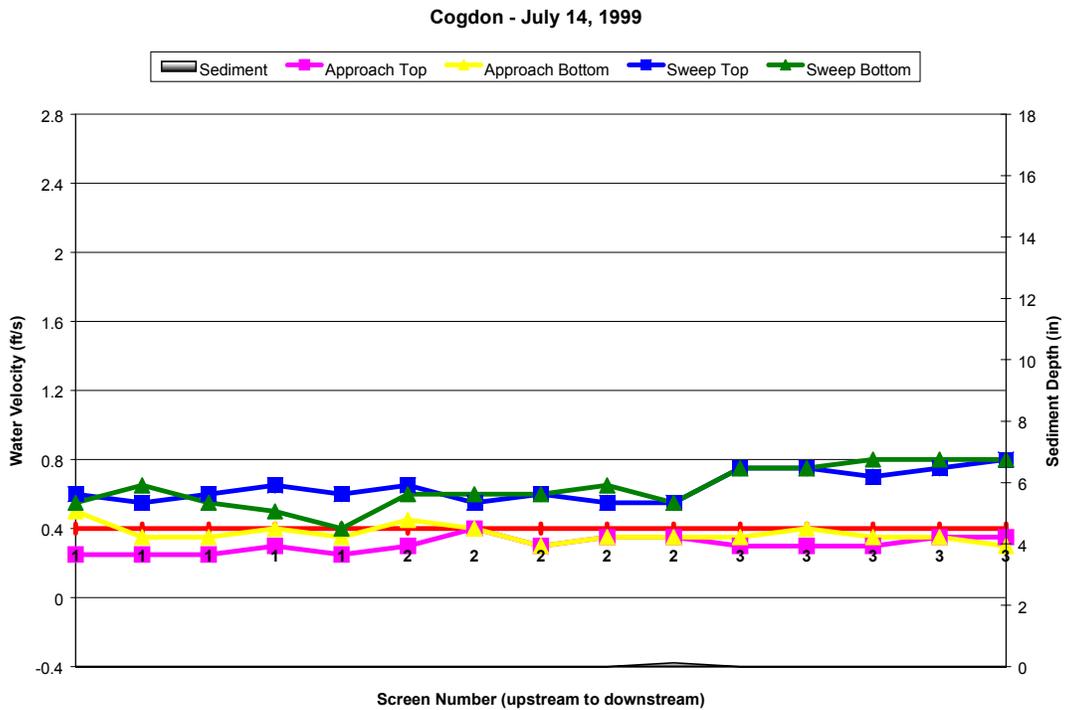
Figure 8. Water velocities and sediment depths at Congdon, 7/14/99.

Bypass velocities averaged higher than sweep velocities at Congdon in 1999. Screen submergence was 88% during the May survey and was down to 82% on the date of the July survey. Water always flowed over the bypass weir and ran freely through the outfall pipe, which was always submerged at its terminus. However, the bypass pipe was never completely full of water (evidenced by the bubbles that were observed). The seals were in good condition and screens always turned smoothly. There were no debris or silt problems observed at Congdon in 1999.

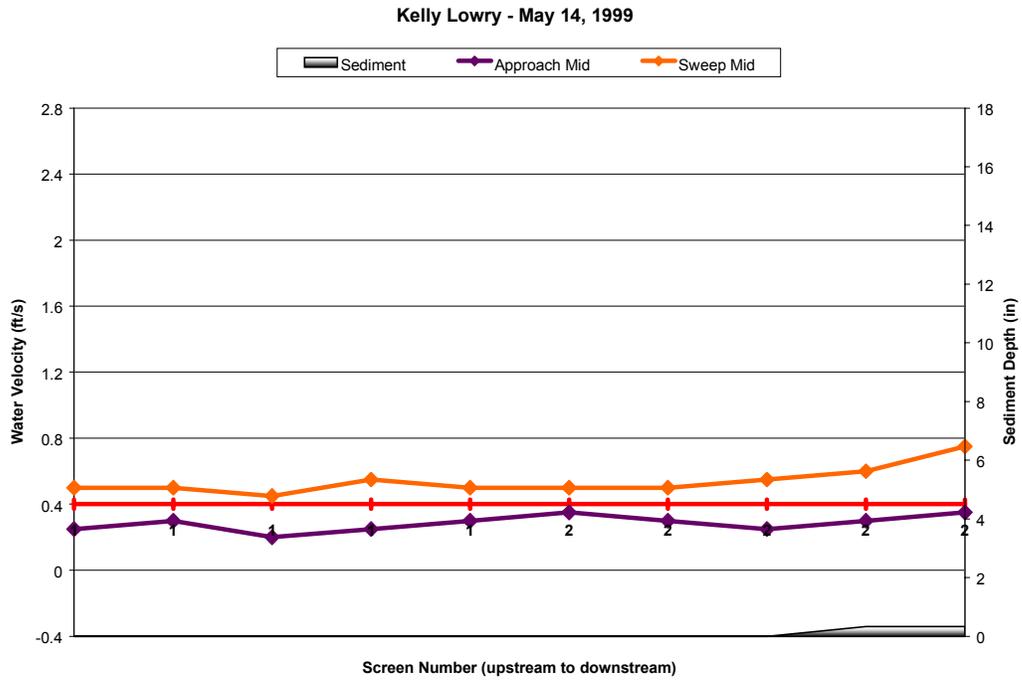
The Kelly Lowry screen site was evaluated 5/14/99 and 7/20/99. All approach velocities recorded at this site met NMFS criteria (Figure 9 and Figure 10). Sweep velocities always exceeded approach velocities, but decreased near the bypass instead of increasing during the July evaluation. There was 1 in. of head-loss across the screens in May due to thick algae/diatom growth on the screens. Mean bypass velocities were lower than mean sweep velocities at this site in 1999. Screen submergence levels met NMFS criteria at 81 and 69%.

Figure 9. Water velocities and sediment depths at Kelly Lowry, 5/14/99.

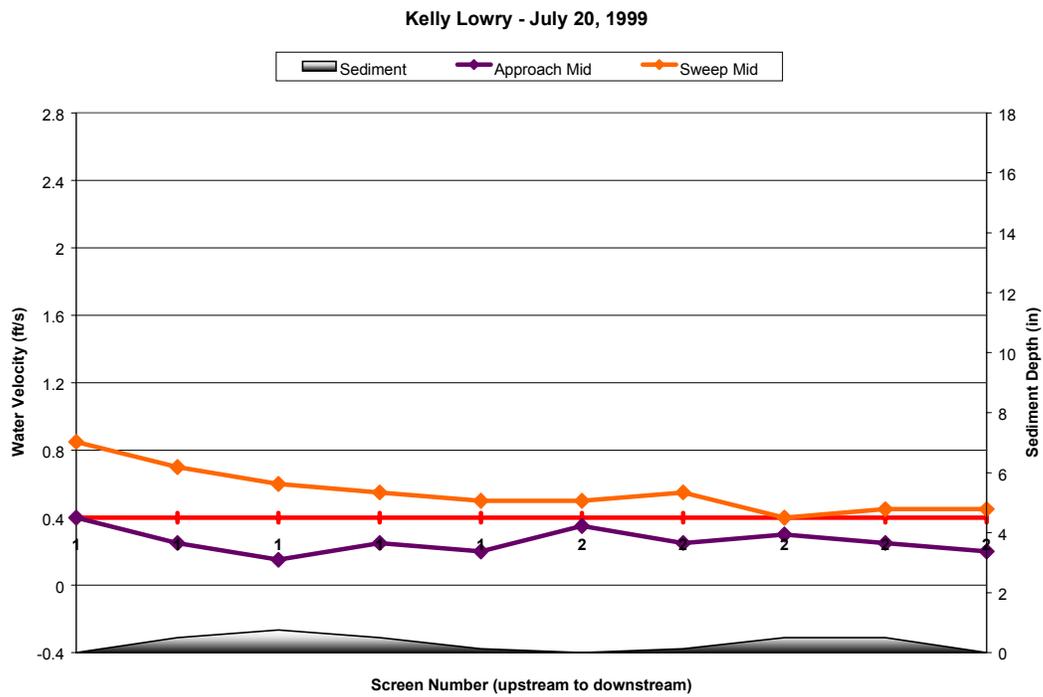
Figure 10. Water velocities and sediment depths at Kelly Lowry, 7/20/99.

The only concern regarding screen condition was the build-up of algae/diatom growth that resulted in some head-loss in May. The screens were in good shape and the drums turned evenly. The seals were in good condition. Water always ran freely over the bypass weir, and conditions for fish at the outfall site were always good.

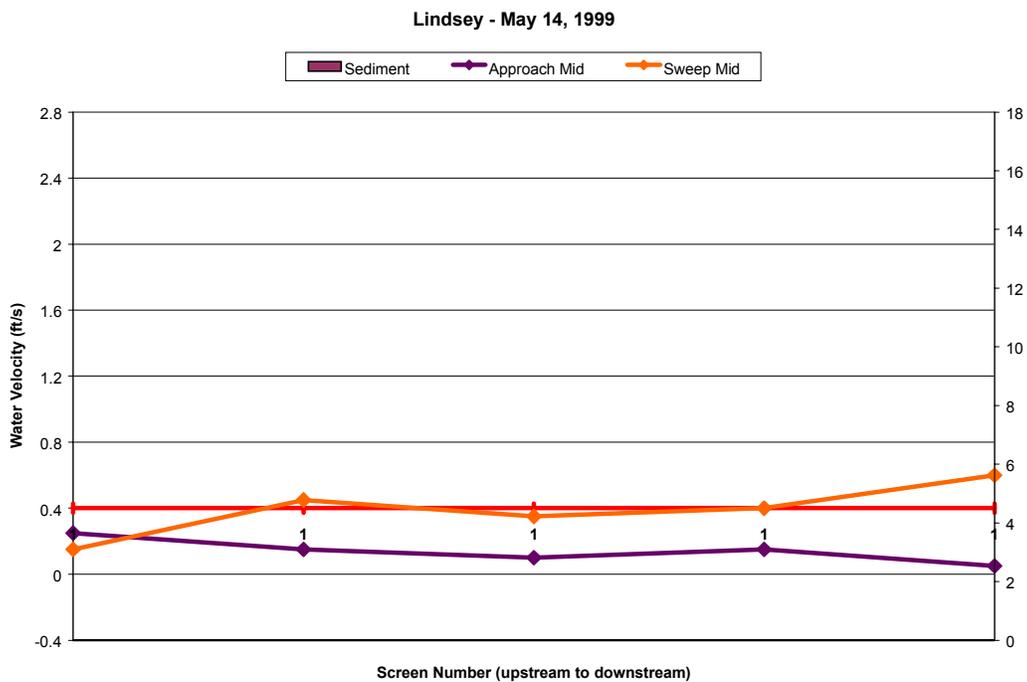
The Lindsey screen site was evaluated 5/14/99 and 7/20/99. All recorded approach velocities at this site met NMFS criteria. Sweep velocities were greater than approach velocities, but did not always increase near the bypass (Figure 11 and Figure 12). Mean bypass velocities exceeded sweep velocities. Screen submergence levels were slightly high at 86 and 89%.

Figure 11. Water velocities and sediment depths at Lindsey, 5/14/99.

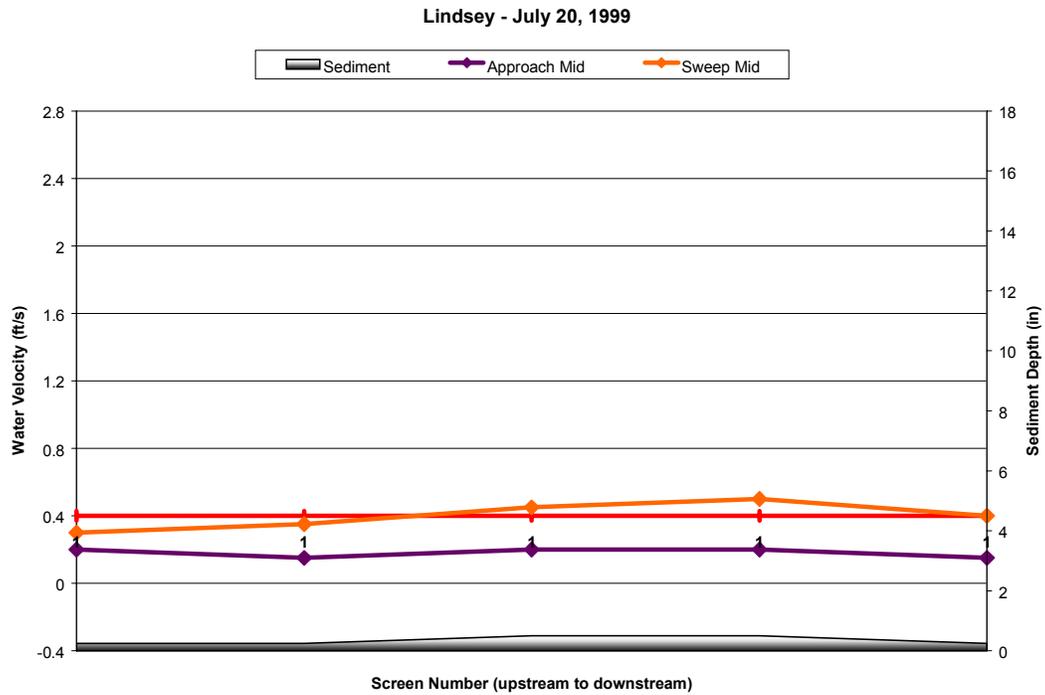
Figure 12. Water velocities and sediment depths at Lindsey, 7/20/99.

The screens and most seals were in good shape. Some white caulking was missing along the bottom in the same place that was identified in 1998. The side seals were in good condition, and the screen always rotated evenly. Water ran freely behind the bypass weir on both surveys. Levels of silt and sand were not excessive. Woody debris was not a problem, though there were some leaves and sticks in the forebay. The bypass was operating effectively and discharged into water over 1 ft deep.

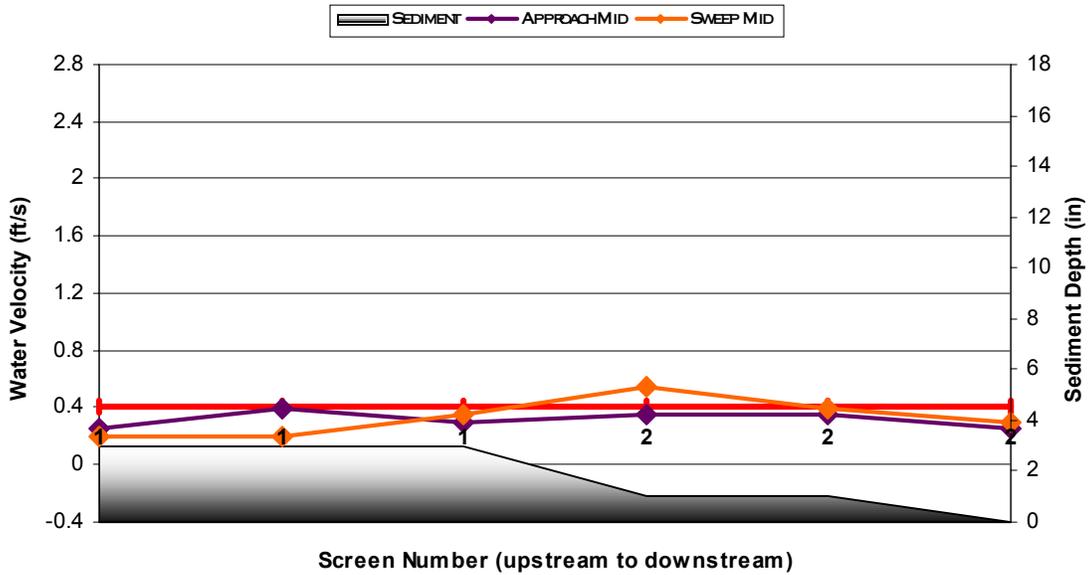
Lower WIP - May 12, 1999

Lower WIP was visited 5/12/99 and 8/4/99. All approach velocities met NMFS criteria. Sweep velocities were not consistently greater than approach velocities and did not tend to increase toward the bypass (Figure 13 and Figure 14). The bypass velocity did not exceed the sweep velocity during the August evaluation. A board had been installed in the bypass that reduced velocities (with board in velocity was 0 fps, with the board removed, the velocity increased to 0.15 fps).

Figure 13. Water velocities and sediment depths at Lower WIP, 5/12/99.

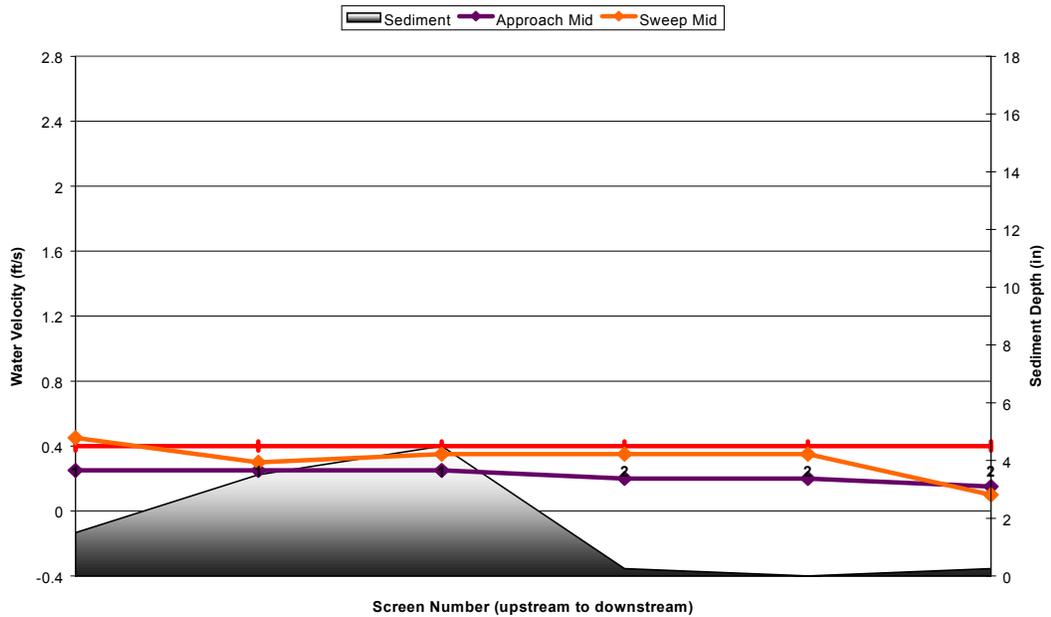
Lower WIP - August 4, 1999

Figure 14. Water velocities and sediment depths at Lower WIP, 8/4/99.

Screen submergence was relatively low (67%) in May and very high (96%) in August. Sediment depth increased to over 4 in. in the forebay in front of the downstream end of screen 1 by August. The screen seals and screening appeared to be in good condition, and the drums were turning evenly. Water was running over the bypass weir, and the bypass was running smoothly into water over 1 ft deep.

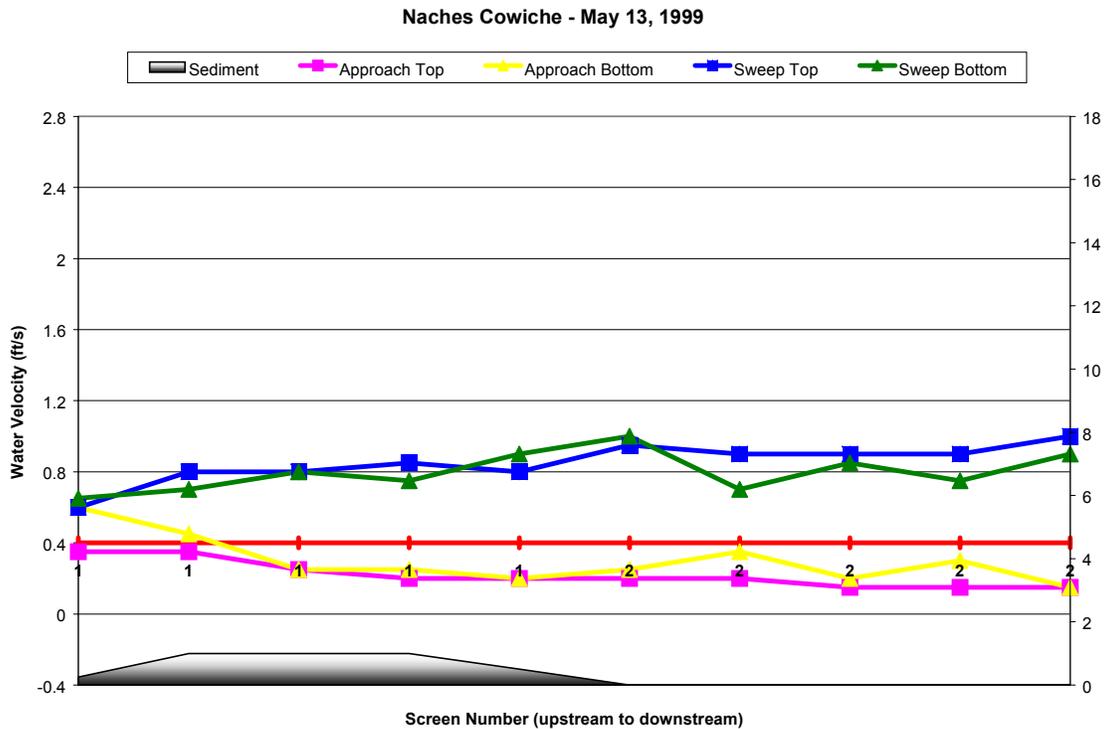
The Naches Cowiche site was evaluated 5/13/99 and 7/15/98. Over 12% of the recorded approach velocity values exceeded 0.4 fps; up from 0% in 1998. The excessive approach velocities were confined to the upstream portion of screen 1 (Figure 15). Sweep velocities were generally greater than their corresponding approach velocities but did not always increase near the bypass. Mean bypass velocities were slightly greater than mean sweep velocities. Screen submergence levels were within the bounds set by NMFS criteria (81 and 82%).

Figure 15. Water velocities and sediment depths at Naches Cowiche, 5/13/99.

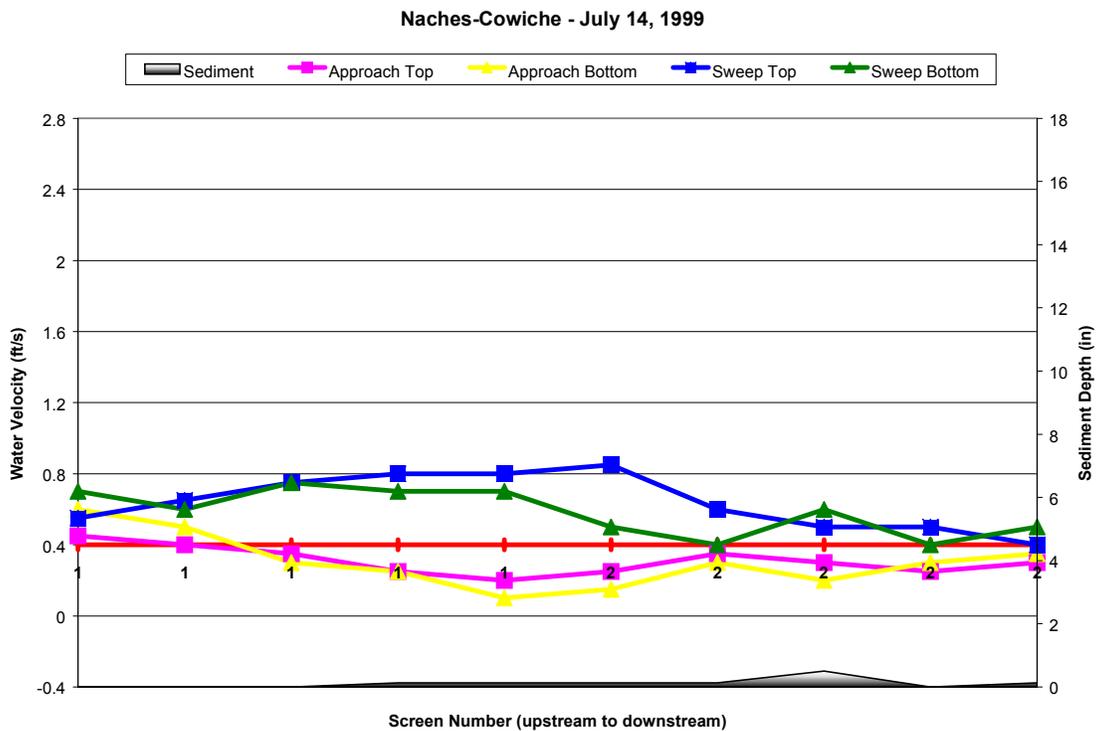
Figure 16. Water velocities and sediment depths at Naches Cowiche, 7/14/99.

Screens and seals were in good condition and drums turned evenly. Water always flowed over the weir. Conditions for fish at the outfall site were always good. In contrast to observations from 1997 and 1998, siltation was a not problem at this site when it was evaluated in 1999.

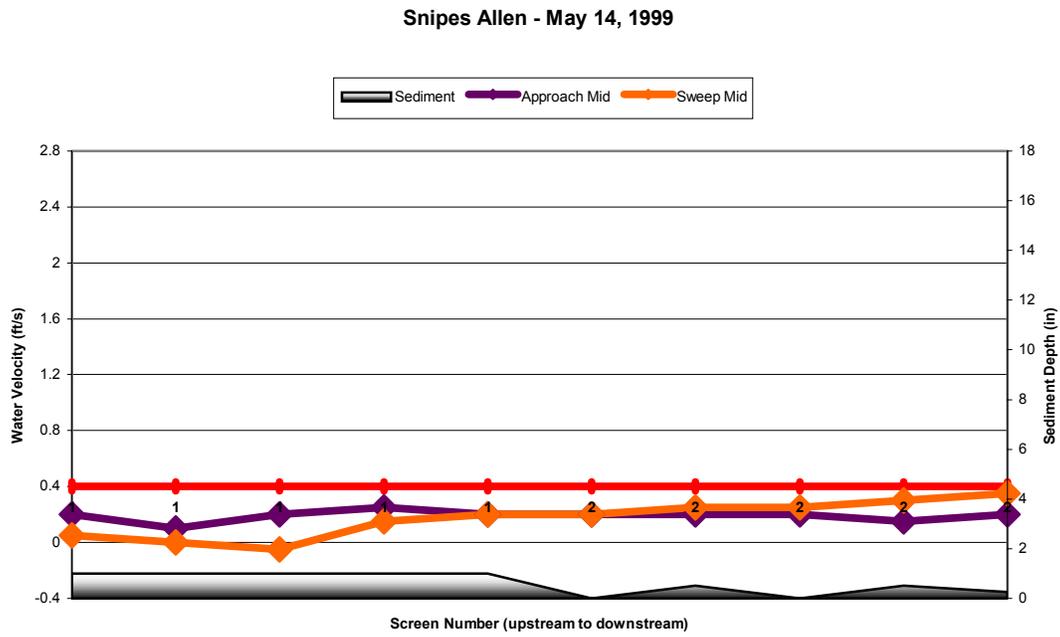
The Snipes-Allen site was evaluated 5/14/99 and 8/4/99. All approach velocities recorded at the Snipes-Allen site met NMFS criteria (Figure 18 and Figure 19). Sweep velocities were generally about the same as approach velocities until near the bypass where they increased. Mean bypass velocities exceeded mean sweep velocities at this site in 1999. Screen submergence was recorded at 81 and 86% (slightly above the criteria of 65-85%). Silt was not a problem at this site in 1999. The screens were partially clogged with diatoms, and there was a small patch on screen 1. Although the screens were brown with algae, they rotated evenly, and the seals were in good condition. The cleaning system did not appear to be working when the site was evaluated in August. Water behind the bypass weir flowed smoothly, though slowly, in August. The outfall

Figure 18. Water velocities and sediment depths at Snipes-Allen, 5/14/99.

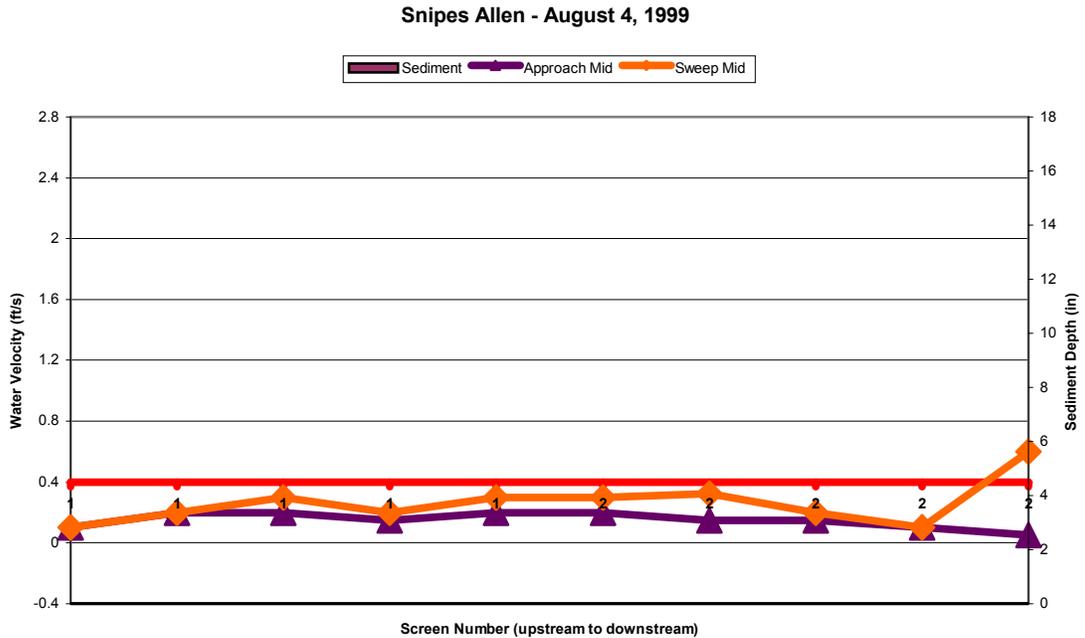
Figure 19. Water velocities and sediment depths at Snipes-Allen, 8/4/99.

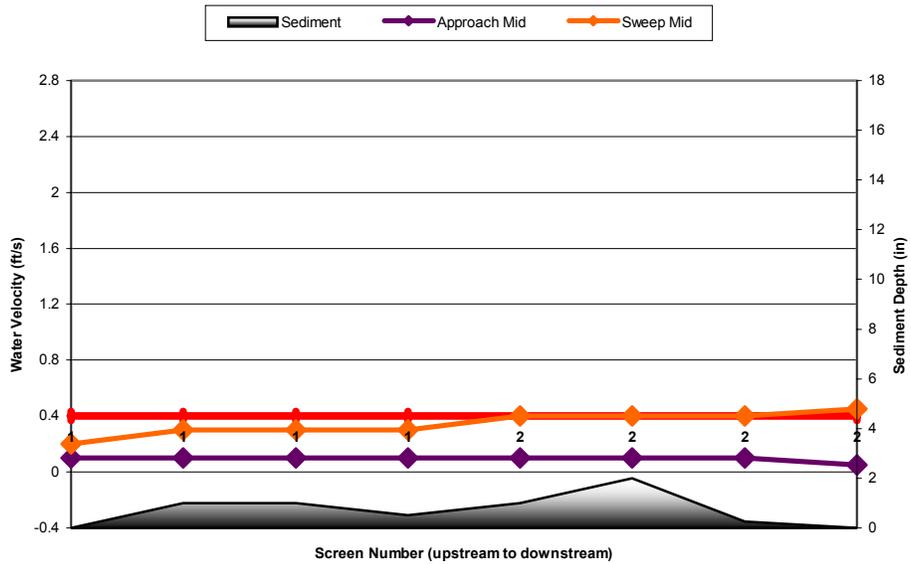
Taylor - May 19, 1999

The Taylor site was evaluated 5/19/99 and 7/22/99. All approach velocities recorded met NMFS criteria. Sweep velocities were generally greater than the corresponding approach velocities and sweep velocities, increased toward the bypass in May (Figure 20), but not in July (Figure 21). Mean bypass velocities exceeded mean sweep velocities at his site in 1999. Screen submergence was 82 and 75%.

Figure 20. Water velocities and sediment depths at Taylor, 5/19/99.

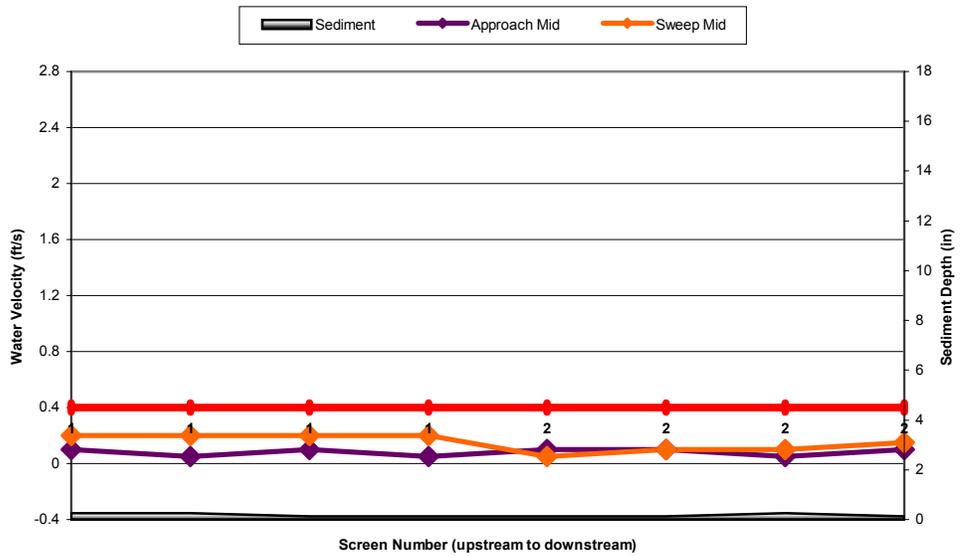
Taylor - July 22, 1999

Screens operated similarly to the way they did in September 1998; screen 2 exhibited a rough jerking motion. The screen seals, however, were in good condition. Debris was not much of a problem, and silt deposition was relatively low. Water flowed freely behind the bypass weir. The bypass outfall was running smoothly and it discharged into an area that was over 1 ft deep.

Figure 21. Water velocities and sediment depths at Taylor, 7/22/99.

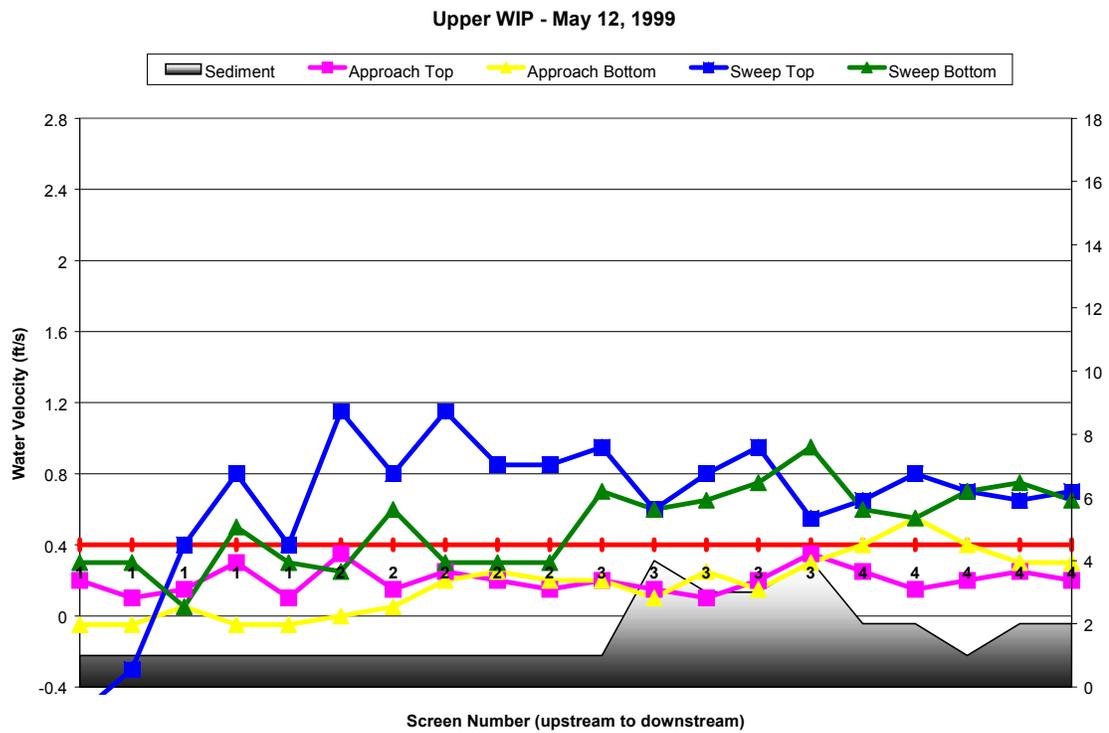
The WIP upper site was visited 5/12/99 and 7/15/99. Almost all of the recorded approach velocities met NMFS criteria (97.5%) (Figure 25 and Figure 26). Sweep velocities generally exceeded approach velocities; however, they did not typically increase toward the bypass. Mean bypass velocities were greater than mean sweep velocities at this site in 1999. Screen submergence levels were 79 and 81%.

Figure 25. Water velocities and sediment depths at the WIP upper site, 5/12/99.

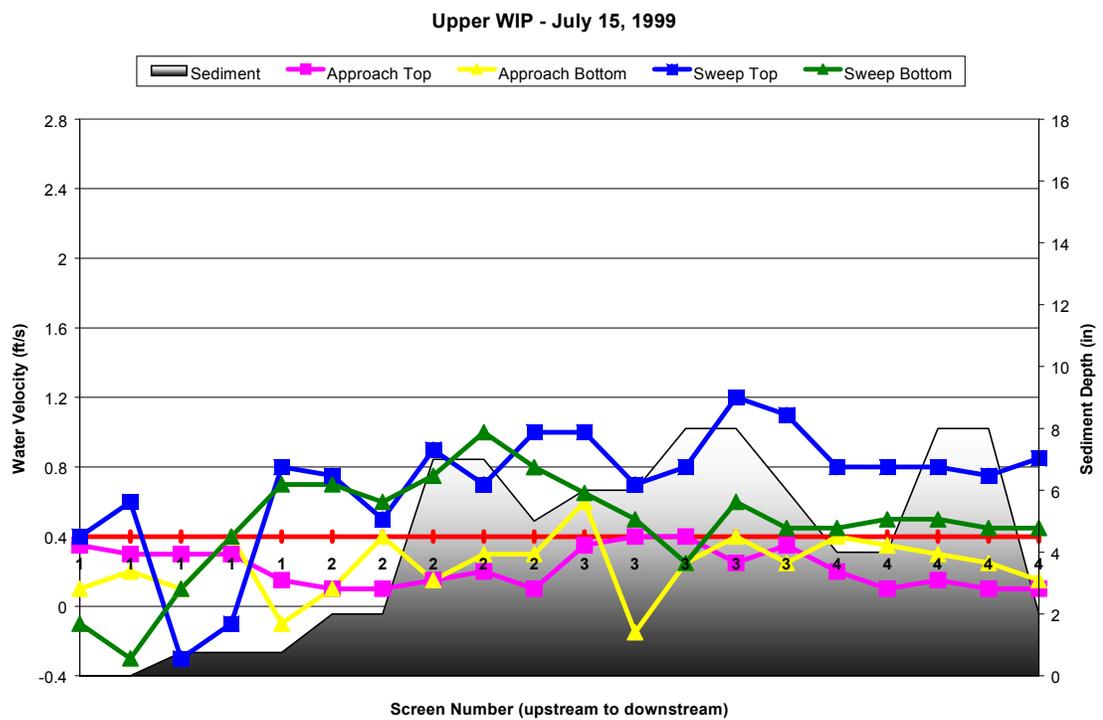
Uneven wear was noted by observing patterns of algal growth on the screens. Screens 1 and 4 had some clean (rubbed) sections while Screens 2 and 3 were clean. It looked like there were small gaps in the seal at screen 1. There was too much silt in front of the seals at Screens 3 and 4 to examine the screen seals with the underwater video camera. Adequate water was bypassed, and water was running freely behind the bypass weir. Outfall conditions at the terminus of the bypass pipe were good for fish passage.

Figure 26. Water velocities and sediment depths at the WIP upper site, 7/15/99.

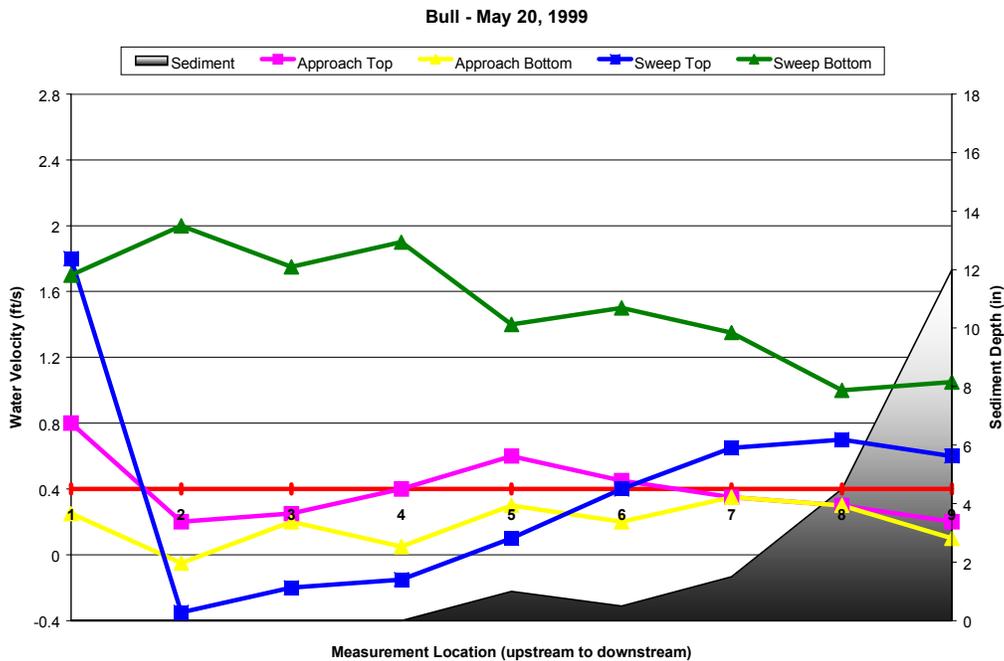
The Bull site was evaluated 5/20/99 and 7/23/99. About 15% of the recorded approach velocities exceeded 0.4 fps. Sweep velocities were not consistently higher than approach velocities, and there was often disparity between top and bottom sweep velocities (Figure 27 and Figure 28). Overall, sweep was slow, and bottom sweep values were often less than corresponding approach velocities. Water in front of the screens was always high, and submergence values for the flat plate screen was 94% on 5/20/99.

Figure 27. Water velocities and sediment depths at Bull, 5/20/99.

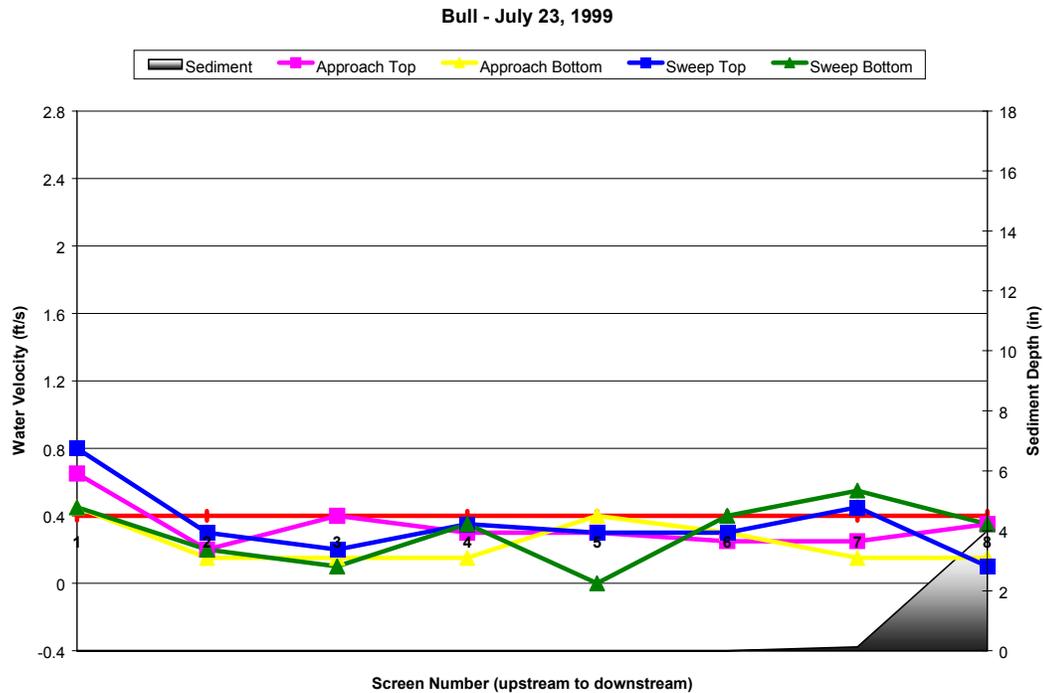
Figure 28. Water velocities and sediment depths at Bull, 7/23/99.

The screens and seals were generally in good condition, though it was difficult to assess screens and seals from the surface. Some leafy material and sticks/limbs were getting stuck in the trash rack and on the screen. The cleaning brushes were ineffective, especially on screen 4, where the brush was not touching the screen. During the May survey, no silt was observed along the upstream end of the screen and increased toward the downstream end of the screen where approximately 12 in. of sand and leaves had accumulated. By July, the amount of silt near the downstream panel was about 4 in. deep.

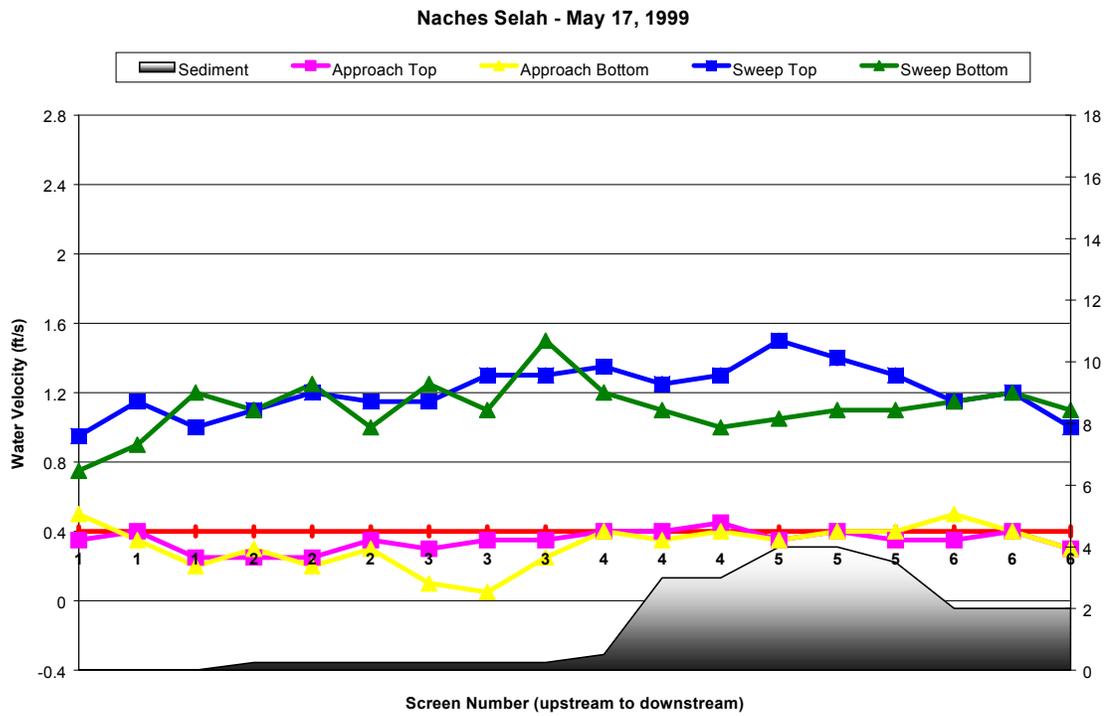
This site was evaluated 5/17/99 and 8/4/99. Almost 28% of the approach velocities at Naches-Selah were greater than 0.4 fps (Figure 31 and Figure 32). This was a significantly higher than during the previous two years (1997: 5.5%; 1998: 2.8%). The high approach velocities were most apparent in August. Sweep velocities were always much greater than their corresponding approach velocities. Bypass velocities were always higher than the average sweep velocities. Screen submergence values for this flat plate screen were 82 and 85%.

Figure 31. Water velocities and sediment depths at Naches-Selah, 5/17/99.

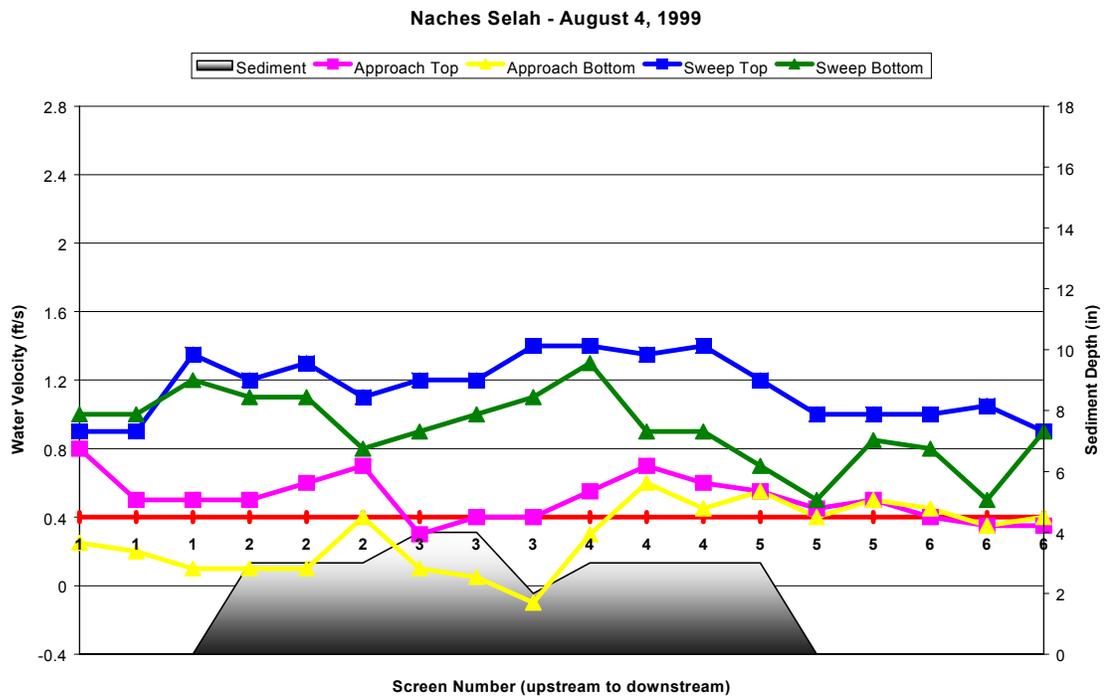
The screen was in generally in fair condition. There were some rust areas showing, and a small patch was on screen 5. Screen 3 had perf plate attached to the face of the profile bar screen. As a result, screen 3 accumulated more leaf matter than adjacent screens. The cleaning system was not touching the entire length of the screen, leaving grasses and leaves behind. Underwater video revealed some loose caulking between panels 2 and 3, 3 and 4, 4 and 5, and 5 and 6. Adequate amounts of water flowed over the weir at all times, and outfall conditions were good for fish passage. Sedimentation was not excessive at Naches-Selah in 1999. Silt depths ranged from 0 to about 4 in.

Figure 32. Water velocities and sediment depths at Naches-Selah, 8/4/99.

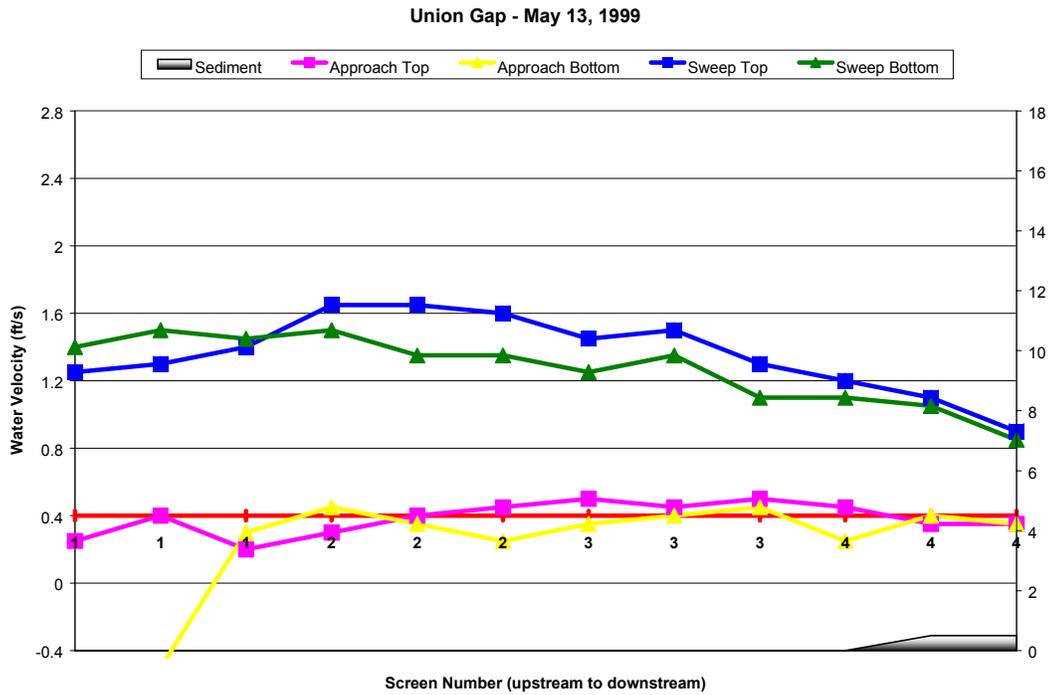
The Union Gap site was evaluated 5/13/99 and 7/14/99. Approach velocities were much higher in 1999 than in previous years. Nearly 23% of the approach velocities exceeded 0.4 fps (Figure 33 and Figure 34). Sweep velocities, while always greater than corresponding approach velocities, generally decreased toward the bypass and were greater than the bypass velocities. Screen submergences at this flat plate site were 85 and 80%. Screen submergence marks were present, but difficult to read because they were under the cleaning system when it was at rest.

Figure 33. Water velocities and sediment depths at Union Gap, 5/13/99.

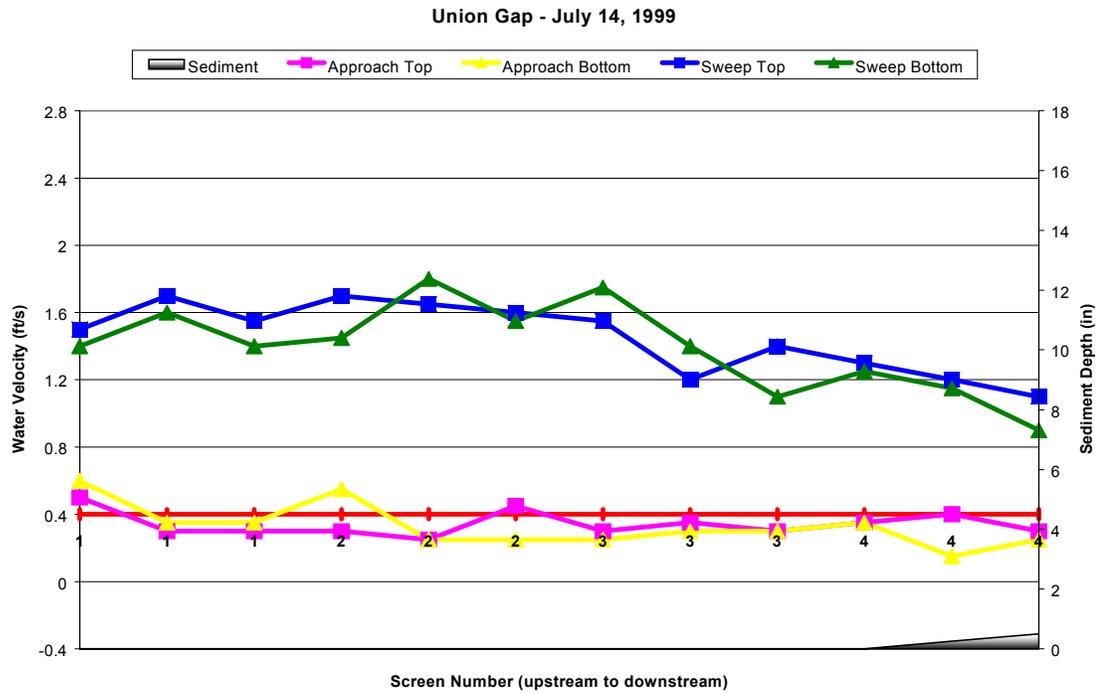
Figure 34. Water velocities and sediment depths at Union Gap, 7/14/99.

The screen and seals were in good condition; however, Screen 3 had a metal plate partially covering it. Screen seals were in poor condition, with missing caulking between screens 2 and 3 and 3 and 4. Adequate amounts of water always flowed over the bypass weir, and all other outfall conditions were good for fish passage. Sediment was not a problem at this site during the 1999 evaluations. The cleaning system failed to remove all leaves because the interval set for brush operation (approximately 1 hour) was too long.

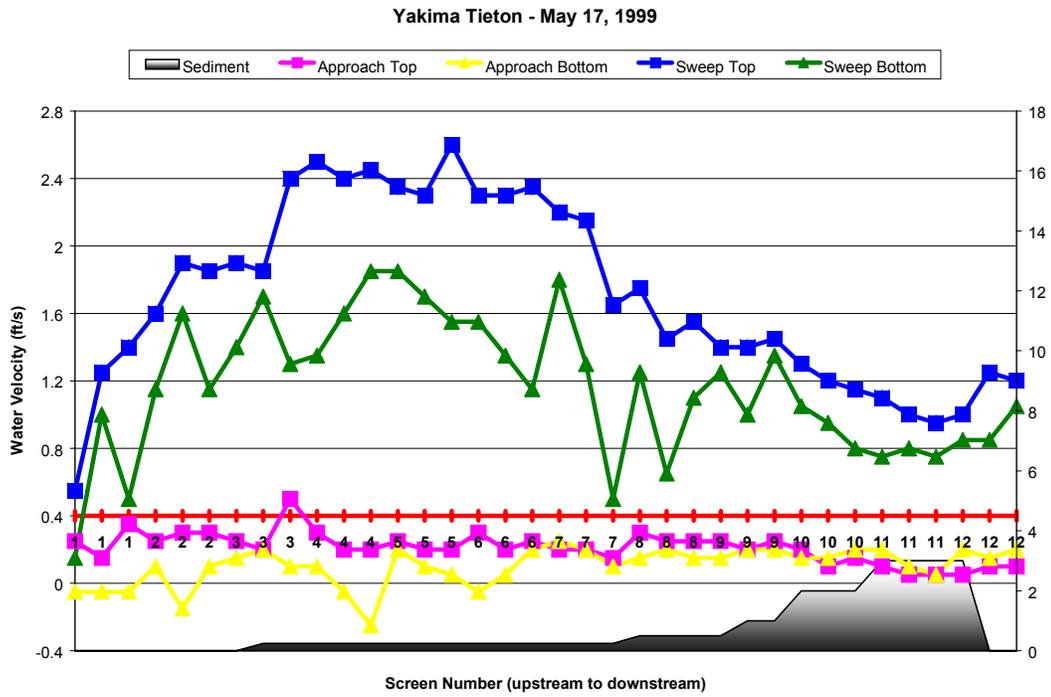
The Yakima-Tieton site was evaluated 5/17/99 and 7/21/99. Eighty-eight percent of the recorded approach velocities were less than 0.4 fps (Figure 35 and Figure 36). There is a fast flow at this site, and sweep velocities were always much higher than their corresponding approach velocities. However, sweep velocities did not increase toward the bypass, but sweep velocities were generally high enough to mitigate this condition. Sweep velocities were slightly higher than bypass velocities. Screen submergence at Yakima-Tieton was approximately 56 and 71%.

Figure 35. Water velocities and sediment depths at Yakima Tieton, 5/17/99.

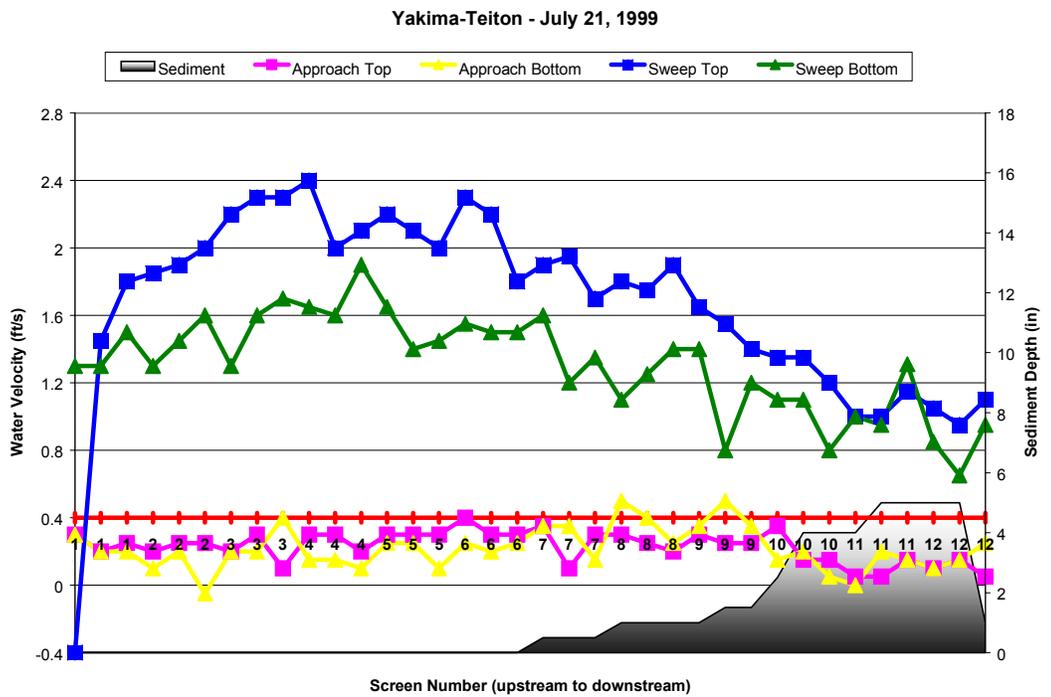
Figure 36. Water velocities and sediment depths at Yakima Tieton, 7/21/99.
