**WASHINGTON PHASE II FISH DIVERSION
SCREEN EVALUATIONS IN THE
YAKIMA RIVER BASIN, 1999**

DOE/BP-00000652-4

Washington Phase II Fish Diversion Screen Evaluations in the Yakima River Basin, 1999

Pacific Northwest National Laboratory
Richland, Washington

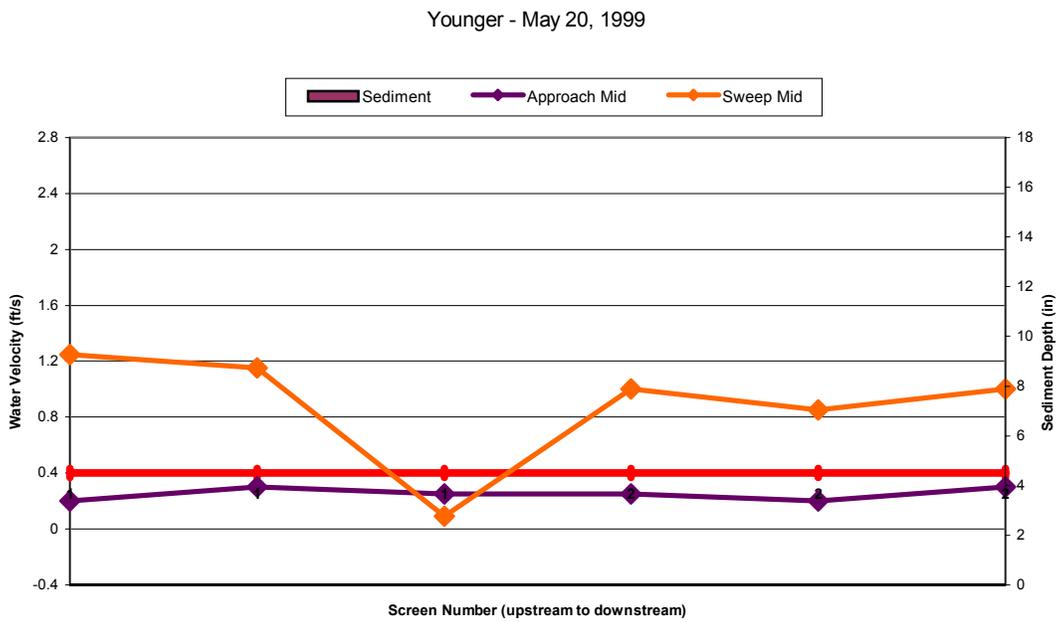
The Younger site, near Cle Elum, was evaluated for the first time on 5/20/99 and again on 7/23/99. All approach velocities were below NMFS criteria of 0.4 fps (Figure 38 and Figure 39). Sweep velocities generally exceeded approach velocities. Screen and seal conditions were good. This site has no bypass. The cleaning brushes were running continuously, and seemed to affect water velocities. Debris was not a problem at Younger during the 1999 evaluations.

Figure 38. Water velocities and sediment depths at Younger, 5/20/99.

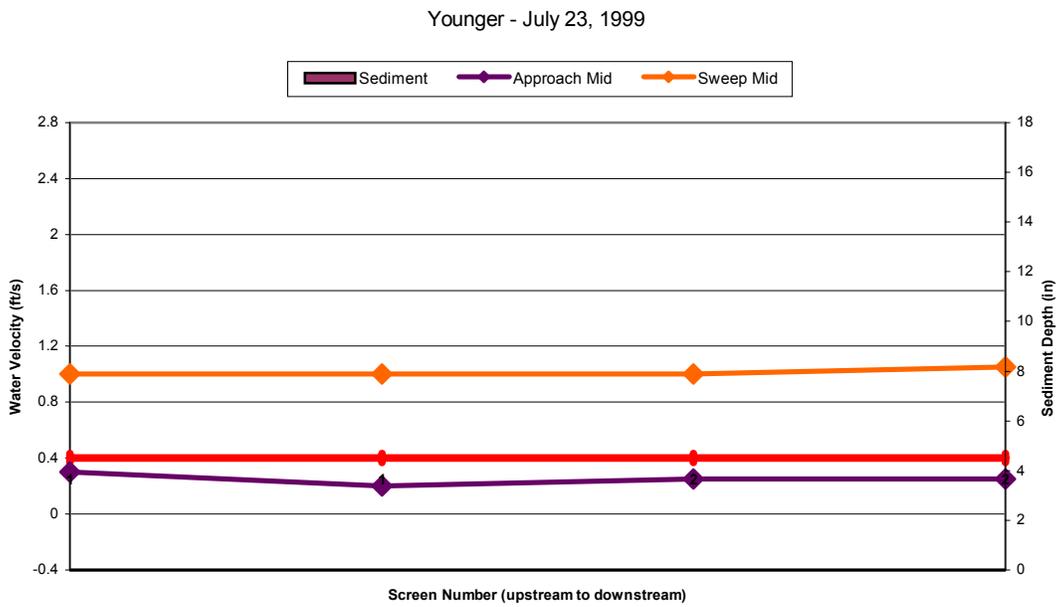
Figure 39. Water velocities and sediment depths at Younger, 7/23/99.
