YAKIMA RIVER BASIN PHASE II FISH SCREEN EVALUATIONS

Annual Report 2001

DOE/BP-00000652-8

Yakima River Basin Phase II Fish Screen Evaluations, 2001

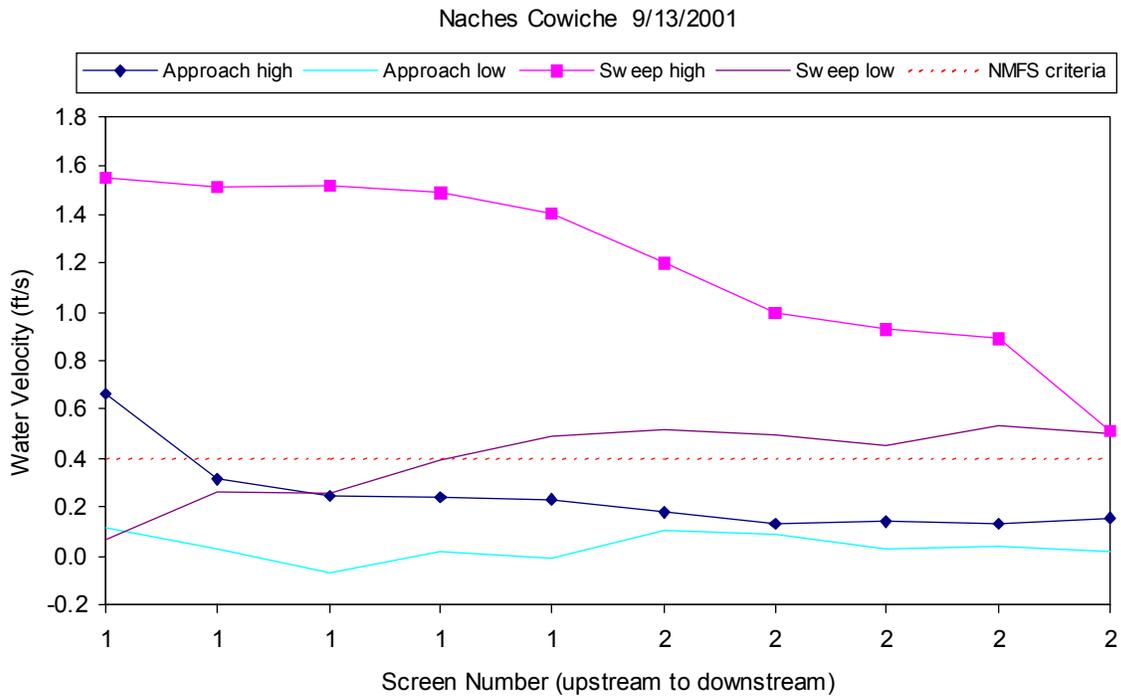
Figure 9. Water Velocities at Naches-Cowiche on 9/13/2001

The Naches-Cowiche site was evaluated on 5/17/2001, 6/22/2001, and 9/13/2001. Water velocity was measured with the ADV using an improper calibration file in May and June; therefore only velocity data from September are presented here. In September, 95% of all approach values met NMFS criteria (Figure 9). Sweeps were generally higher than approaches, but did not increase toward the bypass. The average bypass velocity was slower than the average sweep.

During the September survey the water level in the river was relatively high. This high water level is reflected in the elevated approach velocities observed during this survey, which exceeded 0.6 ft/s in the upstream corner of screen one (Figure 9). It was hypothesized that the stoplogs might have accentuated this problem, and the WDFW removed the stoplogs 1 week later. We remeasured the velocities after the stoplogs were removed and found approaches to be lower than before, though the upstream corner of screen one still exceeded 0.4 ft/s. The water level in the river was lower than on our previous survey; therefore, we cannot conclude that the stoplogs were the cause of the high approaches. The WDFW is planning to move the stoplogs farther upstream in an attempt to minimize eddying and maintain some control over sediment buildup.

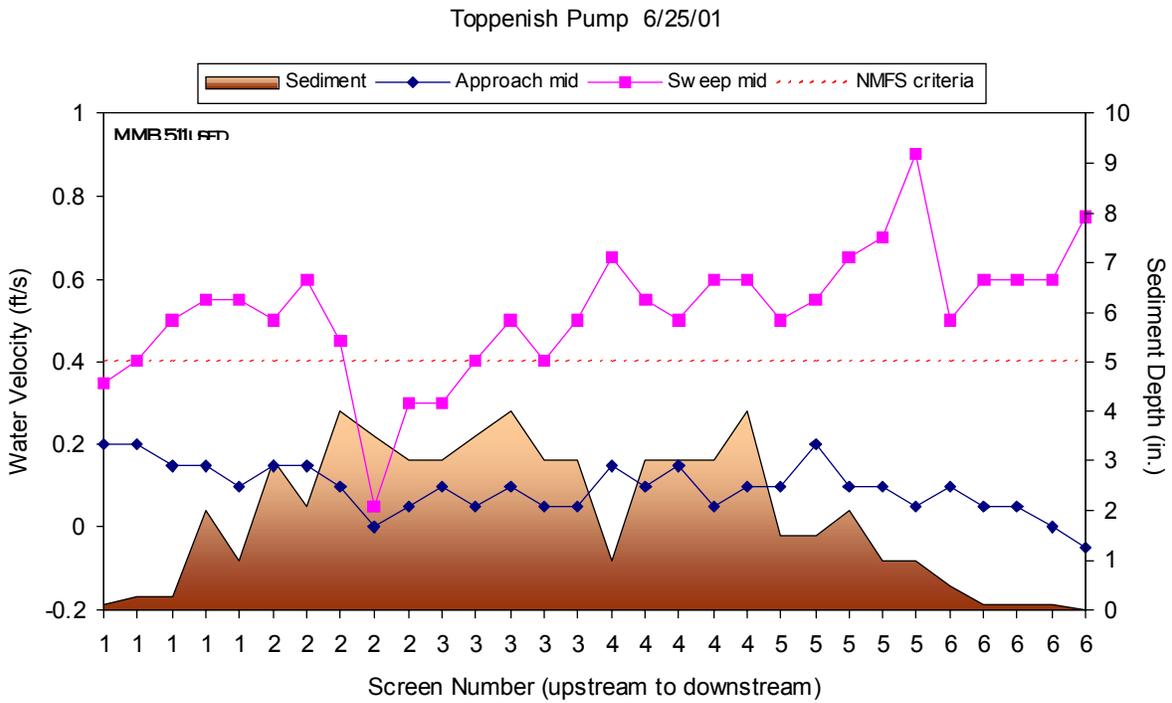
Figure 16. Water Velocities and Sediment Depths at Toppenish Pump on 6/25/2001

The Toppenish Pump site was visited on 5/24/2001, 6/25/2001, and 9/20/2001. The water velocity was measured with the ADV using an improper calibration file in May, so velocity data from that month are not discussed. Velocities were measured using the Marsh-McBirney in June and the ADV in September. Between June and September, 98% of approach velocities met NMFS criteria. Sweeps were always higher than approaches (Figures 16 and 17). Sweep did not generally increase toward the bypass, and bypass velocities were higher than sweeps. In September, the stoplogs were removed from screens 5 and 6, and flows increased in the downstream region of the site.

The screen seals that were visible looked to be in good condition. In May, the water was too murky to evaluate the bottom seals. There were piles of sediment and debris in the downstream corners of each screen bay. The conditions were much the same in June, though it appeared that the debris problem had worsened, and plant growth was abundant in the forebay. In September, a large pile of sediment was still present in front of the first two screens, which covered the bottom seal in places.

The outfall had relatively thick accumulations of sticks and debris extending from the surface of the water, and reaching down at least 6 in. Removal of this debris periodically will help to prevent blockage of the bypass pipe and possible injury to migrating fish.

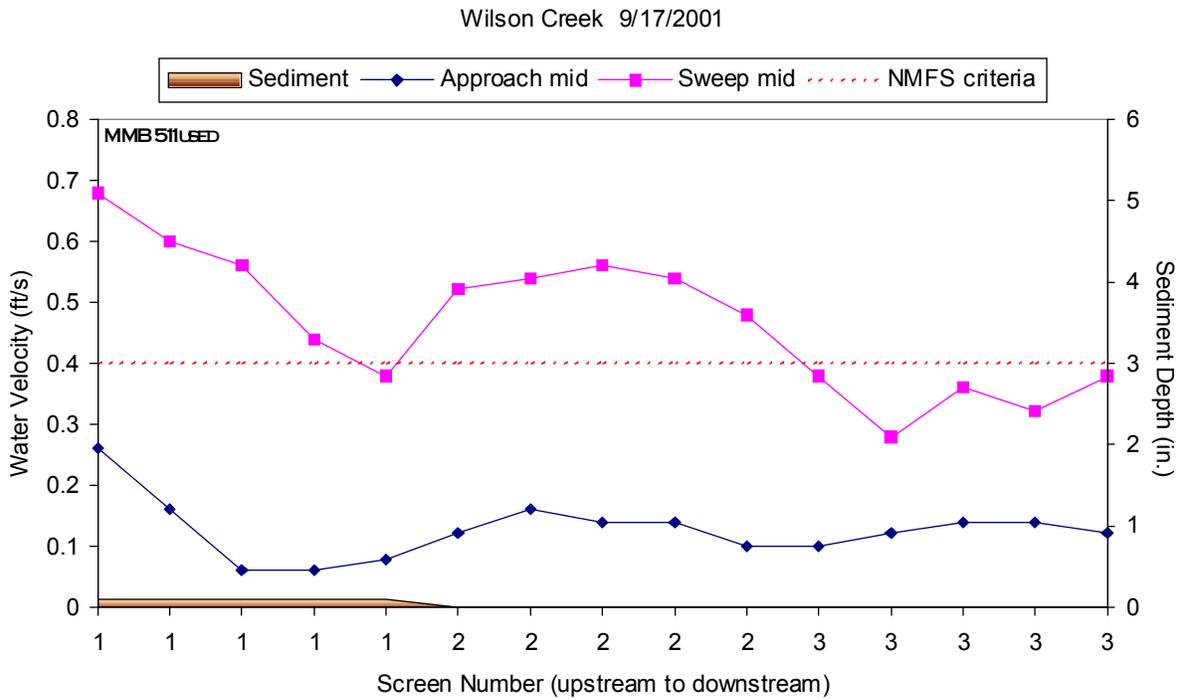
Figure 18. Water Velocities and Sediment Depths at Wilson Creek on 9/17/2001

The Wilson Creek site was visited on 5/22/2001 and 9/17/2001. This site has three drum screens and was constructed to replace Bull Ditch. In May, water velocities were measured with the ADV using an improper calibration file and those data are not presented here. In September, 100% of approach velocities met NMFS criteria (Figure 18). Sweeps were always greater than approaches. Sweep did not increase towards the bypass, and the average bypass velocity was slower than the average sweep.

All seals were in good condition. The first screen had a patch near the upstream seam. There was some buildup of sediment at the downstream end of screen 3 in May, and in September there was a lot of plant material in the forebay, some of which obscured the view of the seals and blocked the bypass. Some plastic debris and a large stick were present in the downwell of the bypass in May, though they were not obstructing water flow. In May, we could not find the outfall to evaluate it. In September, conditions at the outfall were good. The pipe was submerged, the water flowed smoothly, and the depth at the point of discharge was greater than 1 ft, all of which should help to contribute to safe fish passage.

According to notes in the logbook, and our own observations, submergence was at or near criteria all summer. In September it had fallen down to 62%, which does not meet NMFS submergence criteria but was probably not harmful for the fish in this small stream in a low-water year.

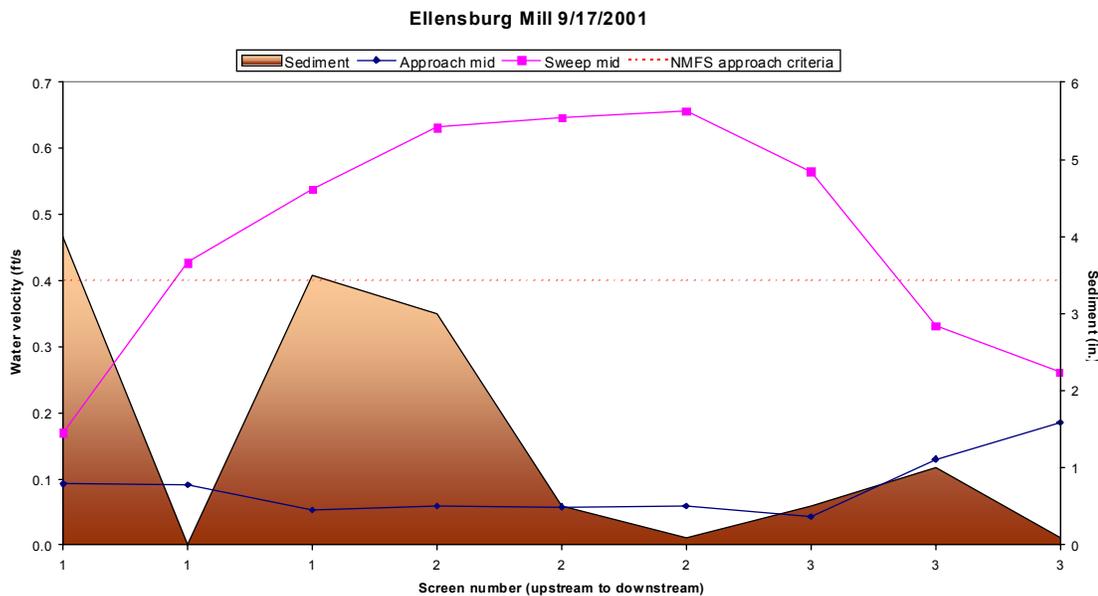
Figure 21. Water Velocities and Sediment Depths at Ellensburg Mill on 9/17/2001

The Ellensburg Mill site was evaluated on 5/15/2001, 6/20/2001, and 9/17/2001. Water velocity was measured with the ADV using an improper calibration file in May and June; therefore, only velocity data from September are presented. In September, all approach values met NMFS criteria, and sweeps were always higher than approaches (Figure 21). Sweep did not generally increase toward the bypass, and bypass velocity was slower than the average sweep.

The bottom seals were in good condition, though there was little caulking between the screens or between the screens and the concrete walls of the forebay. Three inches of sediment had accumulated in front of the screens in May, coming down to 2 in. in June and reaching 4 in. in some spots in September. Also, lots of vegetation was growing in the forebay and in the aftbay.

In May, the brushes were being turned on only when the maintenance crew was there, and a significant amount of algae had built up on the screens. This caused a significant amount of headloss across the screens (13.5 in. during our survey). This was changed on 5/22 when the brushes were set to run continuously, which drastically reduced headloss.

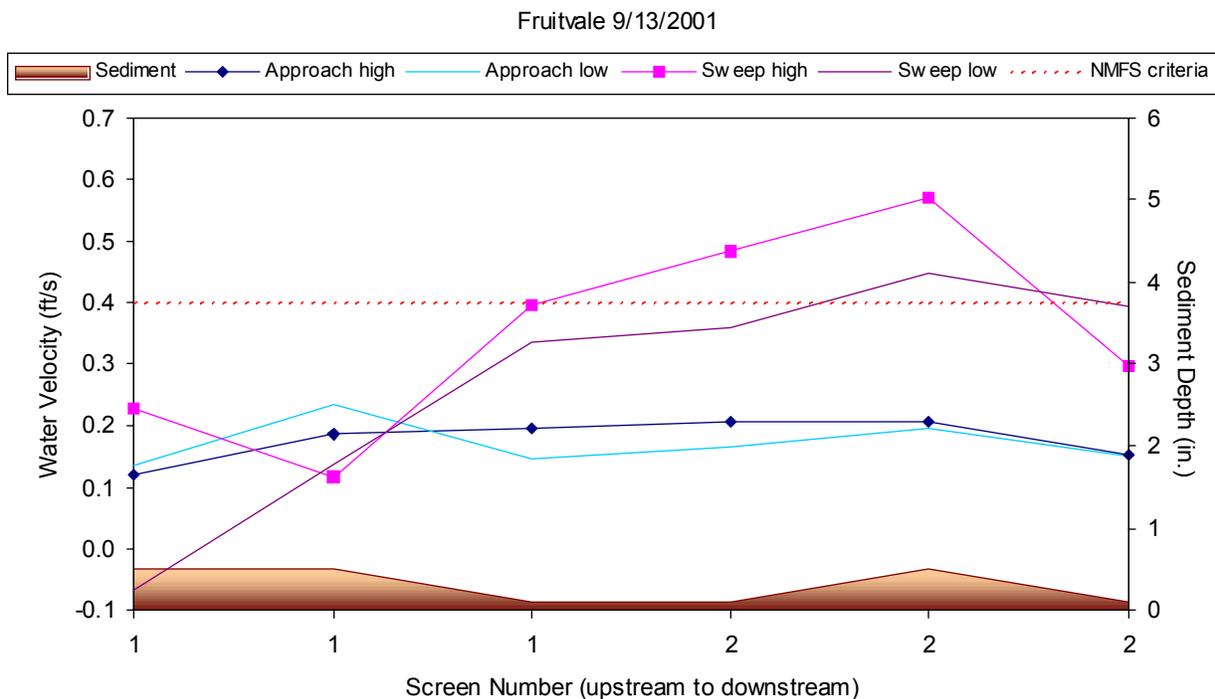
Figure 22. Water Velocities and Sediment Depths at Fruitvale on 9/13/2001

The Fruitvale facility was evaluated on 5/17/2001, 6/27/2001, and 9/13/2001. Water velocity was measured with the ADV using an improper calibration file in May and June, so only velocity data from September are presented here. In September, all approach velocities complied with NMFS criteria, and sweep values were usually higher than approaches (Figure 22). Sweep velocities generally increased toward the bypass, and bypass velocities were higher than the average sweep, creating a clear trajectory toward the bypass.

Submergence levels fluctuated severely throughout the survey period. In May there were indications that the water level had been above the screen material, but not above the metal plate attached to the top of the screens. The submergence level was noted in the logbook as 50% on 7/2 and 7/9, and was up to 100% by 7/16. In September, the screen material was still completely submerged, though no water was flowing over the top.

The screens were missing caulking along the bottom and side seals during all surveys. In May, there were areas of the screen that the brushes were not cleaning. In June, the bypass was completely shut down, and no water flowed through it. The logbook revealed that the bypass was shut off for almost a month starting in mid-June, and that the operator had difficulties getting the bypass ramp up to flush it out because of silt accumulation. Bypass operation was restored on 7/16, though the fishway was blocked off until sometime after 7/30.

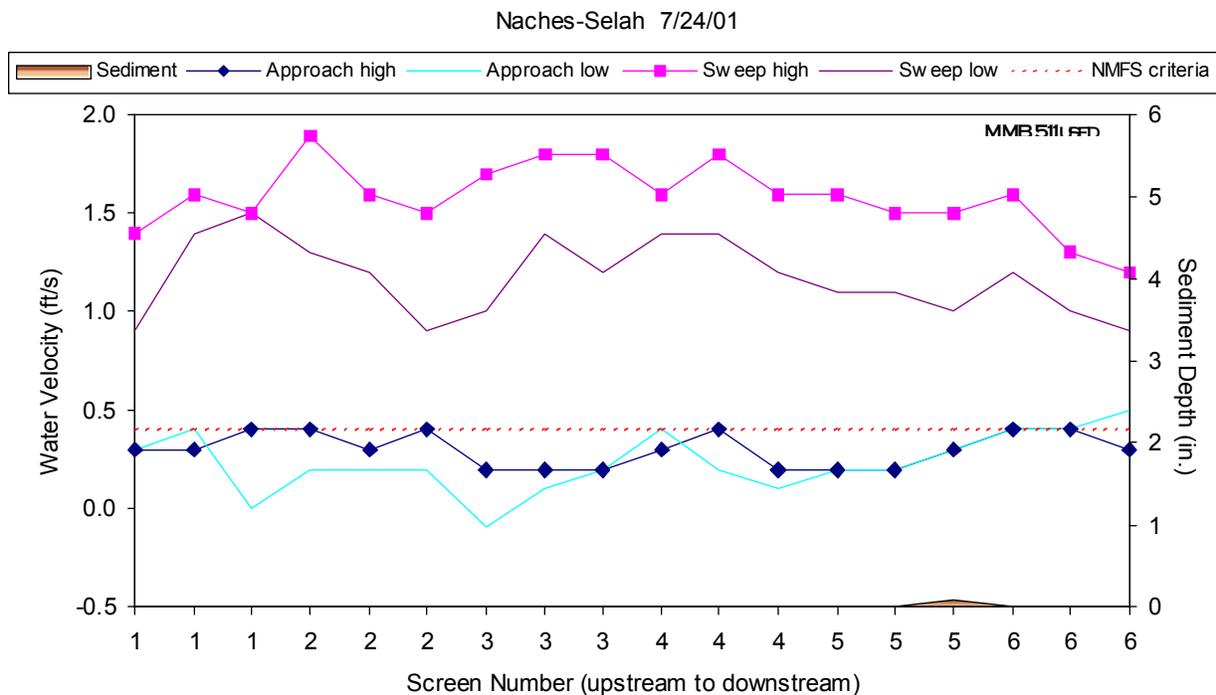
Figure 23. Water Velocities and Sediment Depths at Naches-Selah on 7/24/2001

The Naches-Selah site was evaluated on 5/16/2001, 6/22/2001, 7/24/2001, and 9/19/2001. Water velocities were measured with the ADV using an improper calibration file in May and June, so velocity data from those months are not presented here. Water velocities were measured using the Marsh-McBirney in July and the ADV in September. In July and September, 97% and 92% of approach velocities met NMFS criteria, respectively (Figures 23 and 24). Sweeps were generally greater than approaches, though sweep did not increase toward the bypass, and the bypass velocity was slower than the average sweep both months. In September, vegetation growing near the bypass entrance caused sweep velocities at the downstream end of the site to be unusually low.

The seals between the metal screen and the concrete of the forebay and in between the screens were missing in places. We also noticed that the vertical bar screens had been patched with a perforated plate screen material that could affect the flows in those places. There were no sediment problems at this site, and the mechanical brushes worked properly throughout the survey period.

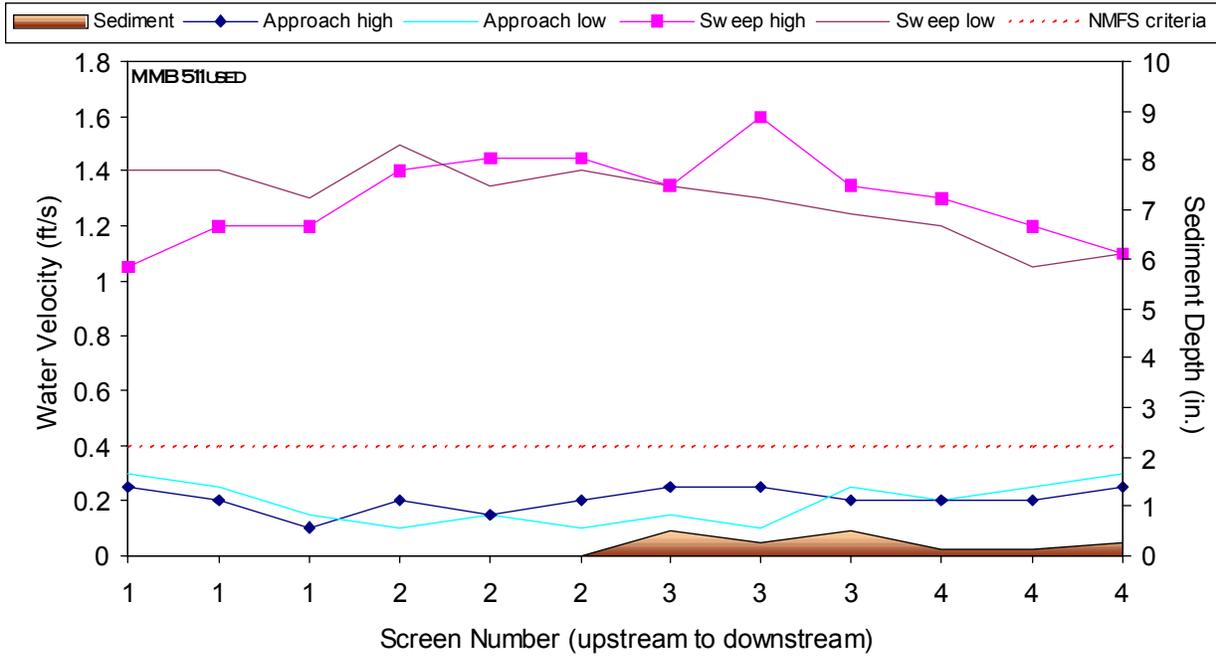
Figure 25. Water Velocities and Sediment Depths at Union Gap on 5/22/2001

Bypass conditions were good during all surveys. Because of lower flow volume, water did not surge through the bypass as it did in previous years. Water flowed freely over the weir and through the outfall. Water depth in the outfall pipe and at the point of discharge was always within criteria.

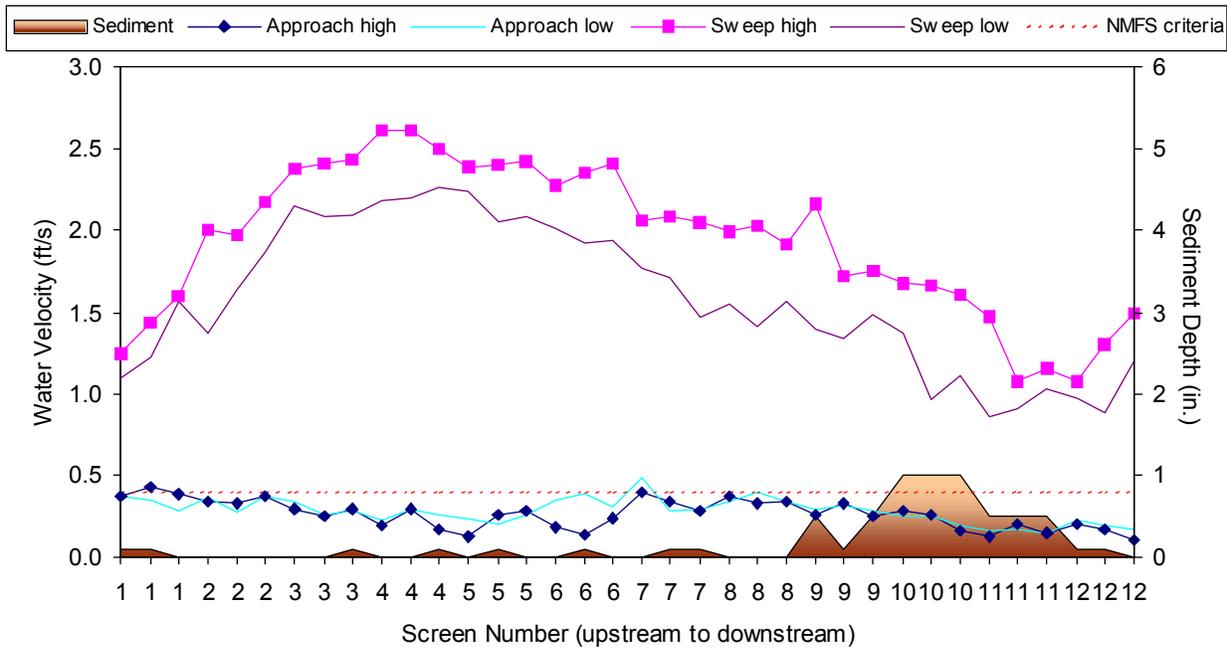
Figure 28. Water Velocities and Sediment Depths at Yakima-Tieton on 9/18/2001

Several screen seals have missing or failing caulking and could benefit from re-caulking. In September, there was a big pile of debris in the bypass. During our visits, water was not flowing over the bypass weir. Instead, the flush gate was open to allow for easier fish and sediment movement through the bypass. In September, the water was very turbulent in the downwell. Water flowed freely through the bypass and out the outfall pipe. Water depth at the point of discharge was less than 1 ft in May, though once it cleared the cement apron the depth in the river was greater than 1 ft.

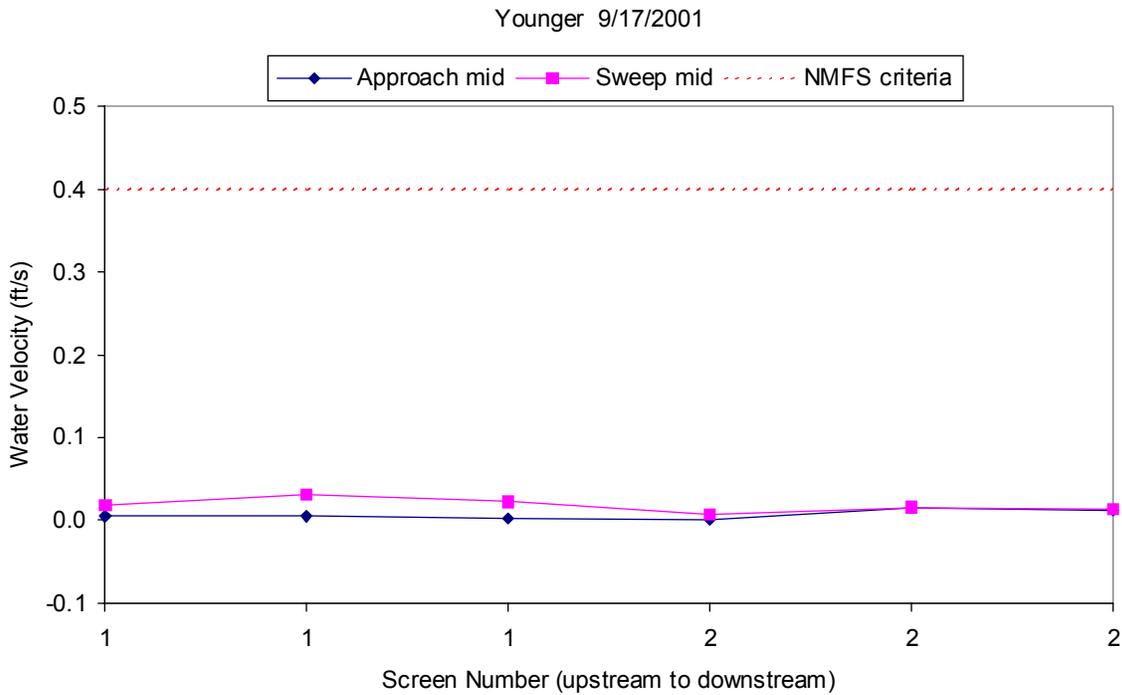
Figure 29. Water Velocities at Younger on 9/17/2001

Submergence was well below NMFS criteria during all surveys at 36, 34, and 30% for May, June, and September, respectively. Low water levels in the river and consequently at the site may account for the low recorded velocities in September (Figure 29). We also noticed that the turning of the paddlewheel was causing a swell or surge in the water in the forebay that raised the water levels approximately 1 in. We have never noticed this before and conclude it is likely due to low flow conditions.

The upstream seal on screen number 1 was lacking caulking in places. There was some evidence of sediment and a small amount of debris in June. The brushes seemed to be effective, and there was little buildup of algae. Several small, unidentified fish were noted in the canal and in the forebay in September.

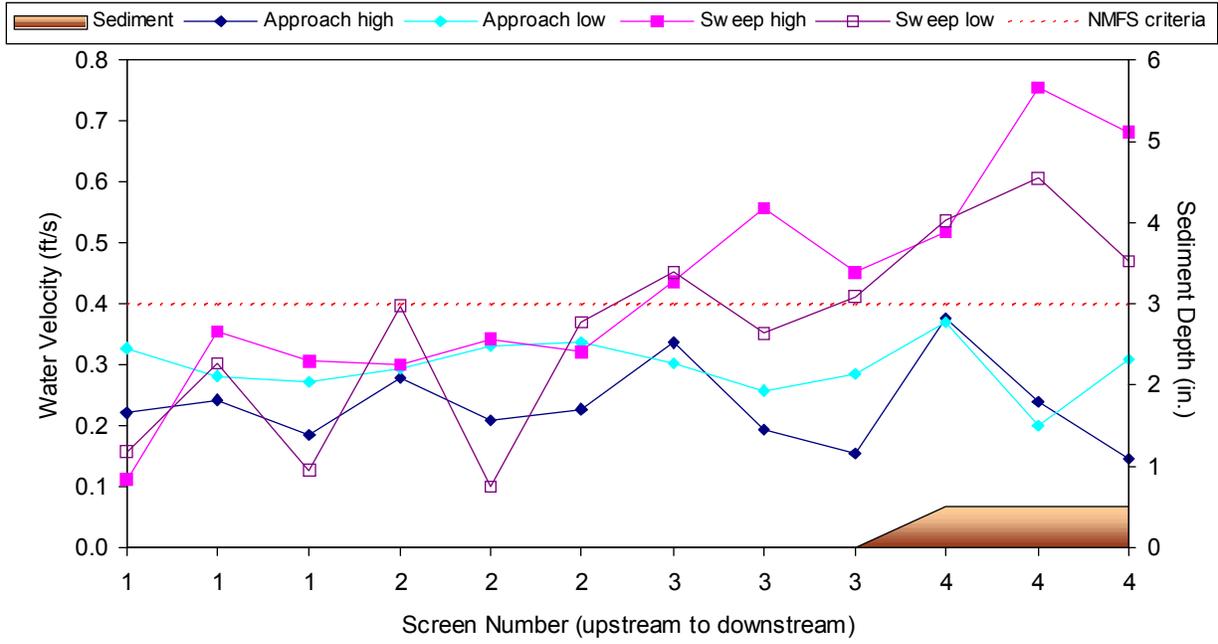
Figure 30. Water Velocities and Sediment Depths at Gleed on 9/19/2001

The Gleed site was evaluated on 5/17/2001, 6/27/2001, and 9/19/2001. Water velocity was measured with the ADV using an improper calibration file in May and June, so only velocity data from September are presented. In September, all approach values met NMFS criteria of ≤ 0.4 ft/s (Figure 30). Sweep was generally greater than approach and increased toward the downstream end of the site.

In May and June, small unidentified fish were seen jumping in the forebay, and there was a note in the logbook from 5/1 that fry were being carried over screens 3 and 4.
