Washington Phase II Fish Diversion Screen Evaluations in the Yakima River Basin

**Annual Report
2002**

January 2003

Yakima River Basin Phase II Fish Screen Evaluations, 2002

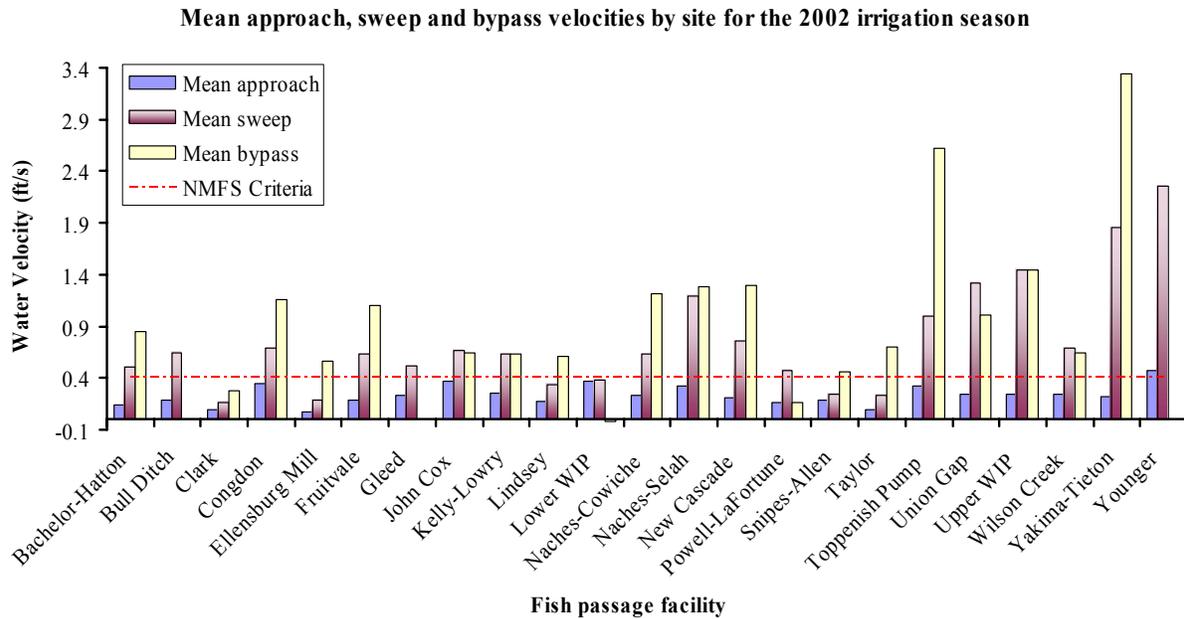
Figure 3. Mean Approach, Sweep, and Bypass Velocities at Phase II Fish Screen Facilities in the Yakima River Basin in 2002 Shown Against a Reference Line for the NMFS Approach Criteria (less than or equal to 0.4 ft/s)

Overall, 90% of all approach velocity measurements met the NMFS approach criteria of less than or equal to 0.4 ft/s (the same as was reported in 2000). This is much lower than the 97% reported in 2001; however, 2001 was an exceptionally low-water year, and many sites did not have enough water to meet other criteria, such as submergence and bypass flow. Areas of the screen (i.e., top, bottom, upstream, downstream) that exceeded these criteria were dependent on factors at the individual sites.

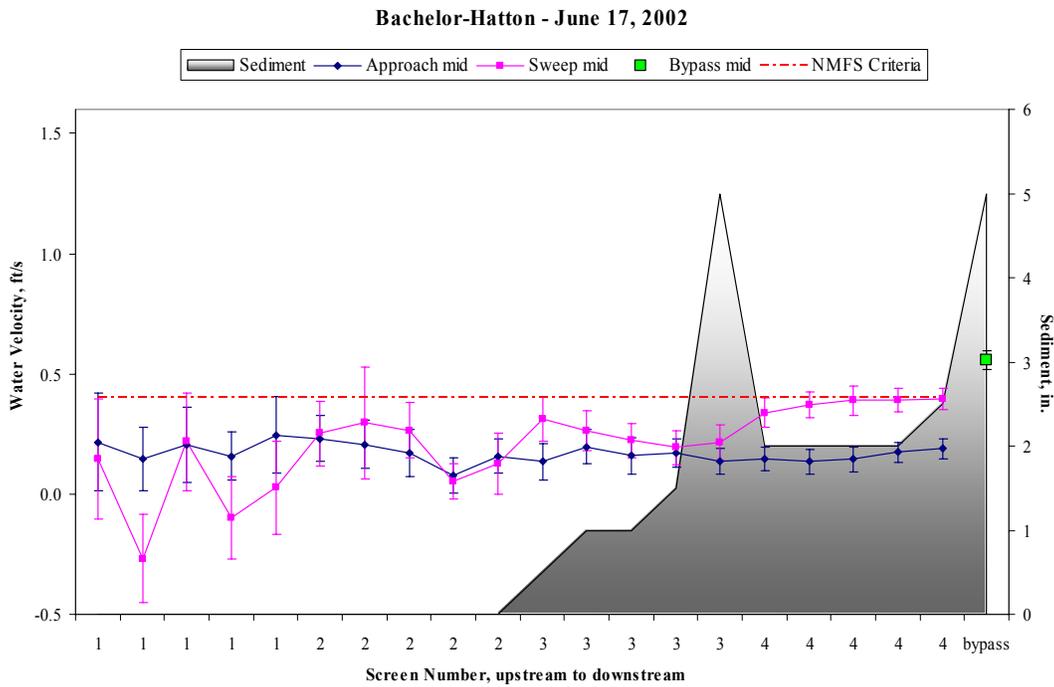
The Bachelor-Hatton site was evaluated May 13, 2002; June 17, 2002; and September 10, 2002; although no water was present at the site in September. In May and June, 95 and 100% of approach velocities met NMFS criteria, respectively (Figures 4 and 5). Water velocities approaching screen 1 were more variable in June, and sweep velocity did not generally increase from the upstream screens to the downstream end of the site, although the bypass velocities were generally greater than the average sweep velocity.

Figure 5. Water Velocities and Sediment Accumulations at Bachelor-Hatton in June 2002. Error bars show turbulence (\pm the root-mean-squared [RMS]) at each point.

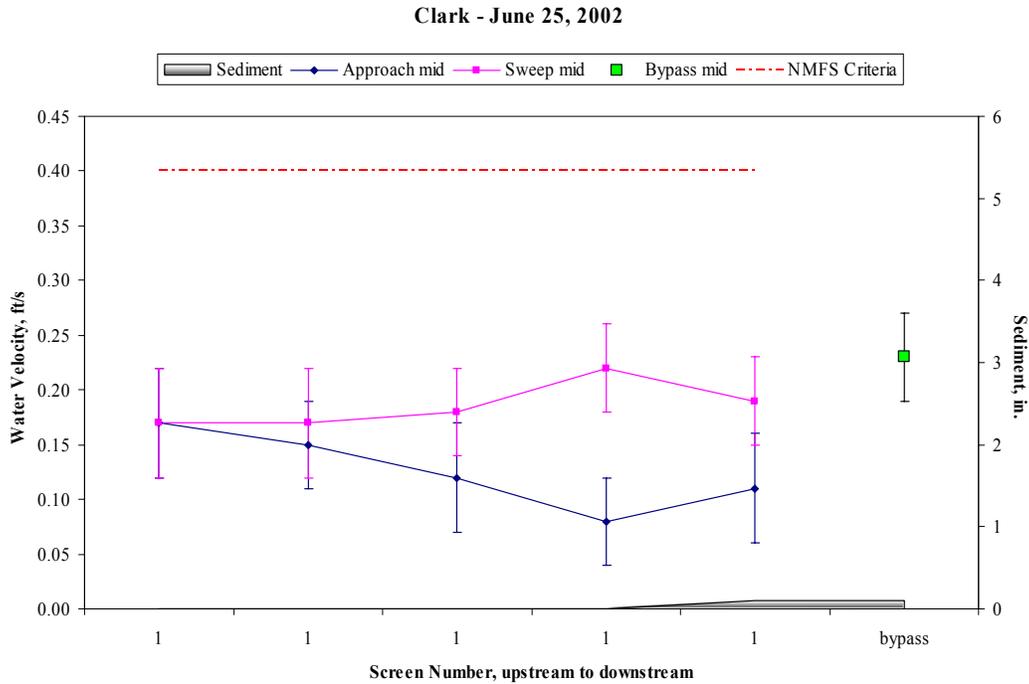
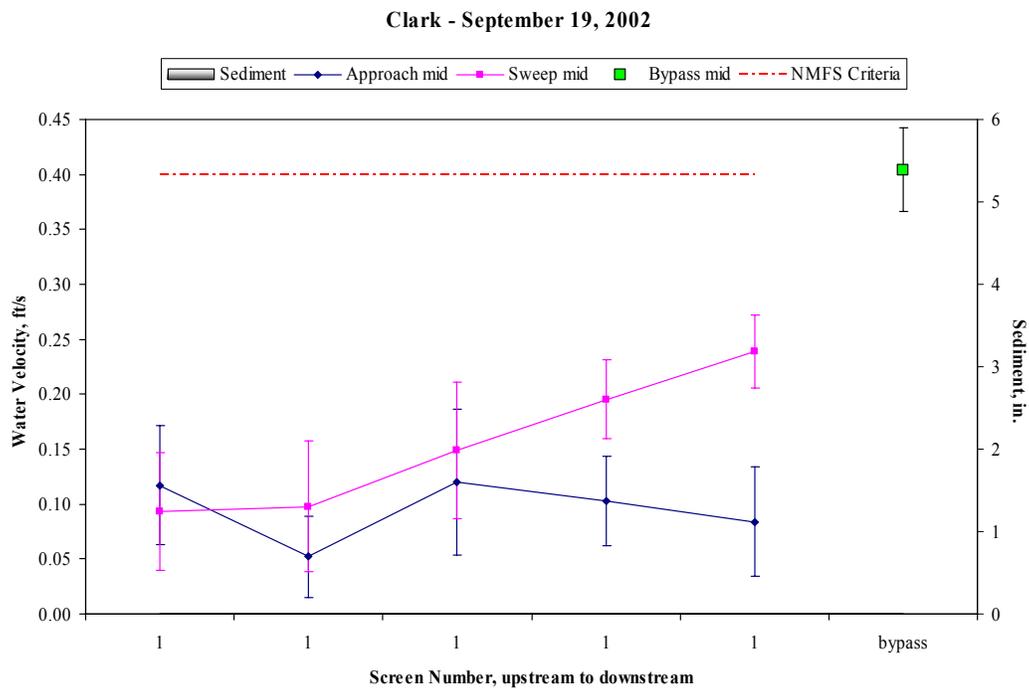
The Clark screening facility was visited on May 16, 2002; June 25, 2002; and September 19, 2002. Water velocities at this site complied with NMFS criteria during all surveys. All approach values were less than 0.4 ft/s, and sweep velocities were generally higher than approach velocities (Figures 6, 7, and 8). The water velocity in the bypass was always greater than the average sweep velocity, and in September, there was a clear increase in sweep velocity from upstream to downstream within the site. These conditions created a clear trajectory towards the bypass and would be expected to expedite fish passage through the site.

The condition of the screen and seals was good throughout all surveys. In June, three juvenile salmonids were observed in the forebay.

Figure 7. Water Velocities and Sediment Depths at Clark in June 2002. Error bars show turbulence (\pm the root-mean-squared [RMS]) at each point.

Figure 8. Water Velocities and Sediment Depths at Clark in September 2002. Error bars show turbulence (\pm the root-mean-squared [RMS]) at each point.

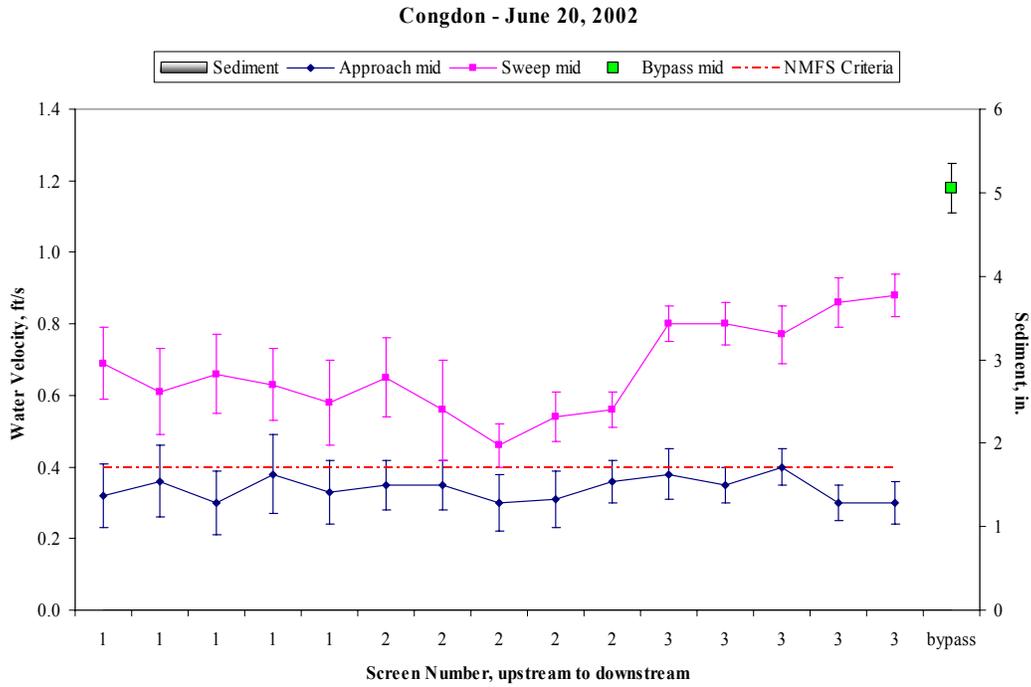
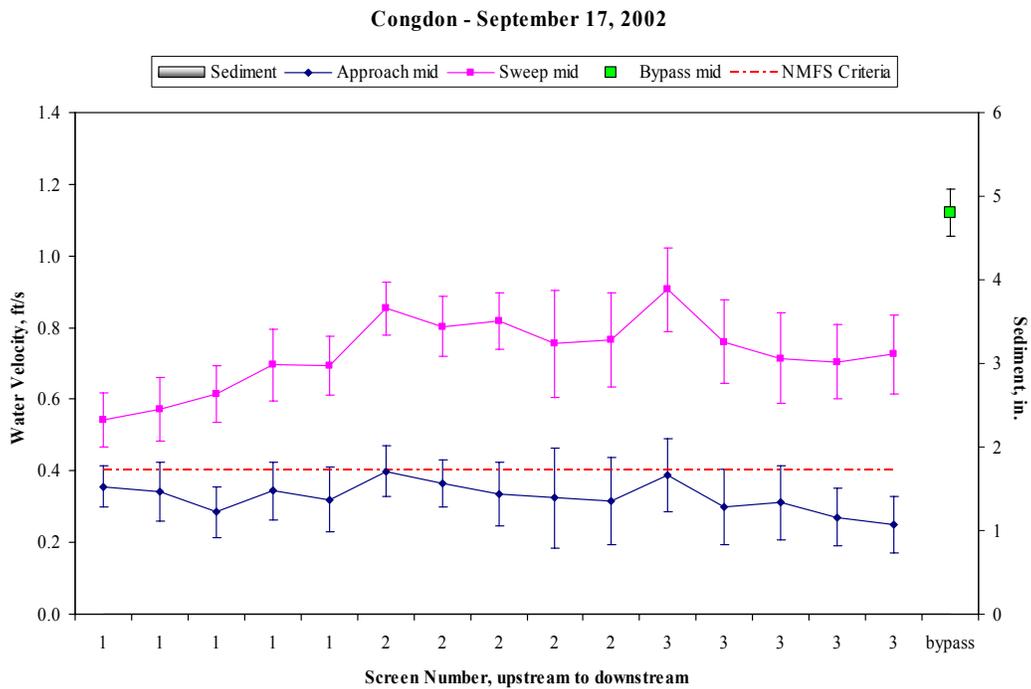
The Congdon facility was evaluated on May 20, 2002; June 20, 2002; and September 17, 2002. During the May evaluation, 67% of approach velocities exceeded NMFS criteria. This figure had greatly improved by June, and all approach velocities met NMFS criteria in June and September (Figures 9, 10, and 11). Sweep velocities were always higher than approach velocities, and the velocity in the bypass was always higher still, creating a clear trajectory towards the bypass during all surveys.

Figure 10. Water Velocities and Sediment Depths at Congdon in June 2002. Error bars show turbulence (\pm the root-mean-squared [RMS]) at each point.

Figure 11. Water Velocities and Sediment Depths at Congdon in September 2002. Error bars show turbulence (\pm the root-mean-squared [RMS]) at each point.

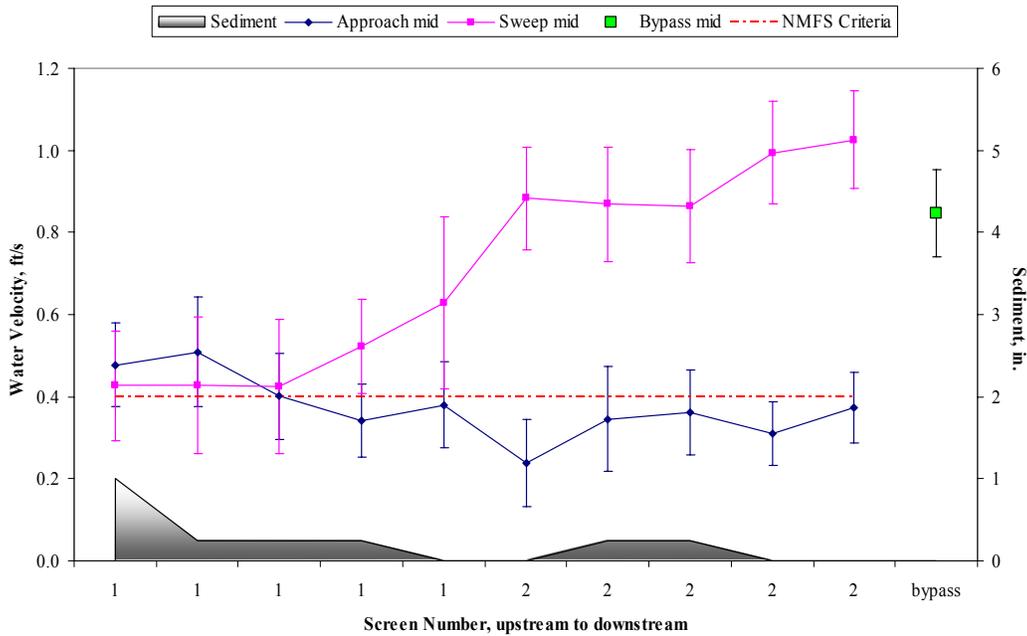
John Cox - June 18, 2002

The John Cox site was evaluated on May 13, 2002; June 17, 2002; and September 10, 2002, although the site was shut down for the season before the September survey. In May and June, 75 and 70% of approach velocities met NMFS criteria, respectively (Figures 12 and 13). However, there was a clear trend of decreasing approach velocity and increasing sweep velocity towards the downstream end of the site during both May and June. The bypass velocity was slower than the average sweep velocity in May, which led the PNNL researchers to believe that there was a blockage in the bypass. The PNNL researchers left a message for John Dyson (U.S. Bureau of Reclamation (USBR) concerning this issue on May 13, 2002. Tom Leonard (USBR) replied that there was no blockage. The PNNL researchers followed up on May 21, 2002, with a visit to the site. After passing a neutrally buoyant object through the bypass, the researchers concurred that the bypass was not blocked, but that it was backed up for some reason. This situation was remedied before the June survey, and in June, the bypass velocity was greater than the average sweep, and water ran freely over the weir and out the outfall.

Figure 13. Water Velocities and Sediment Depths at John Cox in June 2002. Error bars show turbulence (\pm the root-mean-squared [RMS]) at each point.

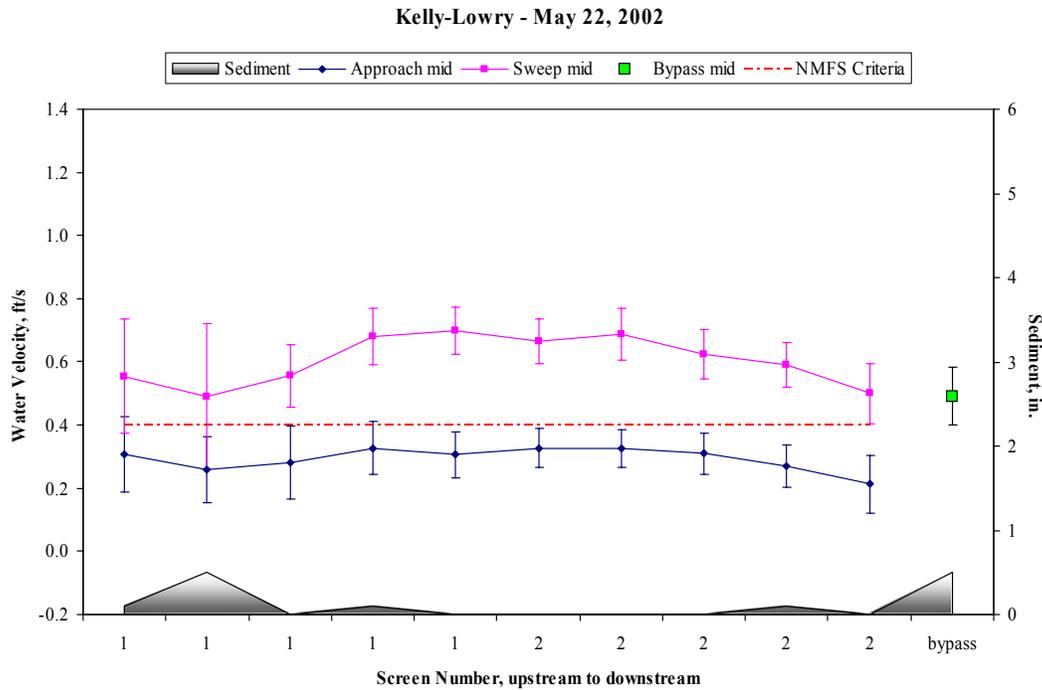
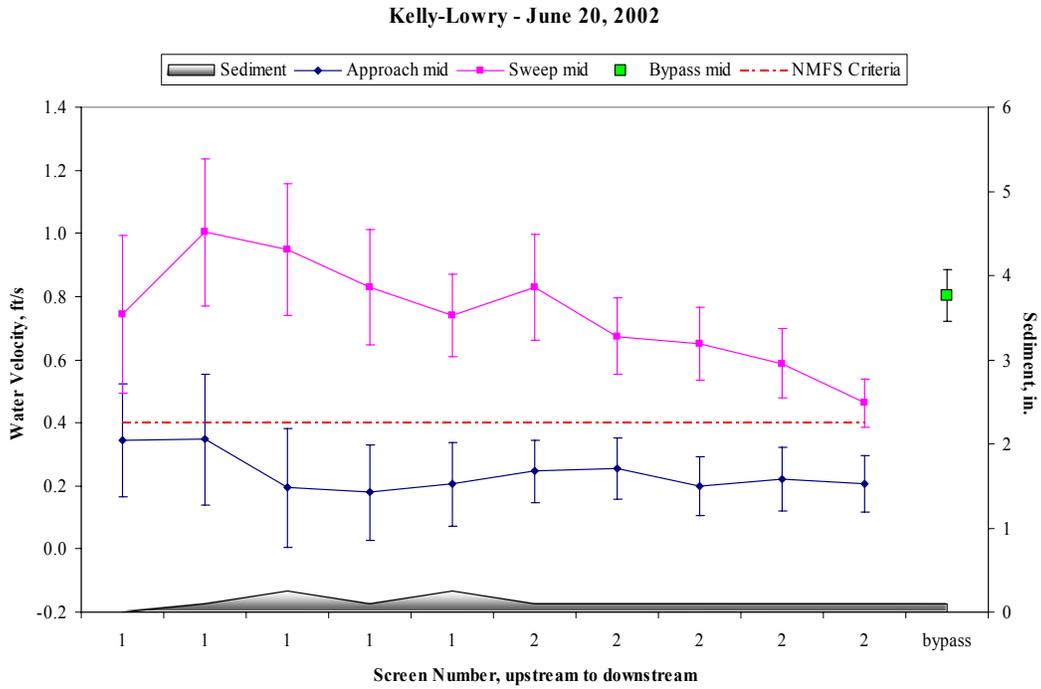
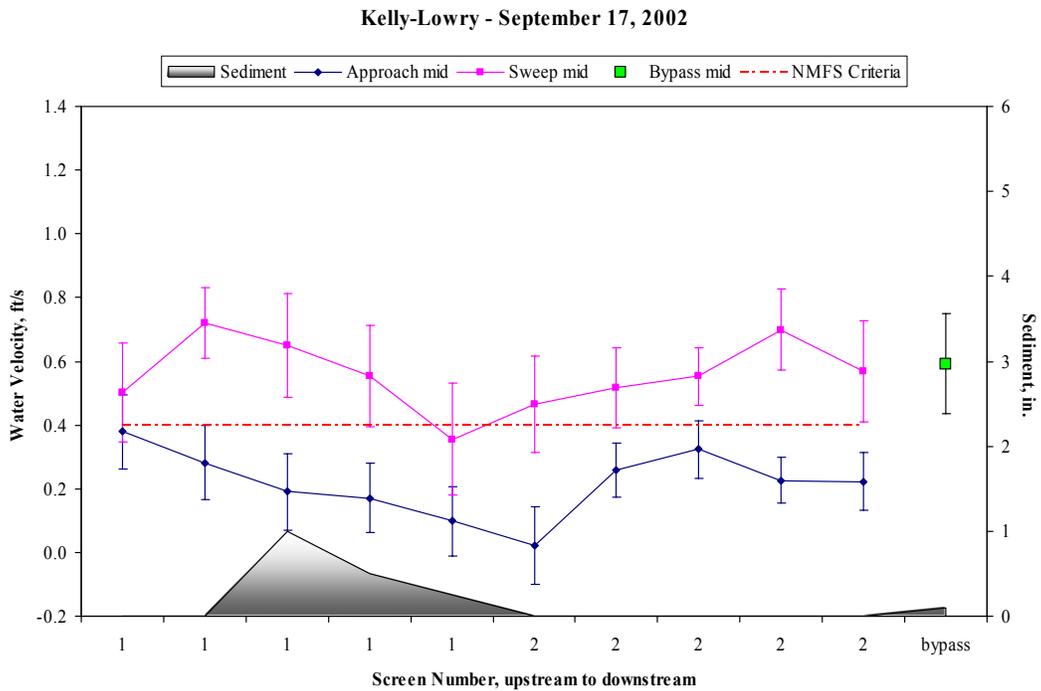
The Kelly-Lowry site was evaluated on May 22, 2002; June 20, 2002; and September 17, 2002. All approach velocities met NMFS criteria during all surveys (Figures 14, 15, and 16). Sweep velocities were always higher than approach velocities, though sweep velocities did not increase towards the bypass. The bypass velocity was slower than the average sweep velocity in May and faster in June and September.

Operator control aids were present, though the submergence marks on the drum screen frame were faint even in May and should be repainted.

Figure 14. Water Velocities and Sediment Depths at Kelly-Lowry in May 2002. Error bars show turbulence (\pm the root-mean-squared [RMS]) at each point.

Figure 15. Water Velocities and Sediment Depths at Kelly-Lowry in June 2002. Error bars show turbulence (\pm the root-mean-squared [RMS]) at each point.

Figure 16. Water Velocities and Sediment Depths at Kelly-Lowry in September 2002. Error bars show turbulence (\pm the root-mean-squared [RMS]) at each point.

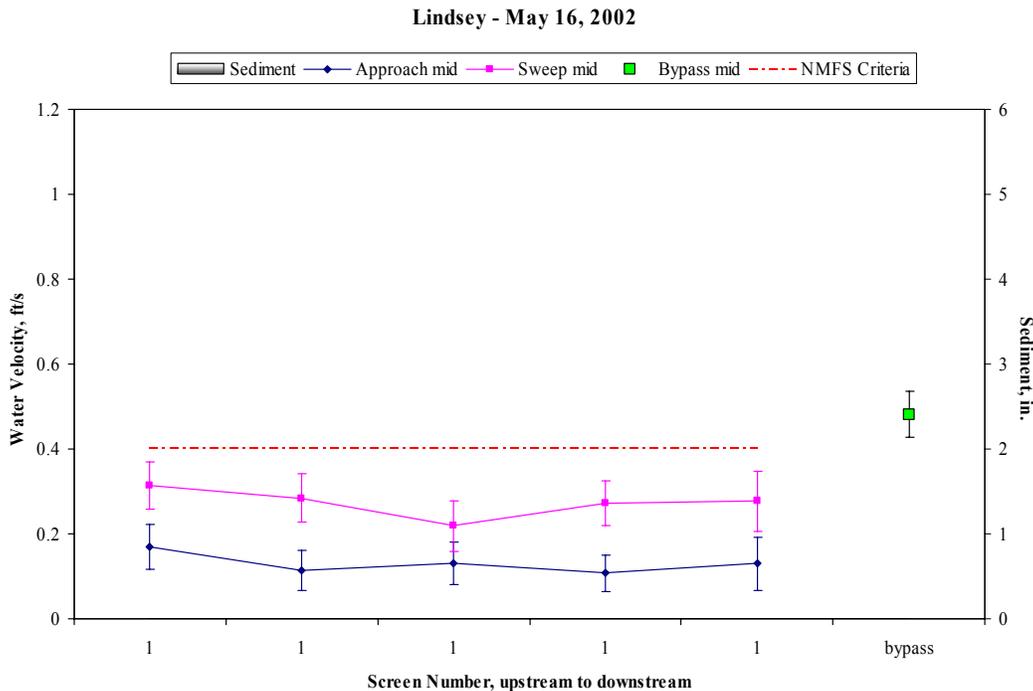
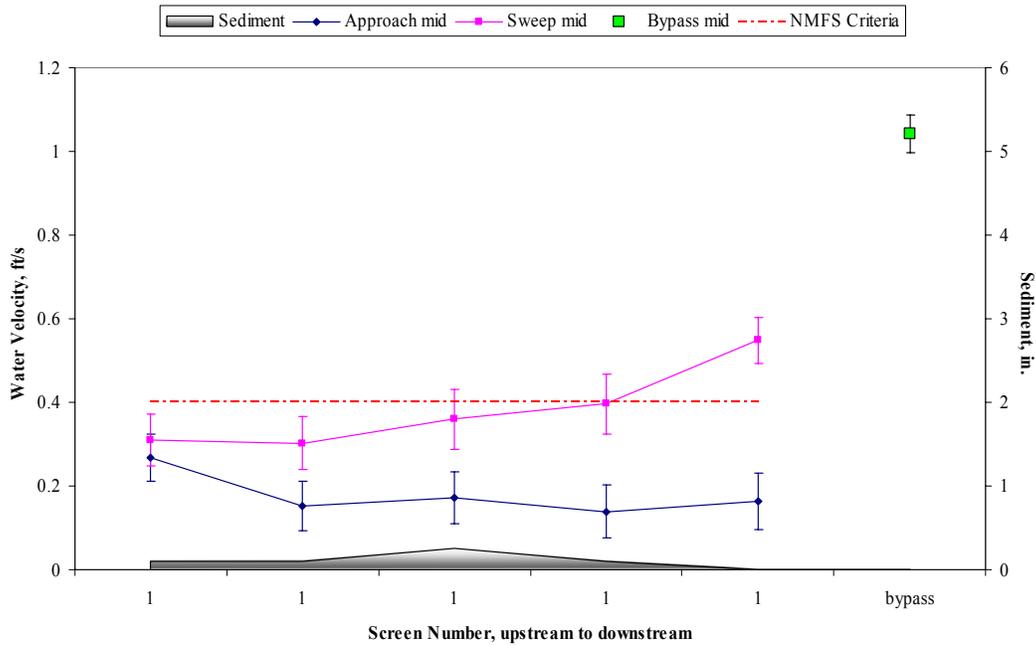
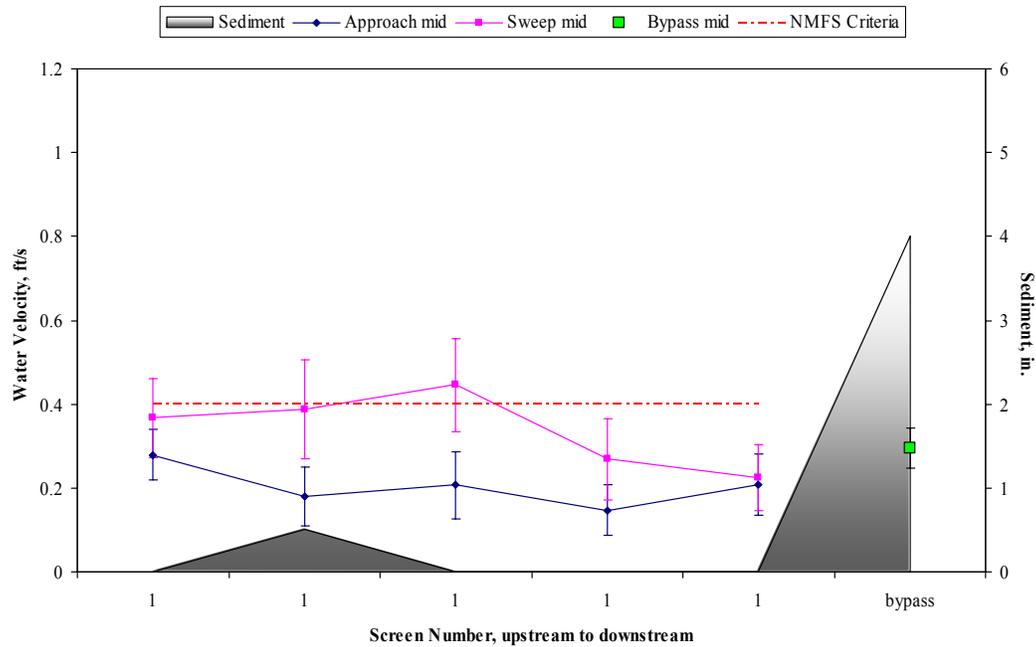
The Lindsey site was evaluated on May 16, 2002; June 25, 2002; and September 18, 2002. During all surveys, 100% of approach velocity values met NMFS criteria (Figures 17, 18, and 19). All sweep velocities were greater than approach velocities, and the bypass velocity was greater than the average sweep velocity, except in September. In June, sweep increased from the upstream end of the site towards the bypass.

Figure 17. Water Velocities and Sediment Depths at Lindsey in May 2002. Error bars show turbulence (\pm the root-mean-squared [RMS]) at each point.

Figure 18. Water Velocities and Sediment Depths at Lindsey in June 2002. Error bars show turbulence (\pm the root-mean-squared [RMS]) at each point.

Figure 19. Water Velocities and Sediment Depths at Lindsey in September 2002. Error bars show turbulence (\pm the root-mean-squared [RMS]) at each point.

This site has always been maintained and operated to meet NMFS criteria and has had very few problems over the last several years. Because of the increasing number of requests to evaluate new sites each year, the PNNL researchers believe that it would be appropriate to inspect Lindsey only once a year.

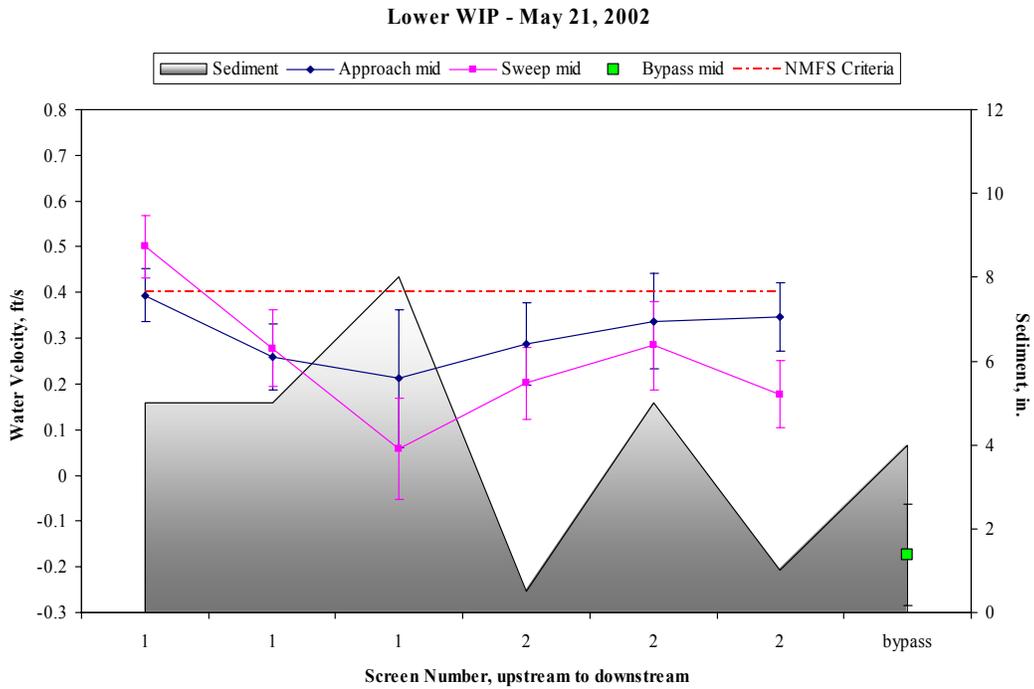
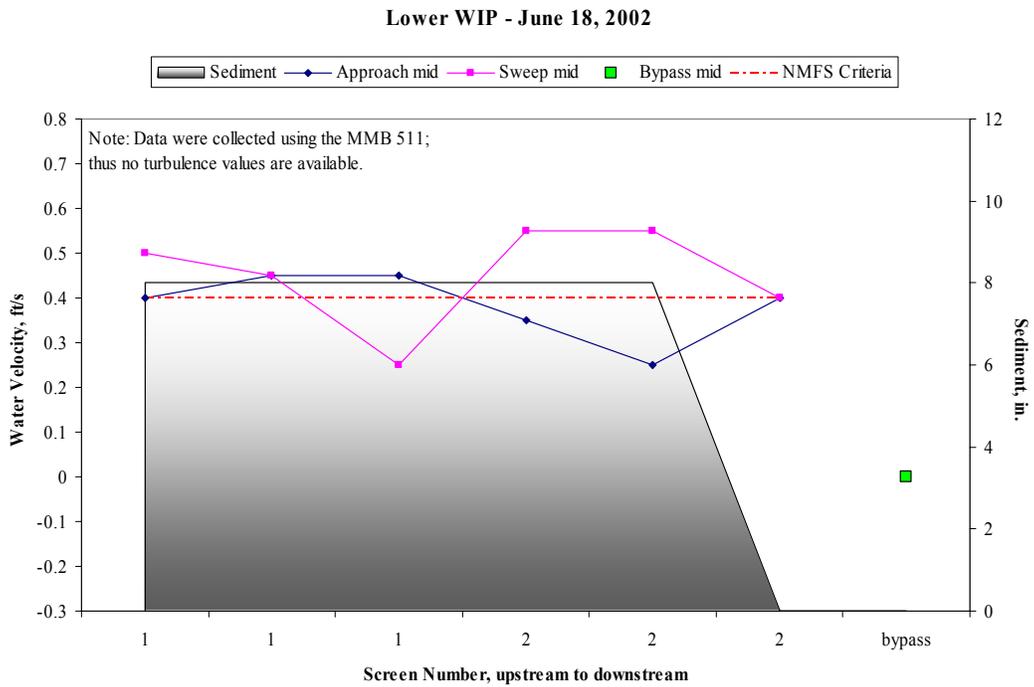
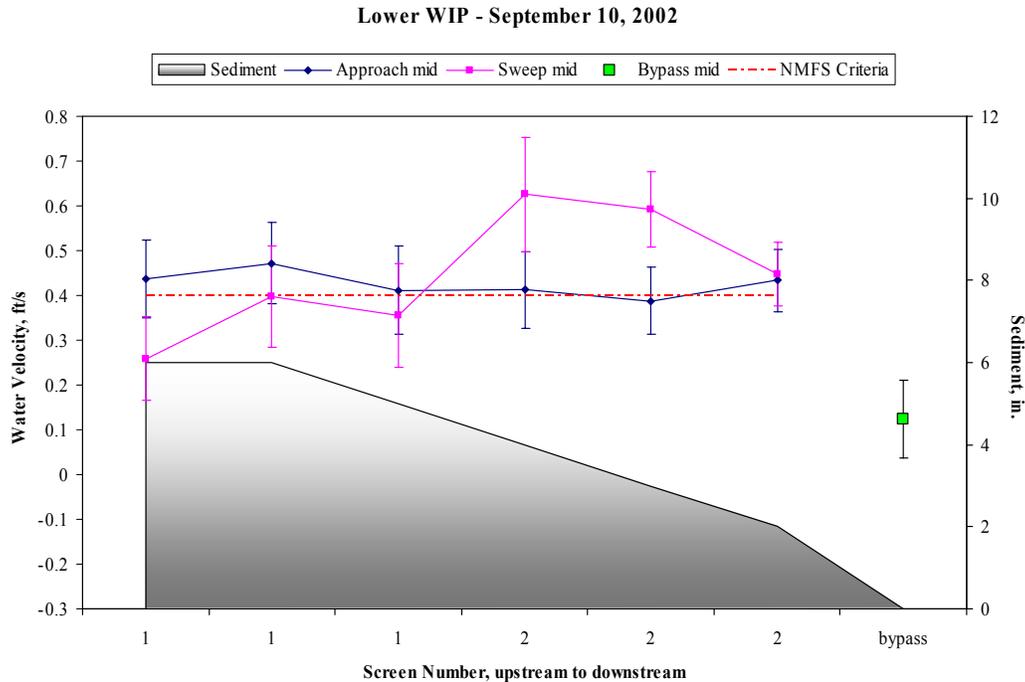
The Lower WIP site was visited on May 21, 2002; June 18, 2002; and September 10, 2002. In May, all approach velocities met NMFS criteria. That figure decreased to 67% in June and 17% in September. In May, approach velocities were greater than sweep velocities. Sweep velocities did not generally increase towards the downstream end of the site, and bypass velocities were slower than the average sweep velocity (Figures 20, 21, and 22). This set of conditions could lead to delay for migrating fish.

In addition to the velocity and sediment problems, an oil leak from screen 1 was noted in the site operator's logbook on April 29, 2002, and was still present during the September survey. Large dents that nearly broke the screen material were noted on screen 1 in September.

Figure 20. Water Velocities and Sediment Depths at Lower Wapato Irrigation Project (WIP) in May 2002. Error bars show turbulence (\pm the root-mean-squared [RMS]) at each point.

Figure 21. Water Velocities and Sediment Depths at Lower Wapato Irrigation Project (WIP) in June 2002

Figure 22. Water Velocities and Sediment Depths at Lower Wapato Irrigation Project (WIP) in September 2002. Error bars show turbulence (\pm the root-mean-squared [RMS]) at each point.

The USBR, which is responsible for the operation and maintenance of this site, was notified May 21, June 18, and September 10, 2002, concerning the non-compliance of the site to NMFS criteria and the other maintenance concerns mentioned earlier. The USBR did not respond to any of these notifications. Velocity and sediment conditions such as these could lead to injury or delay of migrating fish. The PNNL researchers recommend removal of sediment deposits from the screen site, as well as monitoring facility operations more closely in an attempt to meet NMFS criteria.

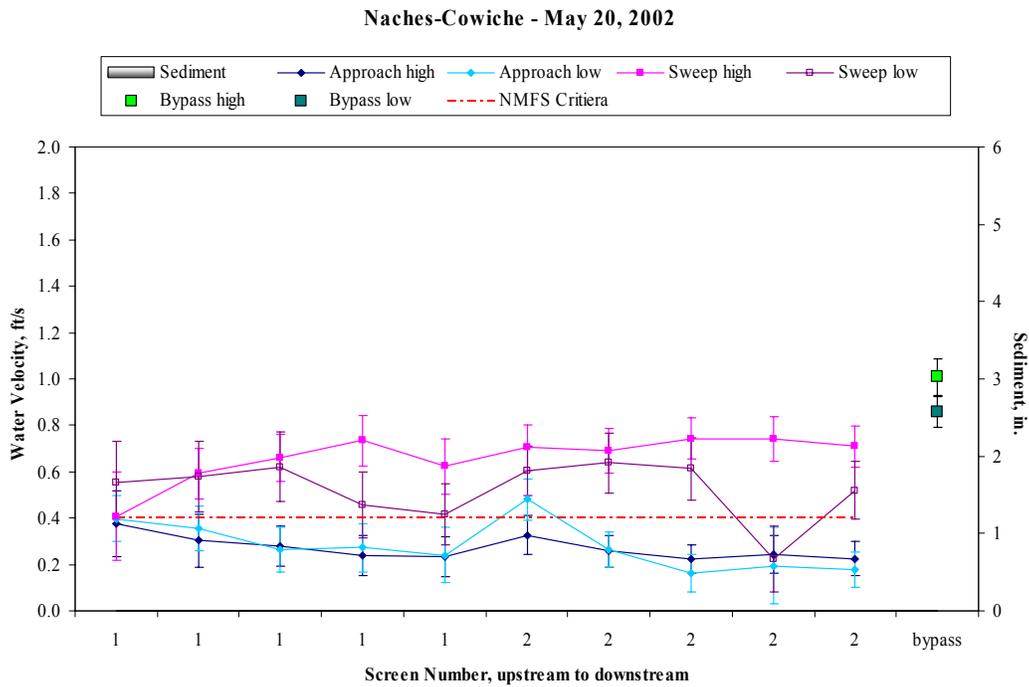
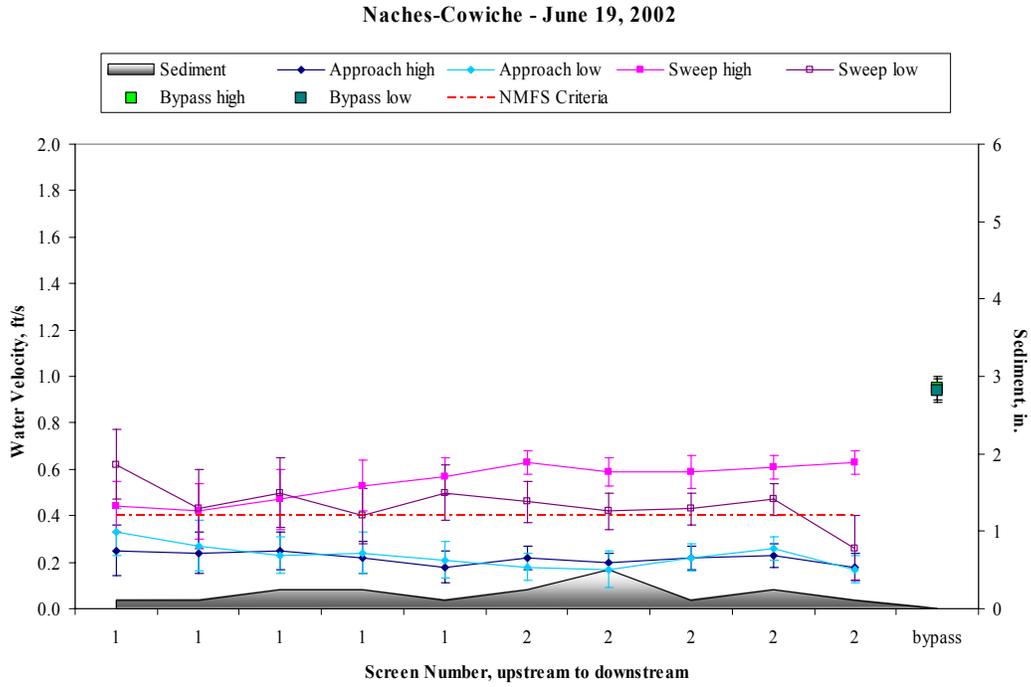
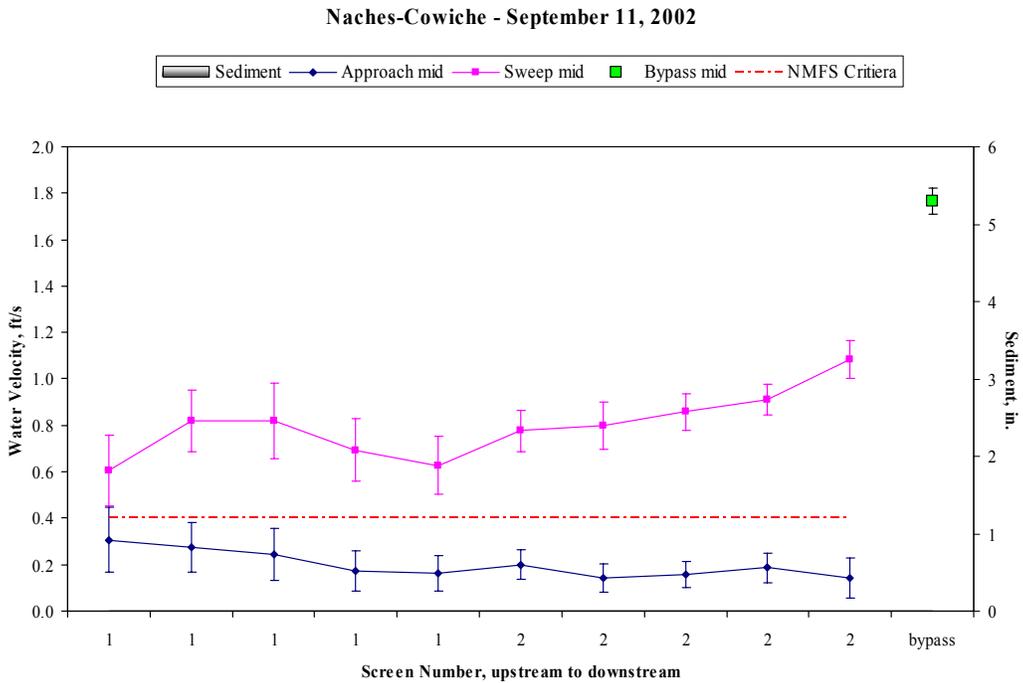
The Naches-Cowiche site was evaluated on May 20, 2002; June 19, 2002; and September 11, 2002. In May, 95% of all approach values met NMFS criteria (Figure 23). This figure increased to 100% for June and September (Figures 24 and 25). Sweep velocities were generally higher than approach velocities but did not increase towards the bypass in May or June. The average bypass velocity was faster than the average sweep velocity during all surveys.

The stoplogs in front of the screens prevented an evaluation of the bottom seals with the video camera. All other visible seals were in good condition. During the June evaluation it was evident that debris had built up between the checkboards and the screens. Submergence was within criteria during all visits and bypass conditions were good for safe fish passage. There was some concern that the design of the bypass outfall did not compensate enough for the shifting riverbed because it became filled with rock when flows were high. The outfall channel has been dug out several times in the past, only to get filled in again when the river level rose. On August 16, 2002, PNNL researchers visited the site to confirm that the bypass was not obstructed by debris, and found it to be passable. That being said, the PNNL researchers recommend the design of the bypass and outfall be reevaluated. If the design of the bypass and outfall cannot be modified to prevent it from becoming filled with rock, then maintenance plans for the site will need to include regular clean-outs of the outfall channel.

Figure 23. Water Velocities and Sediment Depths at Naches-Cowiche in May 2002. Error bars show turbulence (\pm the root-mean-squared [RMS]) at each point.

Figure 24. Water Velocities and Sediment Depths at Naches-Cowiche in June 2002. Error bars show turbulence (\pm the root-mean-squared [RMS]) at each point.

Figure 25. Water Velocities and Sediment Depths at Naches-Cowiche in September 2002. Error bars show turbulence (\pm the root-mean-squared [RMS]) at each point.

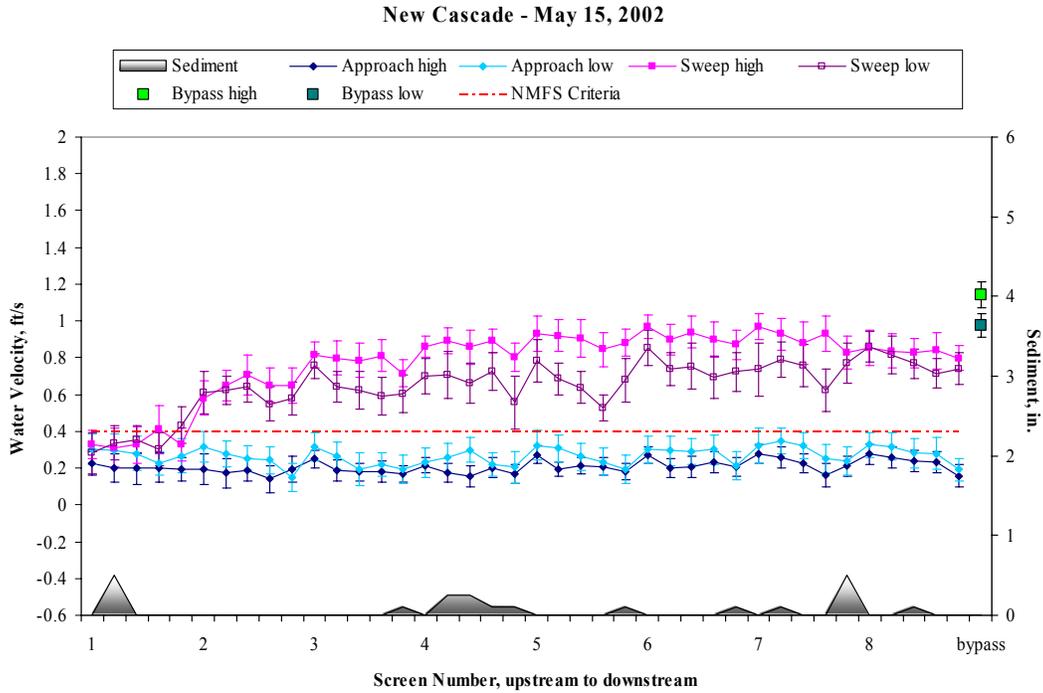
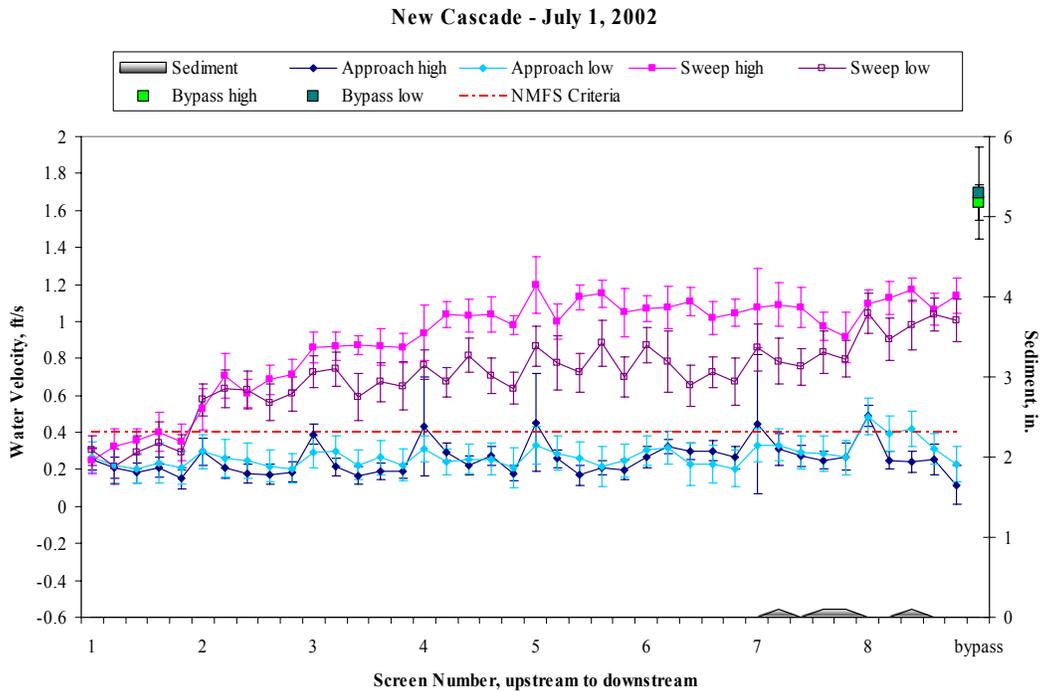
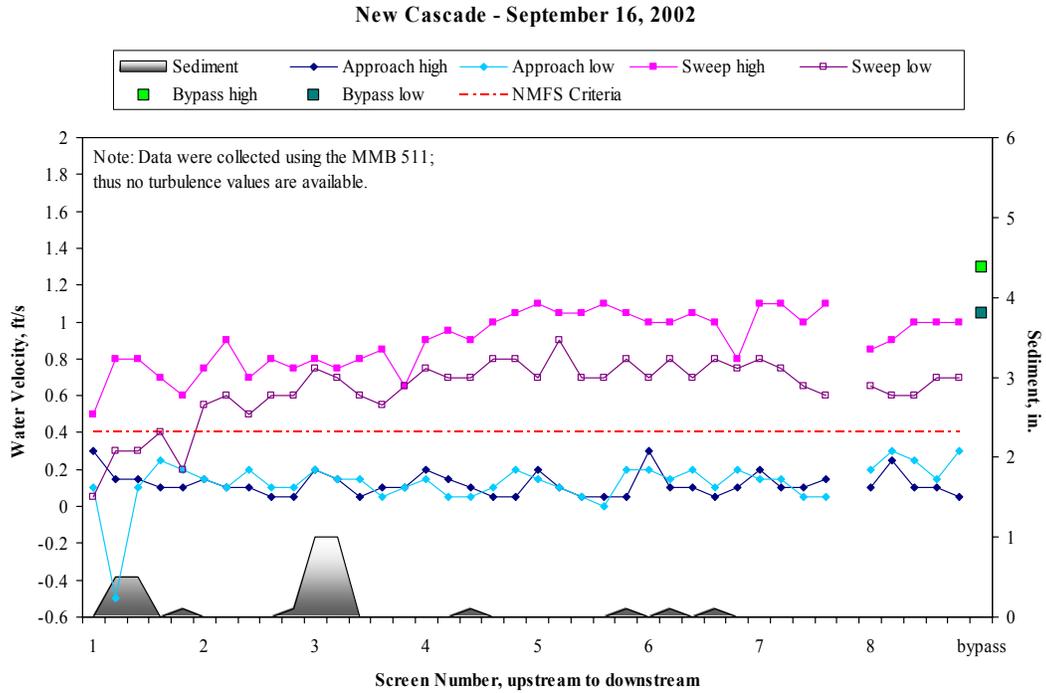
Submergence slightly exceeded criteria in May and July, at 86 and 88%, respectively. In September, submergence was 82%. This site had some problems with sediment buildup, especially in the downstream corners of the screen bays, which obscured the view of the bottom seals in places. This is likely due to water eddying, which was clearly visible in the video surveys. Aquatic plant growth in September blocked the view of the bottom seal in places. The notches noted on the downstream side seal of screen 8 in 2001 were still present in 2002 (Figure 30). Except for the side seal on screen 8, all visible seals appeared to be in good condition, and all cheeks were sealed with expanding foam insulation.

Figure 27. Water Velocities and Sediment Depths at New Cascade in May 2002. Error bars show turbulence (\pm the root-mean-squared [RMS]) at each point.

Figure 28. Water Velocities and Sediment Depths at New Cascade in July 2002. Error bars show turbulence (\pm the root-mean-squared [RMS]) at each point.

Figure 29. Water Velocities and Sediment Depths at New Cascade in September 2002. Error bars show turbulence (\pm the root-mean-squared [RMS]) at each point.

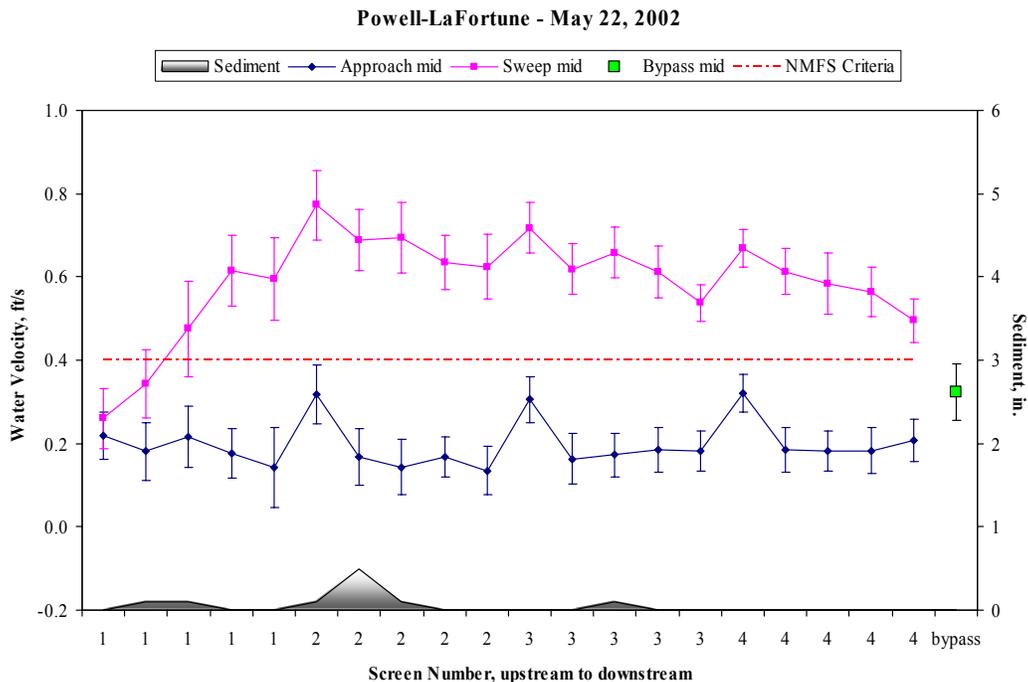
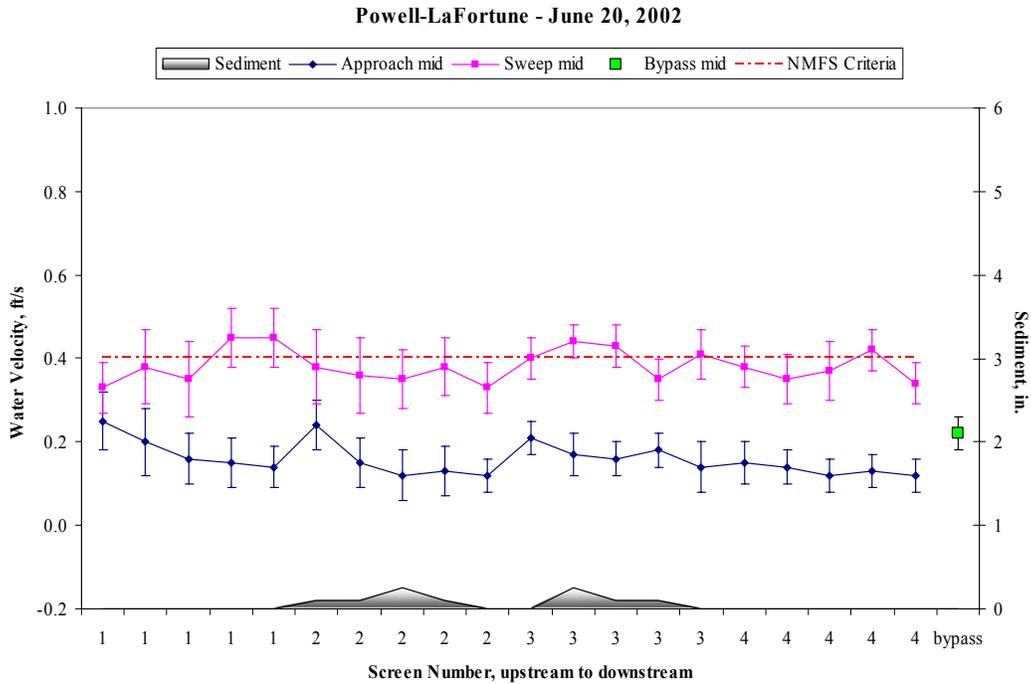
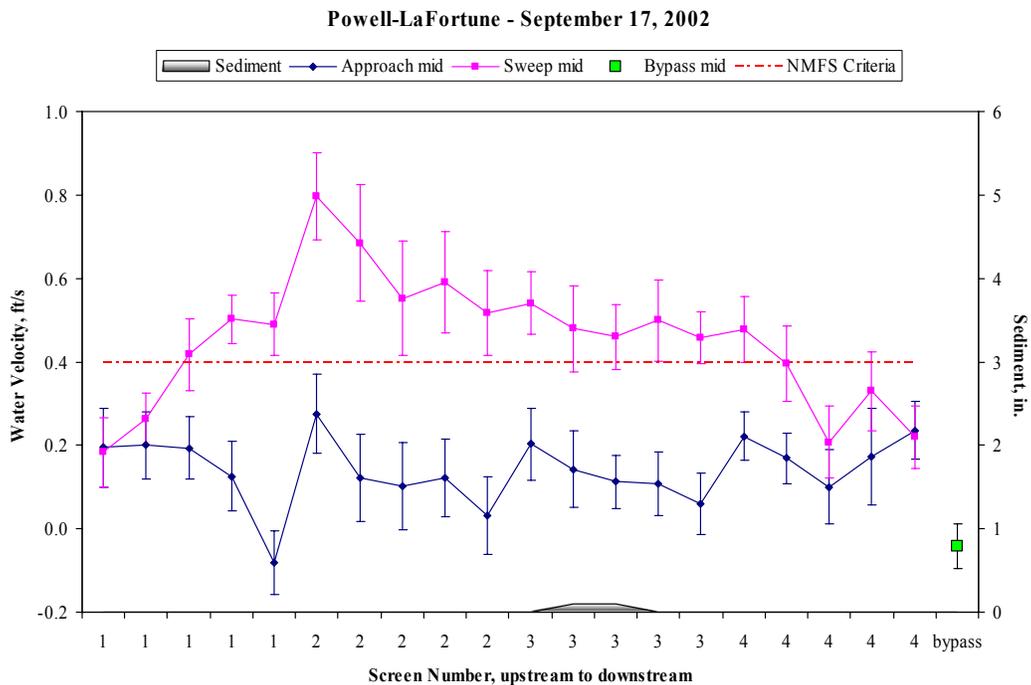
In the past, this site has had problems meeting NMFS criteria for submergence, and these problems continued during the 2002 irrigation season. Notes in the site operator's logbook state that submergence was low (28 to 60%) almost every time the site was visited by WDFW staff May through September, and there was often little to no flow through the bypass at these times (Figure 33). The Powell-LaFortune site has two trashracks: one on the canal leading to the site and the other at the head gates, farther upstream. The trashracks at the head gate often plug with excessive debris and are not cleaned regularly. During the PNNL researchers' visit to the site in June, enough debris had built up on the head-end trashrack to cause more than 1 ft of head loss across the debris. The PNNL researchers recommend that the upper trashrack be cleared of debris by the water users as a part of their daily operations procedures.

Figure 31. Water Velocities and Sediment Depths at Powell-LaFortune in May 2002. Error bars show turbulence (\pm the root-mean-squared [RMS] at each point).

Figure 32. Water Velocities and Sediment Depths at Powell-LaFortune in June 2002. Error bars show turbulence (\pm the root-mean-squared [RMS]) at each point.

Figure 33. Water Velocities and Sediment Depths at Powell-LaFortune in September 2002. Error bars show turbulence (\pm the root-mean-squared [RMS]) at each point.

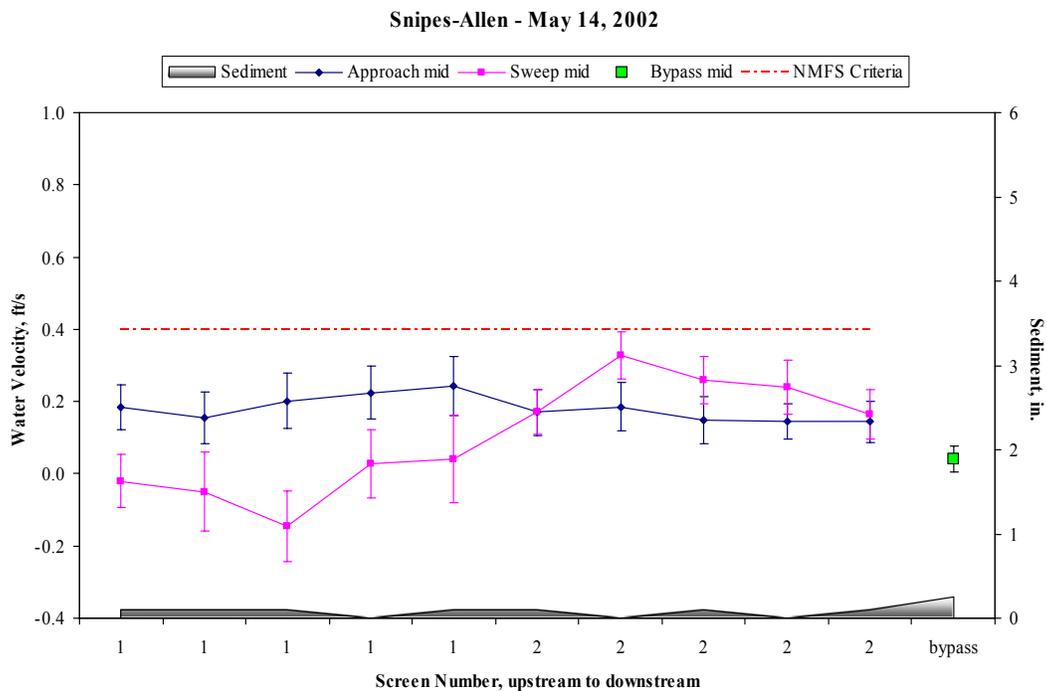
buoyant object through the bypass pipe in June. It passed with no problems. Notes in the site operator's logbook mention additional problems with bypass blockage in August, and during the September survey, PNNL researchers noticed that the downwell was full of sticks, the bypass pipe was half full of debris, and less than 1 in. of water flowed over the weir. PNNL researchers notified Ray Gilmour (WDFW) of the blockage on September 13, 2002. He cleared out the bypass on September 17, 2002. The PNNL researchers followed up on September 19, 2002, and found submergence to be back up to 80%, and 6 in. of water flowed over the weir.

The screens and screen seals at this site were in good condition during all surveys. A 7-in. salmonid was seen in the forebay in early May, along with some other small fish. Some fish were noted in the forebay in May that were possibly chiselmouth or redbreast shiners. In September, several larger fish were seen in the bypass, and small fish were observed upstream of the trashracks and just below the outfall pipe.

Figure 34. Water Velocities and Sediment Depths at Snipes-Allen, May 14, 2002. Error bars show turbulence (\pm the root-mean-squared [RMS]) at each point.
