Washington Phase II Fish Diversion Screen Evaluations in the Yakima River Basin

**Annual Report
2002**

January 2003

Yakima River Basin Phase II Fish Screen Evaluations, 2002

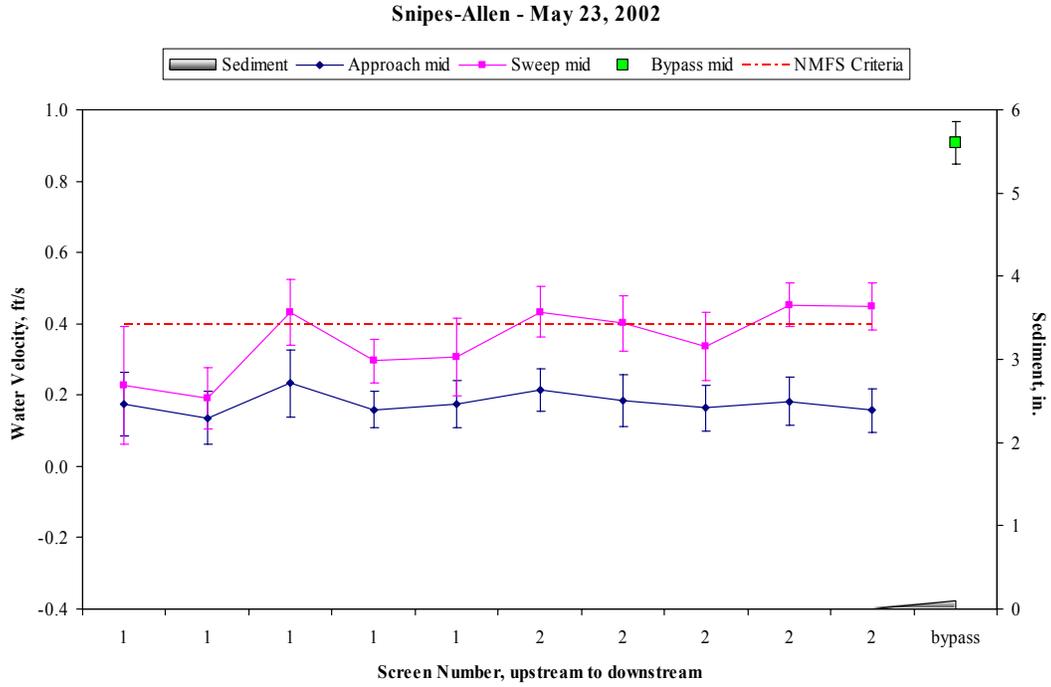
Figure 35. Water Velocities and Sediment Depths at Snipes-Allen, May 23, 2002. Error bars show turbulence (\pm the root-mean-squared [RMS]) at each point.

Screen submergence at Snipes-Allen met NMFS criteria during all surveys except in early May when the submergence was slightly higher (86%). In the past, this site has had many problems with debris catching on the trashracks, and while this problem was not as severe in 2002, there was still an accumulation of debris in the space behind the trashrack that could have provided cover for predator species or disrupted water flow through the site. In June and September, growth of aquatic plants in the forebay was noted. These plants also could provide shelter for predator species. The PNNL researchers recommend the site be regularly cleared of debris and vegetation to prevent harm to migrating fish.

buoyant object through the bypass pipe in June. It passed with no problems. Notes in the site operator's logbook mention additional problems with bypass blockage in August, and during the September survey, PNNL researchers noticed that the downwell was full of sticks, the bypass pipe was half full of debris, and less than 1 in. of water flowed over the weir. PNNL researchers notified Ray Gilmour (WDFW) of the blockage on September 13, 2002. He cleared out the bypass on September 17, 2002. The PNNL researchers followed up on September 19, 2002, and found submergence to be back up to 80%, and 6 in. of water flowed over the weir.

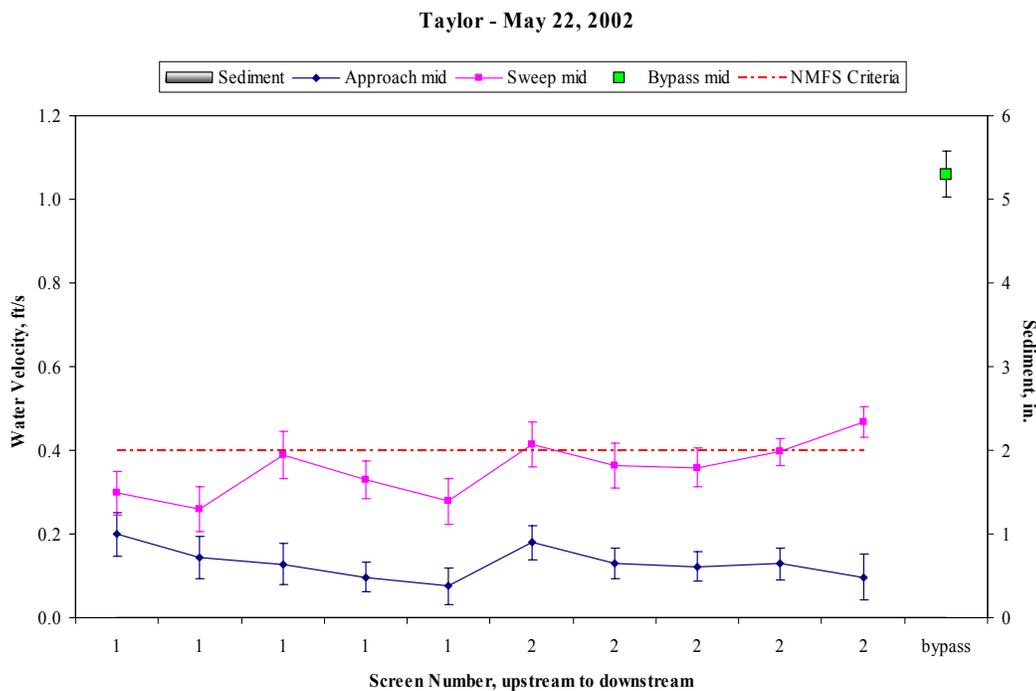
Figure 38. Water Velocities and Sediment Depths at Taylor in May 2002. Error bars show turbulence (\pm the root-mean-squared [RMS]) at each point.

The Taylor site was evaluated on May 22, 2002; June 25, 2002; and September 17, 2002. All approach velocities met NMFS criteria in May and June, and the site was effectively shut down for the season before the September evaluation (Figures 38 and 39). Sweep velocities were always greater than approach velocities, and the bypass velocity was always greater than the average sweep velocity. Percent submergence met criteria during the surveys in May and June.

Screen and seal condition appeared to be fine, and the gaps between the metal frame of the screens and the cement walls were filled with expanding foam insulation. In May, water flowed freely under the bypass ramp, which was lifted completely up, and through the weir into the downwell. In June, the ramp was closed, and water flowed freely over the weir. Outfall conditions were within all criteria limits in May and could not be evaluated in June because the area was overgrown.

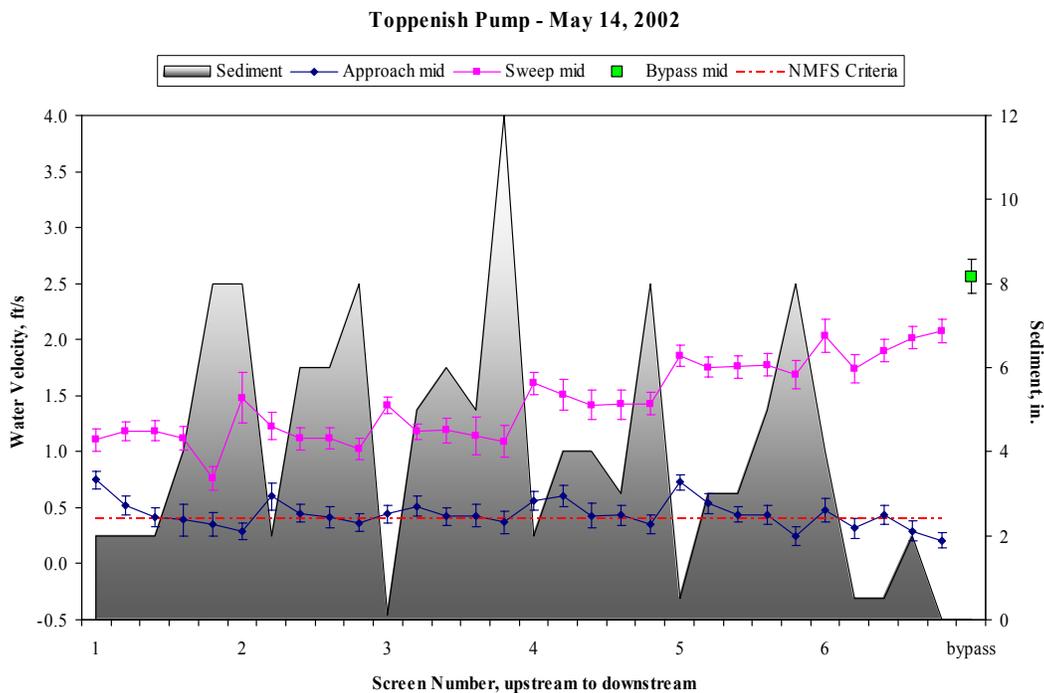
Figure 40. Water Velocities and Sediment Depths at Toppenish Pump in May 2002. Error bars show turbulence (\pm the root-mean-squared [RMS] at each point).

The Toppenish Pump site was visited on May 14, 2002; June 20, 2002; and September 12, 2002. In May, June, and September, 33, 73, and 100% of approach velocities met NMFS criteria, respectively. Sweep velocities were generally higher than approach velocities (Figures 40, 41, and 42). Sweep velocities generally increased towards the bypass, and bypass velocities were higher than sweep velocities. Submergence was calculated to be slightly low in May at 60% and met criteria in June and September. A major cleanout of the main channel and installation of checkboards upstream of the trashracks was happening during the May evaluation, and water levels continued to rise, which may account for the slightly low submergence.

The USBR, which is responsible for the operation and maintenance of the Toppenish Pump facility, was notified on May 21, 2002, concerning the high approach velocities noted during the May survey. Tom Leonard (USBR) estimated that it would be a couple of weeks or more before this would be fixed. On May 23, 2002, the PNNL researchers left a message asking to be notified when something was done about this. The USBR never responded.

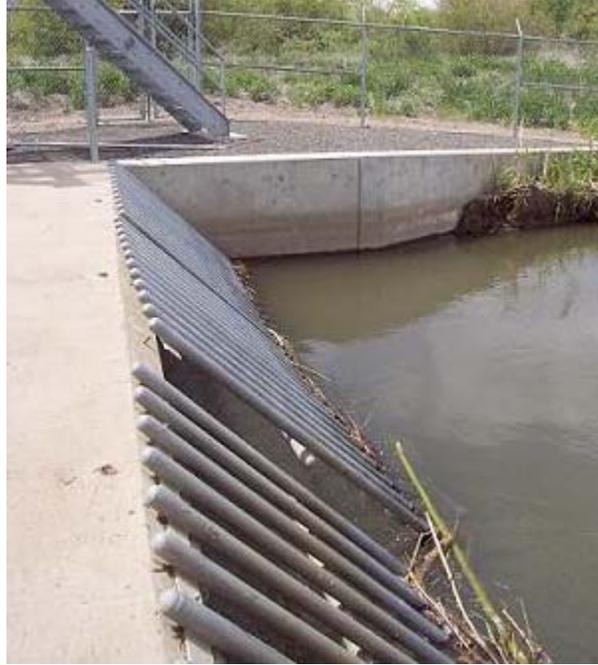
Visible seals appeared to be in good condition during all surveys. In May, some debris was observed on the trashrack, and the middle section of the trashrack had separated approximately 1 ft from the concrete wall (Figure 43). During all surveys, sediment and debris covered nearly all of the bottom seals.

Figure 43. The Trashrack at Toppenish Pump was Partially Separated from the Concrete Wall in May 2002

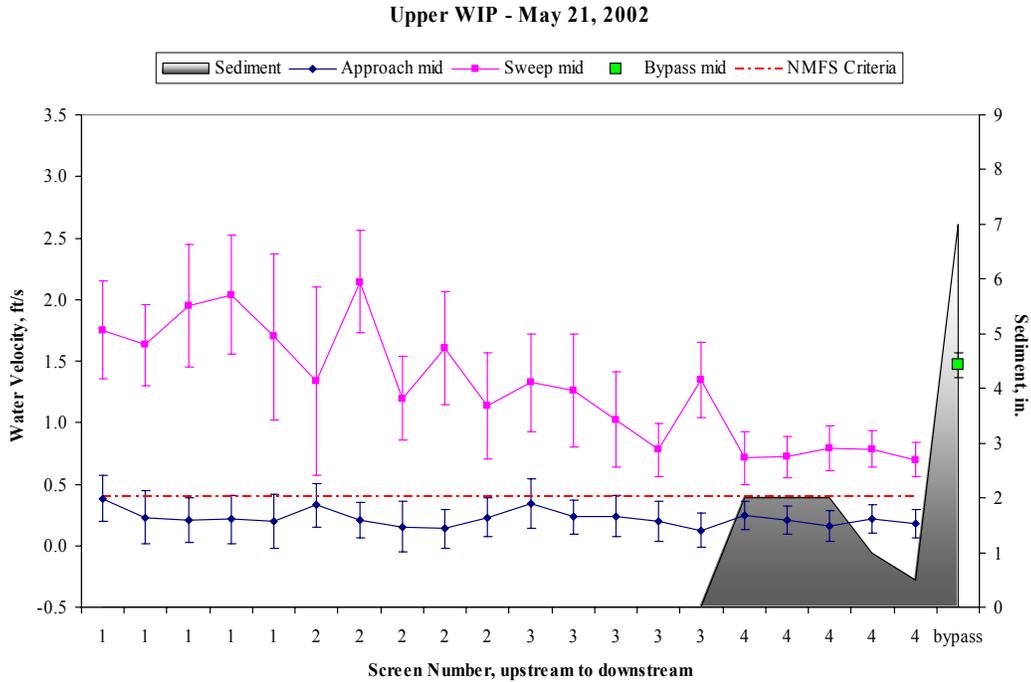
Figure 44. Water Velocities and Sediment Depths at Upper Wapato Irrigation Project (WIP) in May 2002. Error bars show turbulence (\pm the root-mean-squared [RMS]) at each point.

The Upper WIP site was visited on May 21, 2002; June 18, 2002; and September 10, 2002. The site was shut down for the season before the survey in September. All approach velocities met NMFS criteria in May, while only 90% of approach velocities met NMFS criteria in June (Figures 44 and 45). Those points that exceeded 0.4 ft/s were located at the upstream end of the site. During both surveys, sweep velocities were much more turbulent than approach velocities. Sweep velocities did not increase towards the bypass, and in June, the bypass velocity was less than the average sweep velocity.

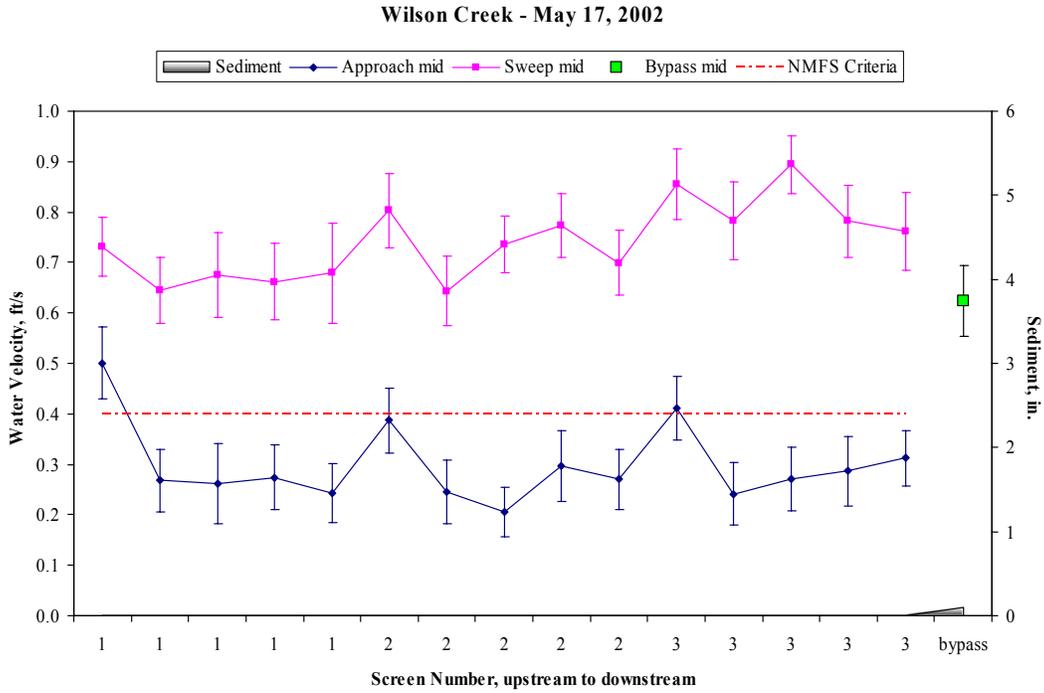
Figure 46. Water Velocities and Sediment Depths at Wilson Creek in May 2002. Error bars show turbulence (\pm the root-mean-squared [RMS]) at each point.

The Wilson Creek site was visited on May 17, 2002; July 2, 2002; and September 16, 2002. Because of excessive growth of aquatic plants in the forebay in July, the Marsh-McBirney 511® velocity meter was used, so no turbulence values are available. In May, July, and September, 87, 100 and 100% of approach velocities met NMFS criteria, respectively (Figures 46, 47, and 48). Sweep velocities were always greater than approach velocities. Sweep velocities did not increase towards the bypass, and the average bypass velocity was slower than the average sweep velocity in May and July.

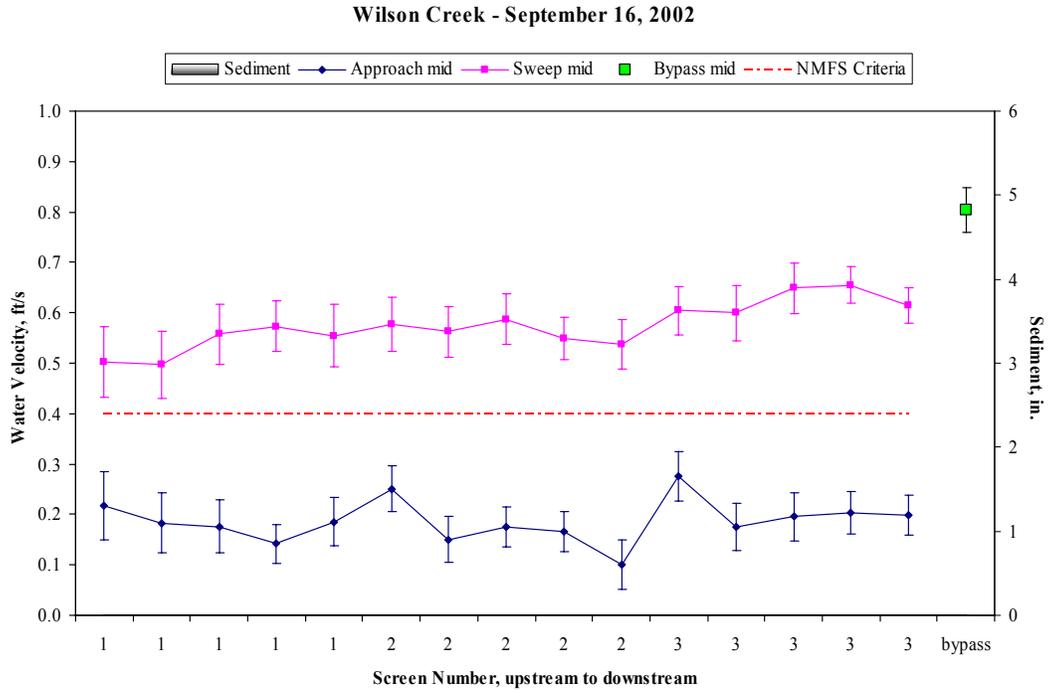
Figure 48. Water Velocities and Sediment Depths at Wilson Creek in September 2002. Error bars show turbulence (\pm the root-mean-squared [RMS]) at each point.

Drums turned freely and evenly during all surveys and rolled leaf matter into the aftbay. Water flowed freely over the weir and out the outfall in May and July. In September, the outfall pipe surged, which may have been caused by a partial plug in the downwell or in the bypass pipe. Ray Gilmour (WDFW) believes that this may have been caused by taking too much water into the site. The outfall pipe was submerged during all surveys and the depth at the point of discharge was greater than 1 ft.

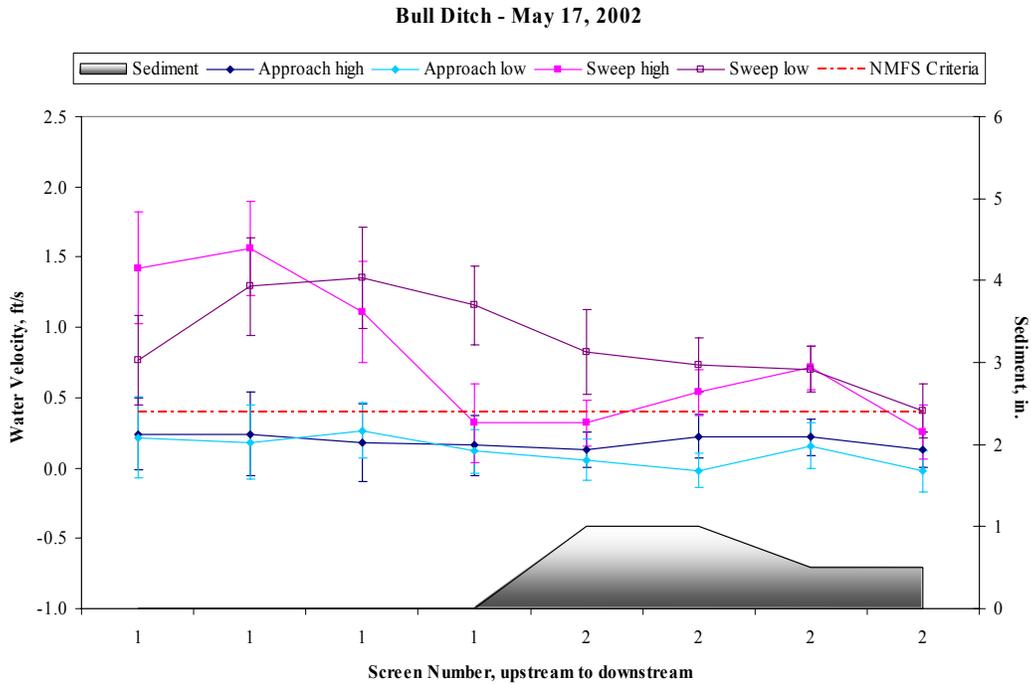
Figure 50. Water Velocities and Sediment Depths at Bull Ditch in May 2002. Error bars show turbulence (\pm the root-mean-squared [RMS]) at each point.

The Bull Ditch site was evaluated on May 17, 2002; July 2, 2002; and September 17, 2002. Sweep velocities were generally higher than approach velocities in May but not in July or September (Figures 50, 51, and 52). Approach velocities met NMFS criteria 100, 63, and 100% of the time in May, July, and September, respectively. Sweep velocities tended to decrease over the length of the site, and in September, both sweep and approach velocities at the downstream end of the site were approximately zero.

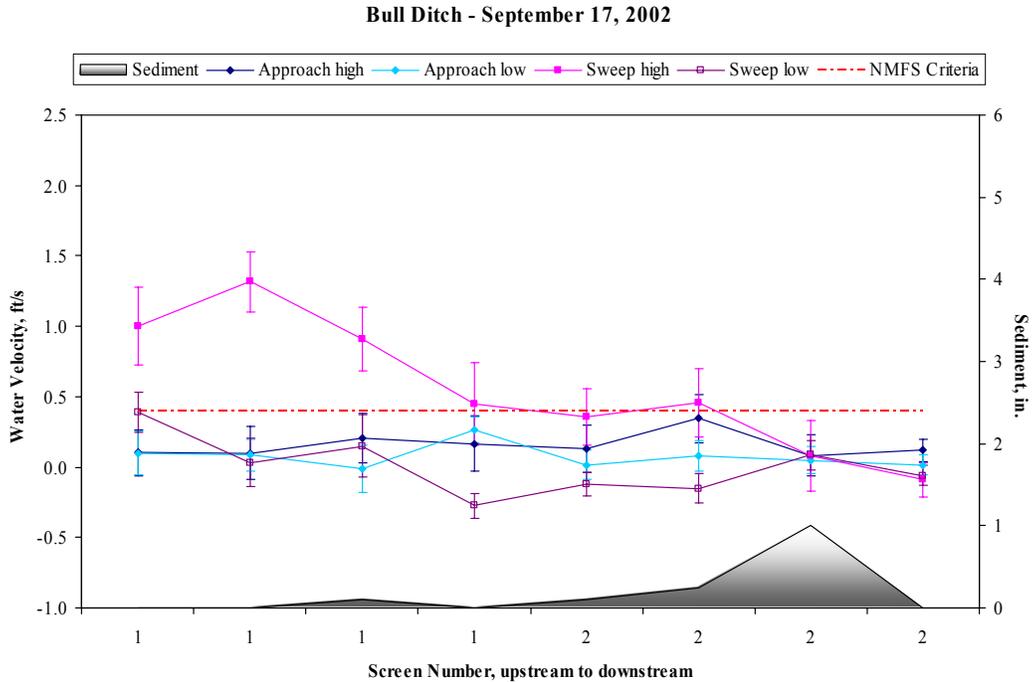
Figure 52. Water Velocities and Sediment Depths at Bull Ditch in September 2002. Error bars show turbulence (\pm the root-mean-squared [RMS]) at each point.

Low sweeping velocities at the downstream end of the site combined with the presence of predator habitat may result in the delay of and predation on migrating salmonids. The slower water may also cause sediment accumulation at the downstream end of the site. The PNNL researchers recommend that procedures be evaluated to increase sweep velocities and minimize predator habitat growth and sediment accumulation.

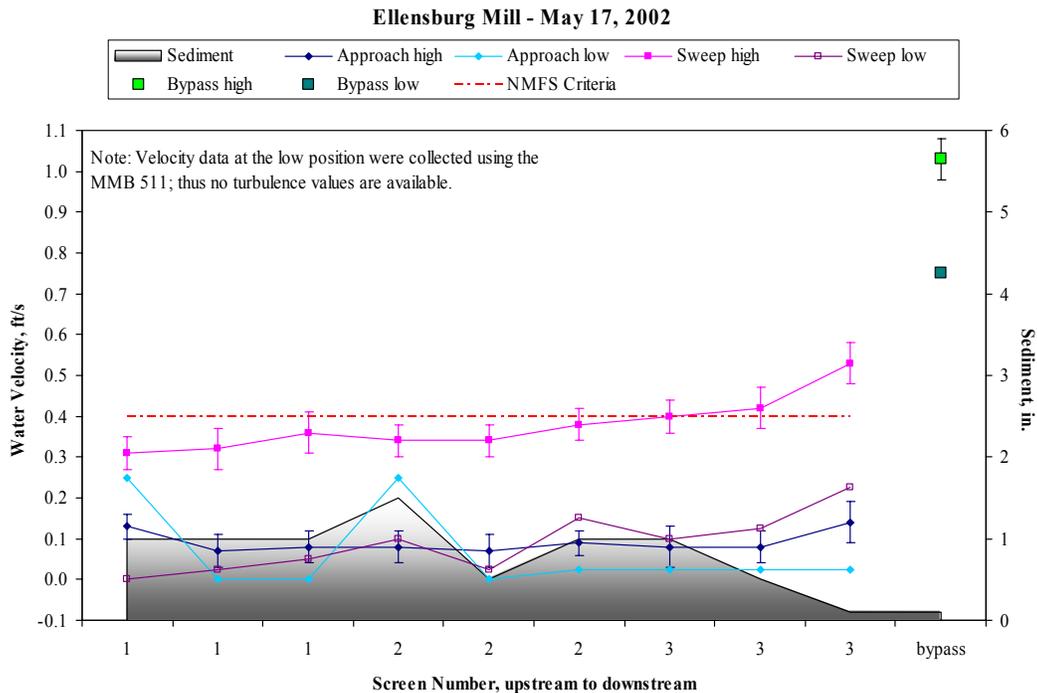
Figure 53. Water Velocities and Sediment Depths at Ellensburg Mill in May 2002. Error bars show turbulence (\pm the root-mean-squared [RMS]) at each point.

The Ellensburg Mill site was visited on May 17, 2002; July 1, 2002; and September 16, 2002. Because of aquatic vegetation growth in the forebay, the Marsh-McBirney 511® flow meter was used to measure velocity at the low position in May and June, so turbulence values are not available for those measurements. All approach velocities met NMFS criteria during all surveys (Figures 53, 54, and 55). Sweep velocities were not always higher than approach velocities, especially at the low position. This was probably due to the presence of aquatic plants in the forebay and near the screen surfaces. Sweep velocities did not increase towards the bypass, although the bypass velocity was greater than the average sweep velocity in May and September.

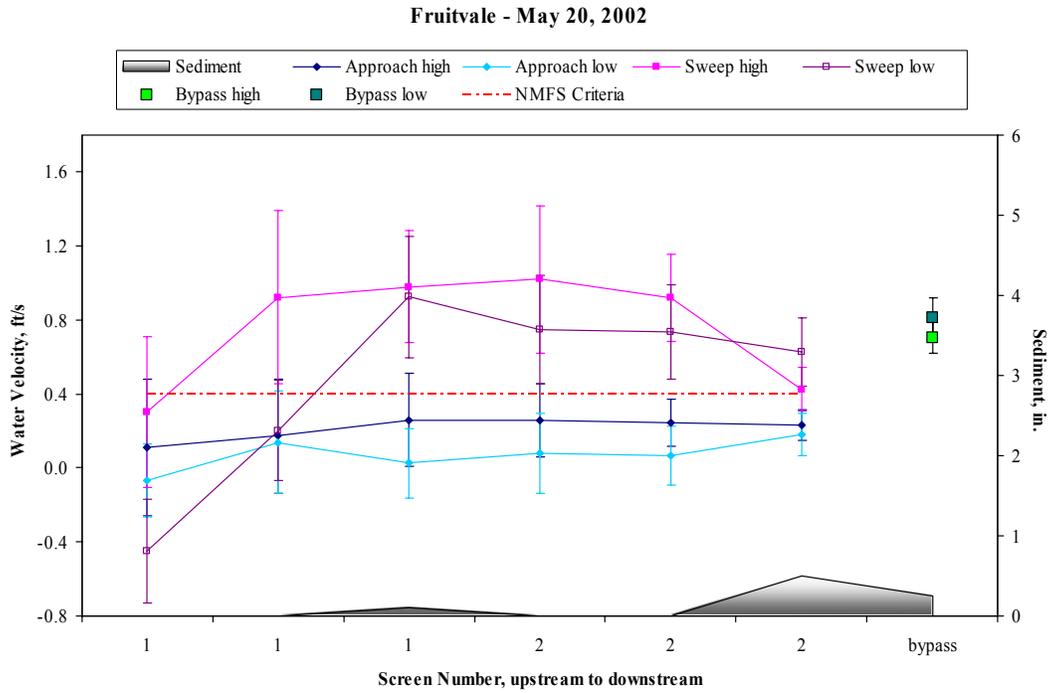
Figure 56. Water Velocities and Sediment Depths at Fruitvale in May 2002. Error bars show turbulence (\pm the root-mean-squared [RMS]) at each point.

The Fruitvale site was visited on May 20, 2002; June 19, 2002; and September 11, 2002. In May, June, and September, 100, 83, and 100% of approach velocities met NMFS criteria, respectively (Figures 56, 57, and 58). Sweep velocities were not always higher than approach velocities and did not increase towards the bypass. Bypass velocities were higher than the average sweep velocity during all surveys.

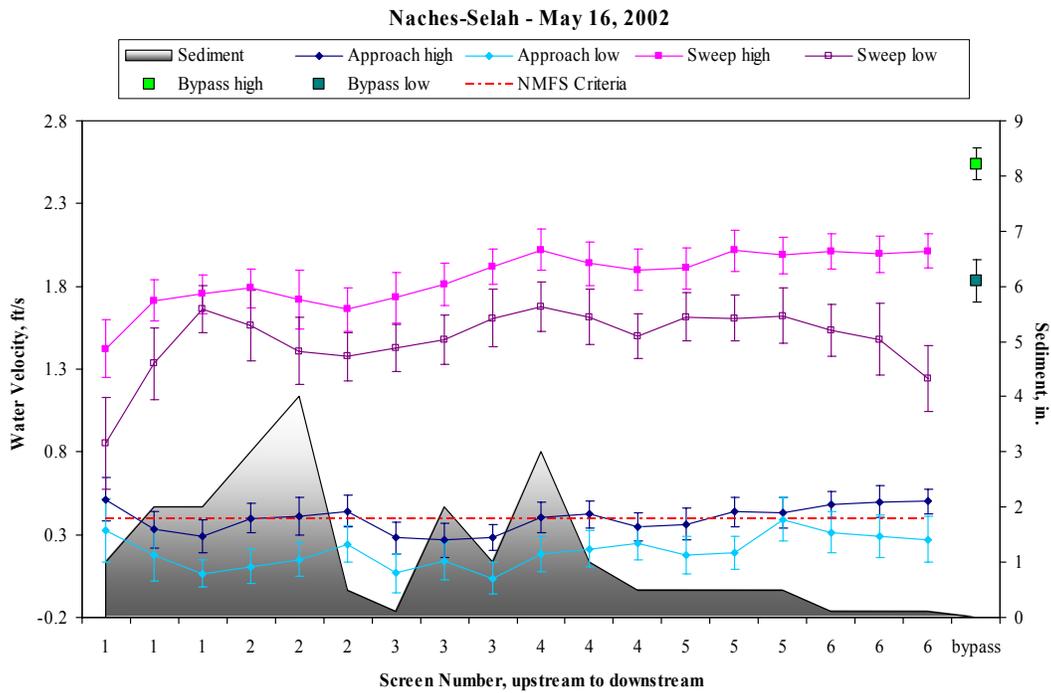
Figure 59. Water Velocities and Sediment Depths at Naches-Selah in May 2002. Error bars show turbulence (\pm the root-mean-squared [RMS]) at each point.

The Naches-Selah site was visited on May 16, 2002; June 25, 2002; and September 19, 2002. In May, June, and September, 72, 89, and 50% of approach velocities met NMFS criteria, respectively (Figures 59, 60, and 61). Sweeping velocities were greater than approach velocities and increased towards the bypass only in May. The average bypass velocity was greater than the average sweep velocity in May. In June and September, sweep velocities were usually greater than approach velocities but did not increase towards the bypass, and bypass velocities were slower than the average sweep velocity. This site has one of the worst records as far as meeting NMFS velocity criteria (Table 4). The PNNL researchers recommend that site operating procedures be evaluated to attempt to protect migrating fish from injury as they pass through this site.

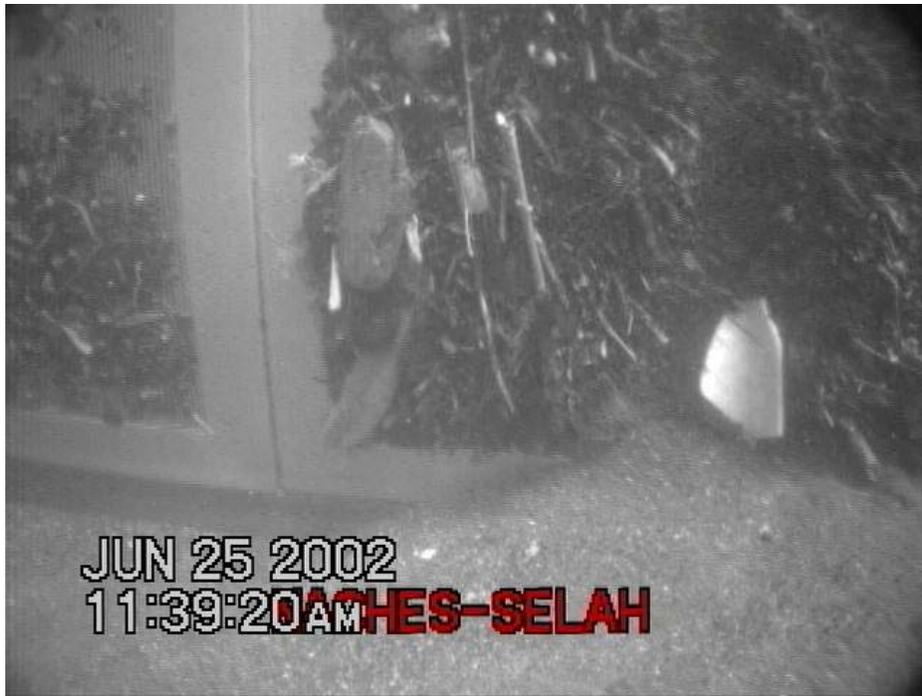
The screens were patched in places, but they appeared to be in good condition during all surveys. The caulking between the screens and under the screens was missing in places. In May, the bypass was approximately half filled with sand underneath the ramp. In June, sand and debris had built up near screen 6 to the point that it covered all of the bottom seal and prevented the brush from cleaning the screen (Figure 62), and the bypass ramp was completely plugged with sand and debris. The PNNL researchers notified Bill Werst (WDFW) on June 25, 2002. The problems were fixed on June 26, 2002.

Figure 62. Sediment Accumulation and Debris on Screen 6 at Naches-Selah in June 2002

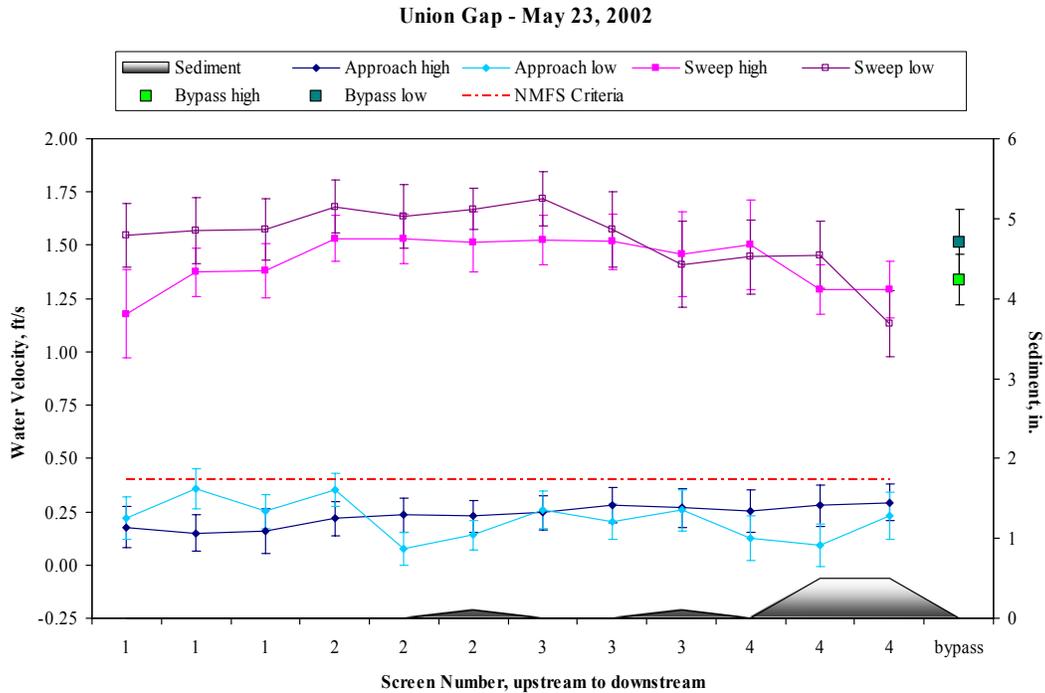
Figure 63. Water Velocities and Sediment Depths at Union Gap in May 2002. Error bars show turbulence (\pm the root-mean-squared [RMS]) at each point.

The Union Gap site was evaluated on May 23, 2002; June 19, 2002; and September 11, 2002. In May, June, and September, 100, 92, and 100% of approach velocities met NMFS criteria, respectively (Figures 63, 64, and 65). Sweep velocities were almost always higher than approach velocities. Sweep velocities did not increase towards the bypass, and the average bypass velocity was slower than the average sweep velocity.

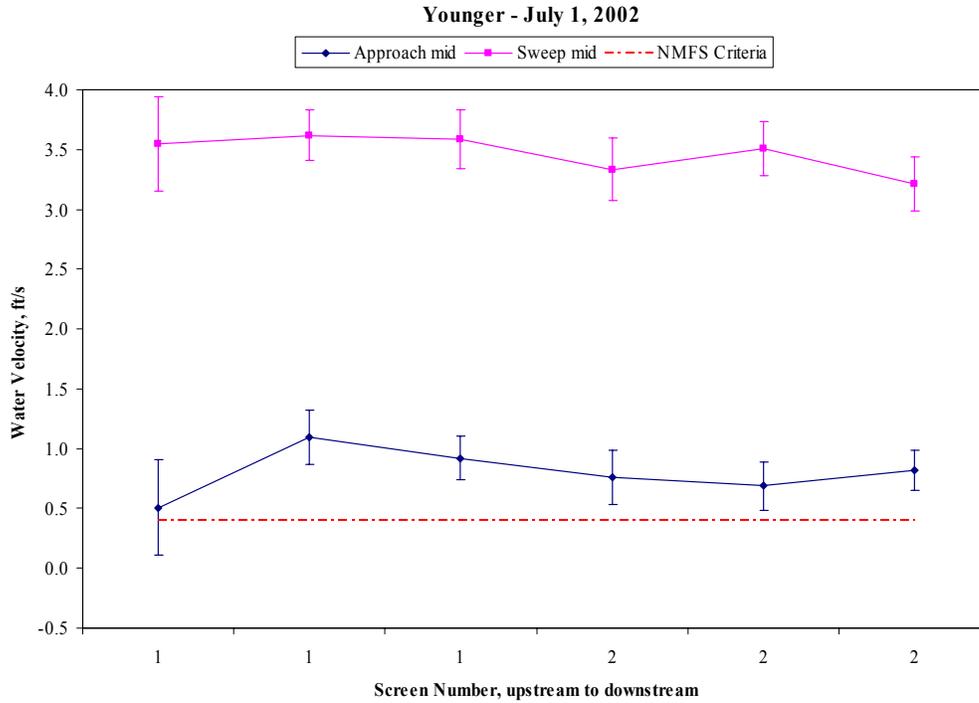
Figure 70. Water Velocities at Younger in June 2002. Error bars show turbulence (\pm the root-mean-squared [RMS]) at each point.

The Younger site was visited on May 15, 2002; July 1, 2002; August 1, 2002; and September 16, 2002. In May, July, and August, 83, 0 and 50% of approach values met NMFS criteria, respectively (Figures 69, 70, and 71). The site was shut down before the September survey. Sweep velocities were generally higher than approach velocities, though they did not increase towards the downstream end of the site. Because none of the approach values met NMFS criteria in July, Jose Molano (WDFW) was notified on July 1, 2002, and Ray Gilmour (WDFW) was notified on July 2, 2002. Molano said that he would check the site on July 2, 2002, and fix it the week of July 8, 2002. The researchers followed up with Molano on July 11, 2002, and he said that it had been fixed. The researchers revisited the site on August 1, 2002, and found that while approach velocities were still high in places, the site average was below 0.4 ft/s.

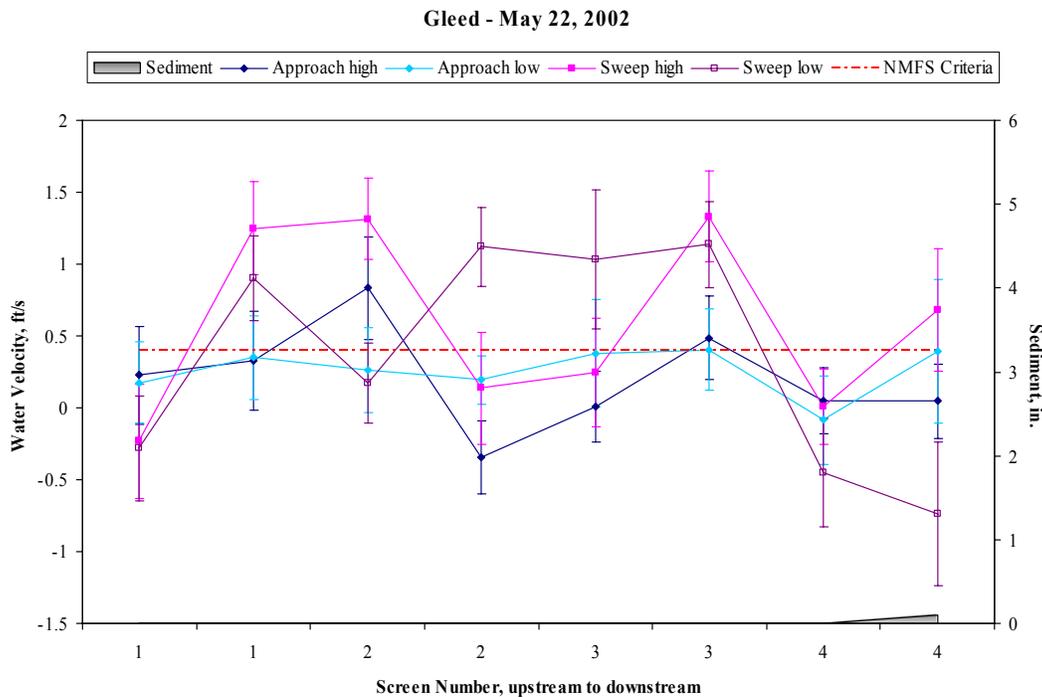
Figure 72. Water Velocities and Sediment Depths at Glead in May 2002. Error bars show turbulence (\pm the root-mean-squared [RMS]) at each point.

The Glead site was evaluated on May 22, 2002; June 25, 2002; and September 19, 2002. In May, June, and September, 81, 79, and 88% of approach values met NMFS criteria of less than or equal to 0.4 ft/s, respectively (Figures 72, 73, and 74). Aside from fast water, fish encountering this site also had to deal with highly turbulent water, without a clear trajectory. Sweep velocities were not always greater than approach velocities and did not increase towards the downstream end of the site.

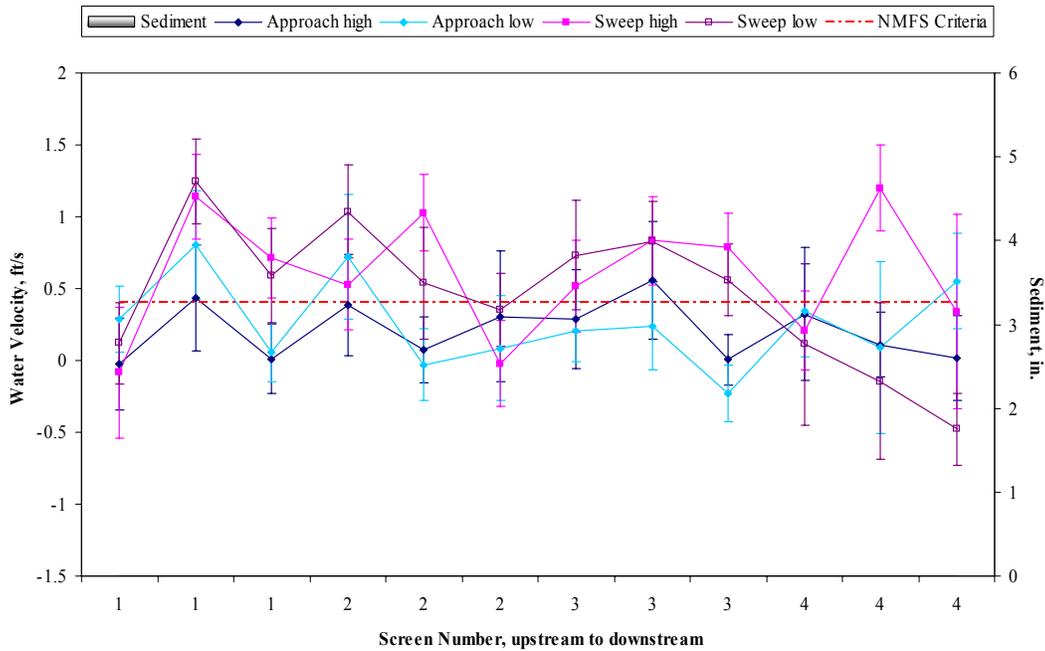
Gleed - June 25, 2002

Figure 73. Water Velocities and Sediment Depths at Gleed in June 2002. Error bars show turbulence (\pm the root-mean-squared [RMS]) at each point.

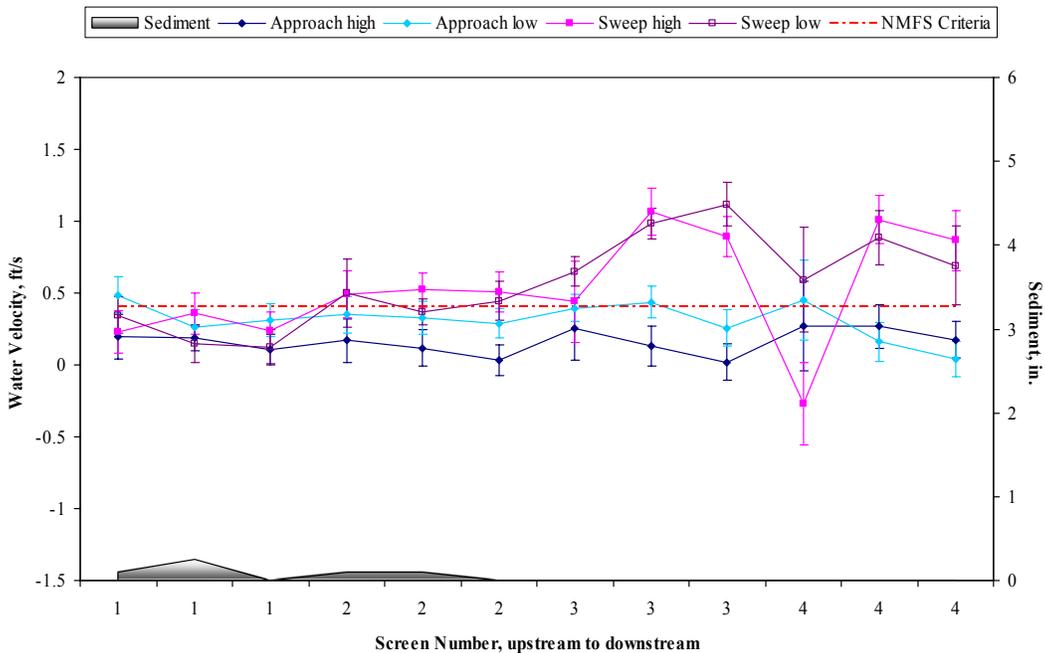
Gleed - September 19, 2002

Figure 74. Water Velocities and Sediment Depths at Gleed in September 2002. Error bars show turbulence (\pm the root-mean-squared [RMS]) at each point.
