# Washington Phase II Fish Diversion Screen Evaluations in the Yakima River Basin

**Annual Report  
2003**

## Yakima River Basin Phase II Fish Screen Evaluations, 2003

May 2004

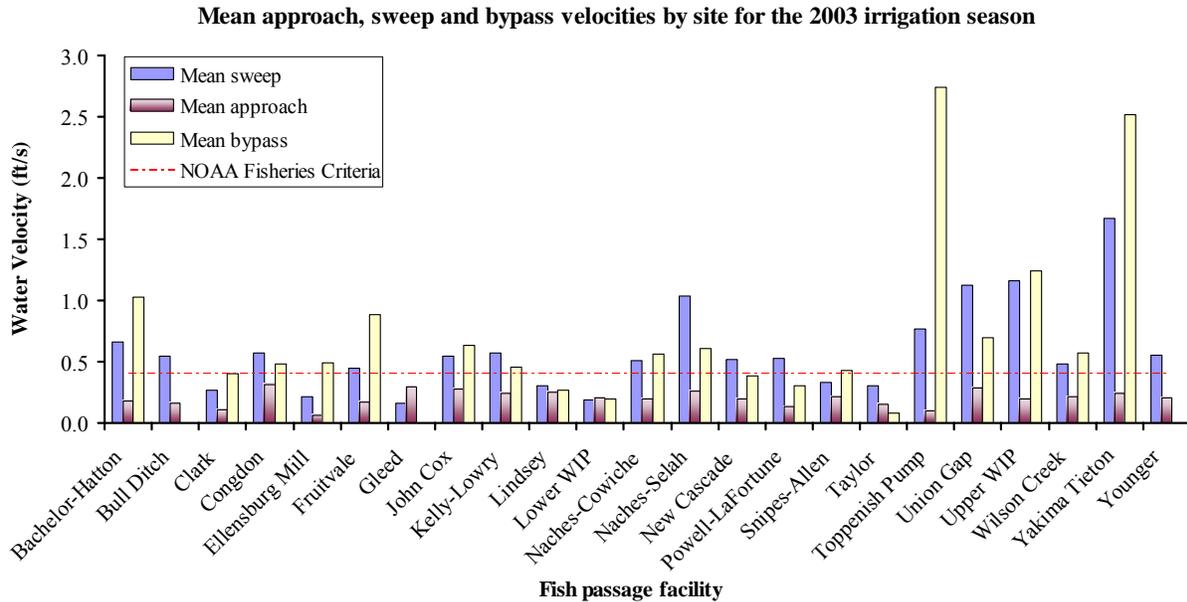
Although velocities often fluctuated widely from site to site and over time, average sweep velocities for the year exceeded average approach velocities for the year (Table 2). Only 2 out of 23 screen sites had mean approach velocities greater than the mean sweep velocities in 2003. Mean approach velocities were generally below the NOAA Fisheries criteria of less than or equal to 0.4 ft/s. The number of sites with average approach velocities greater than 0.4 ft/s decreased from 9 in 2002 to 3 in 2003, and the sites that had average approach velocities greater than 0.4 ft/s were the same sites that exceeded the criteria over the past several years (Table 3). The number of sites that had bypass velocities that were slower than sweep velocities increased from 9 in 2002 to 14 in 2003 (Table 4, Figure 4).

**Figure 4.** Mean Approach, Sweep, and Bypass Velocities at Phase II Fish Screen Facilities in the Yakima River Basin in 2003 Shown Against a Reference Line for the NOAA Fisheries Approach Criteria (less than or equal to 0.4 ft/s)

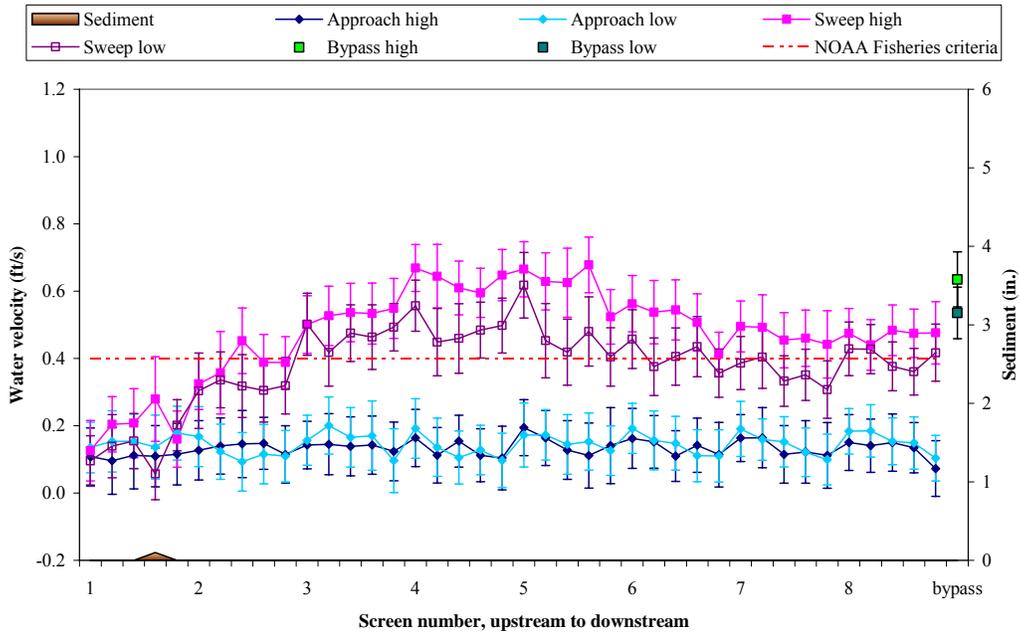
The New Cascade site was evaluated on May 12, 2003; June 25, 2003; and September 15, 2003. During all surveys, 100% of approach velocities met NOAA Fisheries criteria (Figures 28, 29, and 30). Sweep velocities were generally faster than approach velocities, and sweep velocities increased slightly towards the bypass in June. Bypass velocities were faster than the average sweep velocity during June.

Figure 29. Water Velocities and Sediment Depths at New Cascade in June 2003. Error bars show turbulence ( $\pm$  the root-mean-squared [RMS]) at each point.

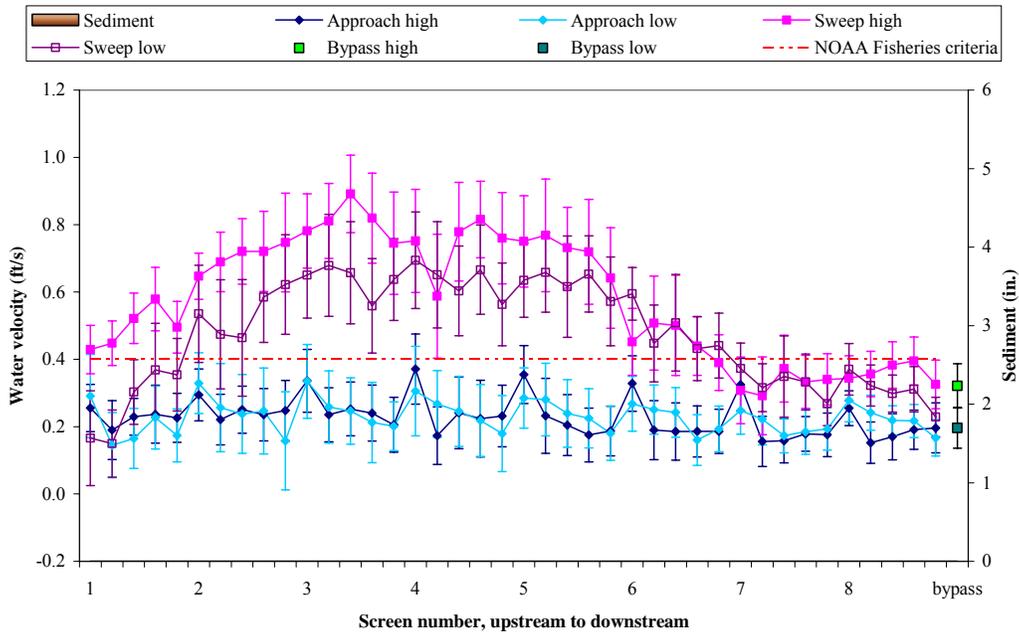
Figure 30. Water Velocities and Sediment Depths at New Cascade in September 2003. Error bars show turbulence ( $\pm$  the root-mean-squared [RMS]) at each point.

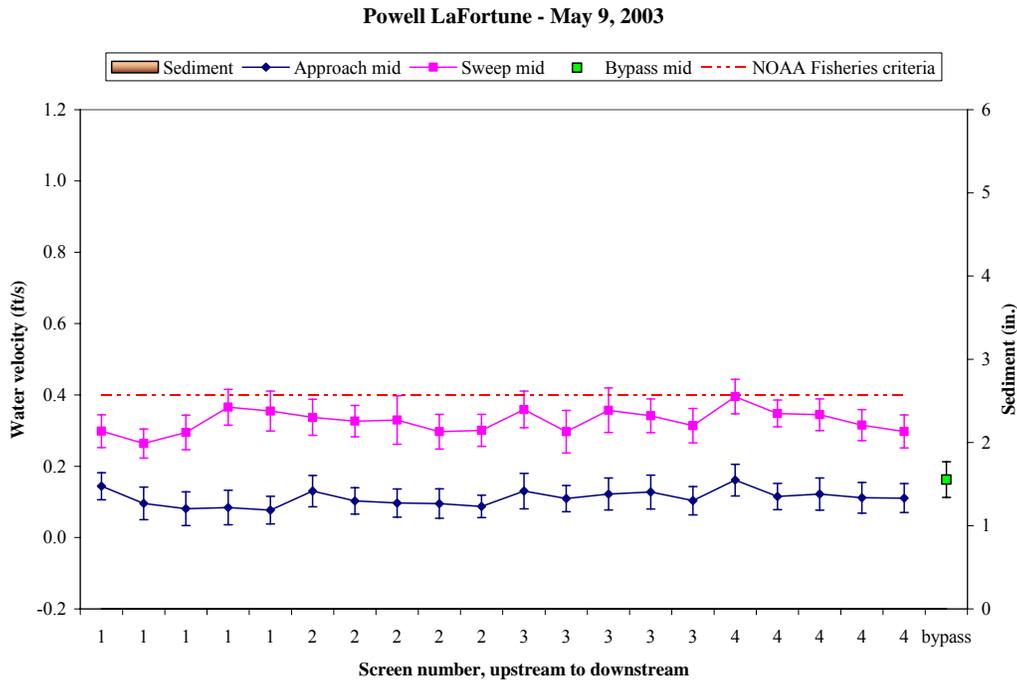
The Powell-LaFortune site was evaluated on May 9, 2003; June 26, 2003; and September 16, 2003. In May and June, 100% of approach velocities met NOAA Fisheries criteria. In September, 95% of approach velocities met NOAA Fisheries criteria. Sweep velocities were always higher than approach velocities but did not generally increase towards the bypass (Figures 31, 32, and 33). Bypass velocities were slower than the average sweep velocity. Percent submergence met the NOAA Fisheries criteria in May, June, and September at 77%, 80%, and 72% respectively.

**Figure 31.** Water Velocities and Sediment Depths at Powell-LaFortune in May 2003. Error bars show turbulence ( $\pm$  the root-mean-squared [RMS]) at each point.

In the past, this site has had problems meeting NOAA Fisheries criteria for submergence, and while submergence was within criteria during our visits in 2003, these problems continued throughout the 2003 irrigation season. Notes in the site operator's logbook state that submergence was low (10% to 60%) almost every time the site was visited by WDFW staff May through mid-July, when a wing dam was installed in the river. After that point, submergence was generally at the high end of the criteria range to above criteria (between 82% and 100%). The Powell-LaFortune site has two trash racks: one on the canal leading to the site and the other at the head gates, farther upstream. The trash racks at the head gate often plug with excessive debris and are not cleaned regularly. Notes in the site operator's logbook state that on May 17, enough debris had built up on the head-end trash rack to cause more than 13 in. of head loss across the debris, and PNNL observed similar conditions during the September inspection. The PNNL researchers recommend that the upper trash rack be cleared of debris by the water users as a part of their daily operations procedures.

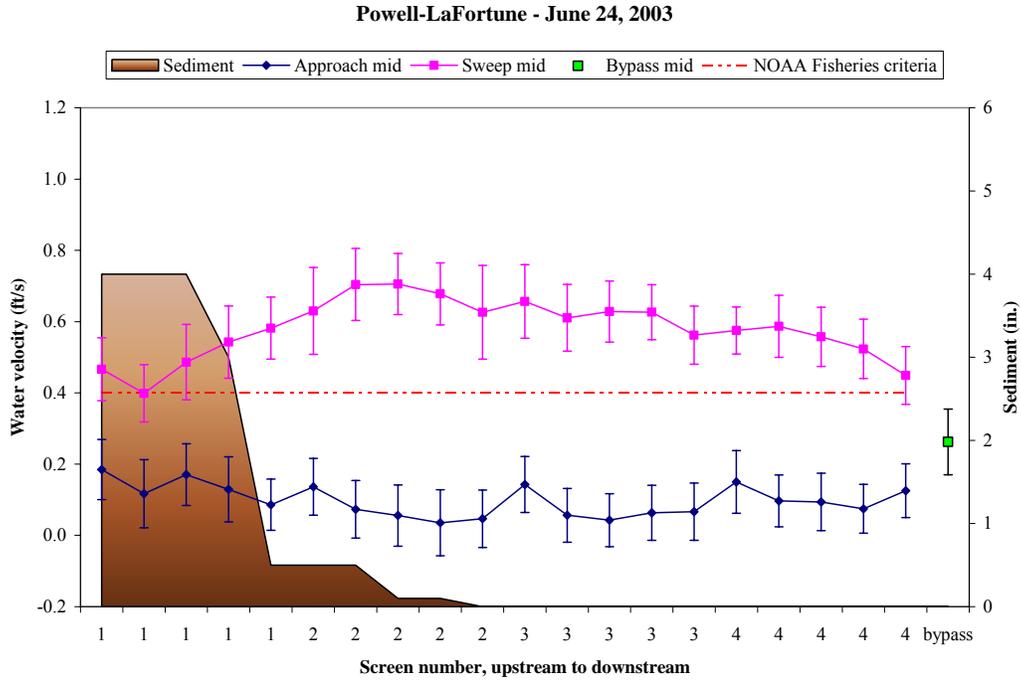
**Figure 32.** Water Velocities and Sediment Depths at Powell-LaFortune in June 2003. Error bars show turbulence ( $\pm$  the root-mean-squared [RMS]) at each point.

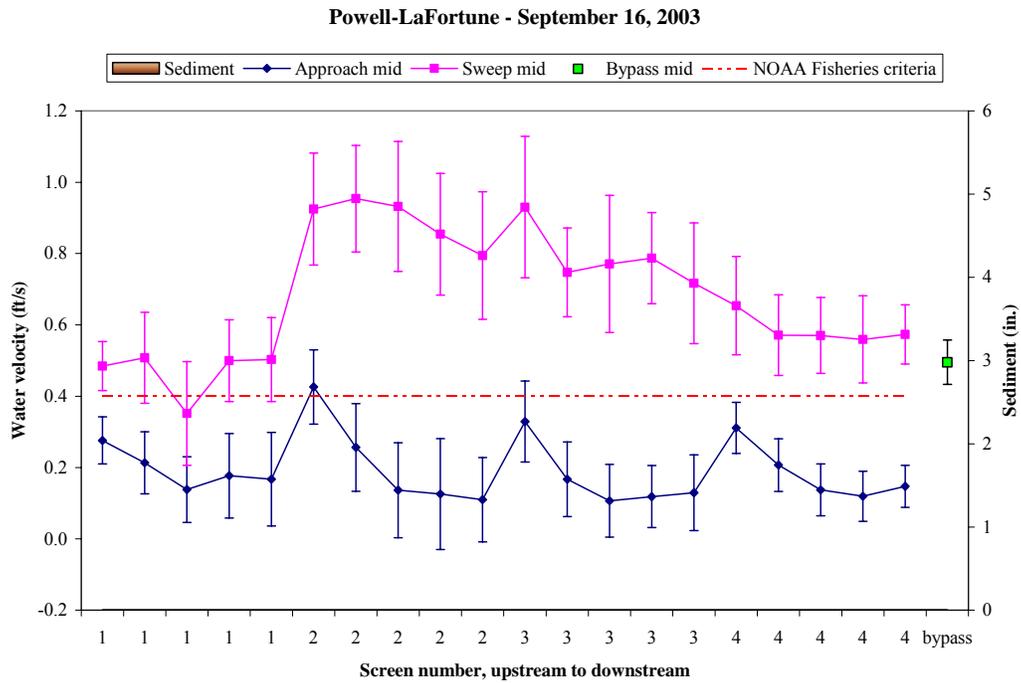
**Figure 33.** Water Velocities and Sediment Depths at Powell-LaFortune in September 2003. Error bars show turbulence ( $\pm$  the root-mean-squared [RMS]) at each point.

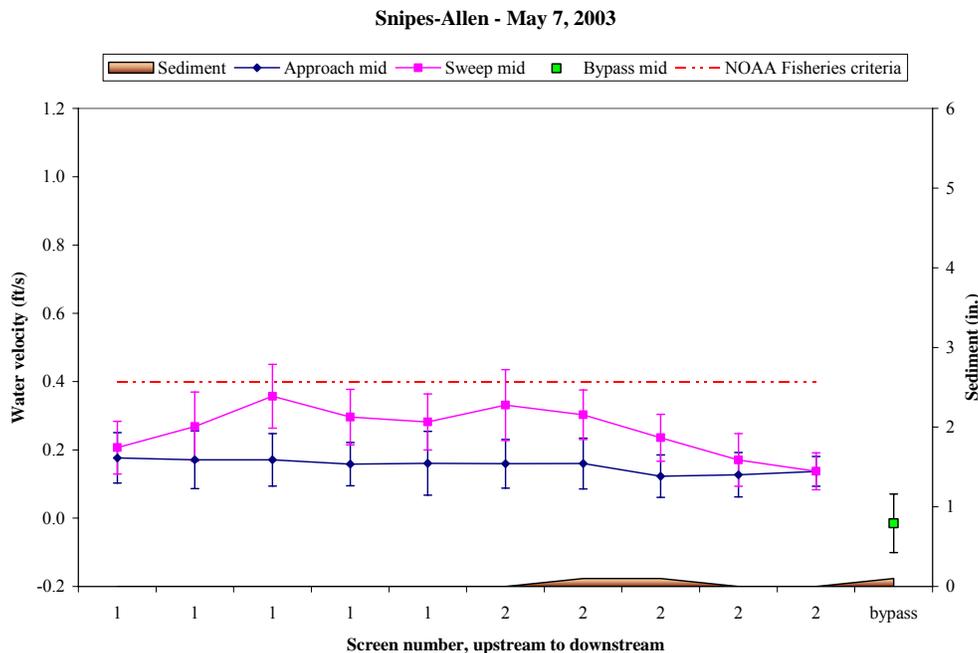
The Snipes-Allen site was evaluated on May 7, 2003; June 17, 2003; and September 23, 2003. All approach velocities met NOAA Fisheries criteria during all surveys (Figures 34, 35, and 36). Sweep velocities were generally higher than approach velocities during all surveys (Figures 34, 35, and 36). Sweep velocities did not increase towards the bypass except in September, and the average bypass velocity was slower than the average sweep velocity in May and June.

**Figure 34.** Water Velocities and Sediment Depths at Snipes-Allen in May 2003. Error bars show turbulence ( $\pm$  the root-mean-squared [RMS]) at each point.

Bypass conditions were generally safe for fish passage during all three evaluations. In the past, this site has had many problems with bypass obstructions, and it appeared that these problems had been resolved for 2003. During our evaluations, water ran freely behind the weir and out the outfall, and water depth at the point of discharge was always greater than 1 ft. However, it is apparent from notes in the logbook that there was not always enough flow through the headgates to produce bypass flow. Construction of the diversion dam has diverted all water (except leakage) through the site. Accumulation of debris on the trash rack may be to blame for problems with low submergence and bypass flow. We would recommend that the trash rack be cleaned as a part of daily ditch operations.

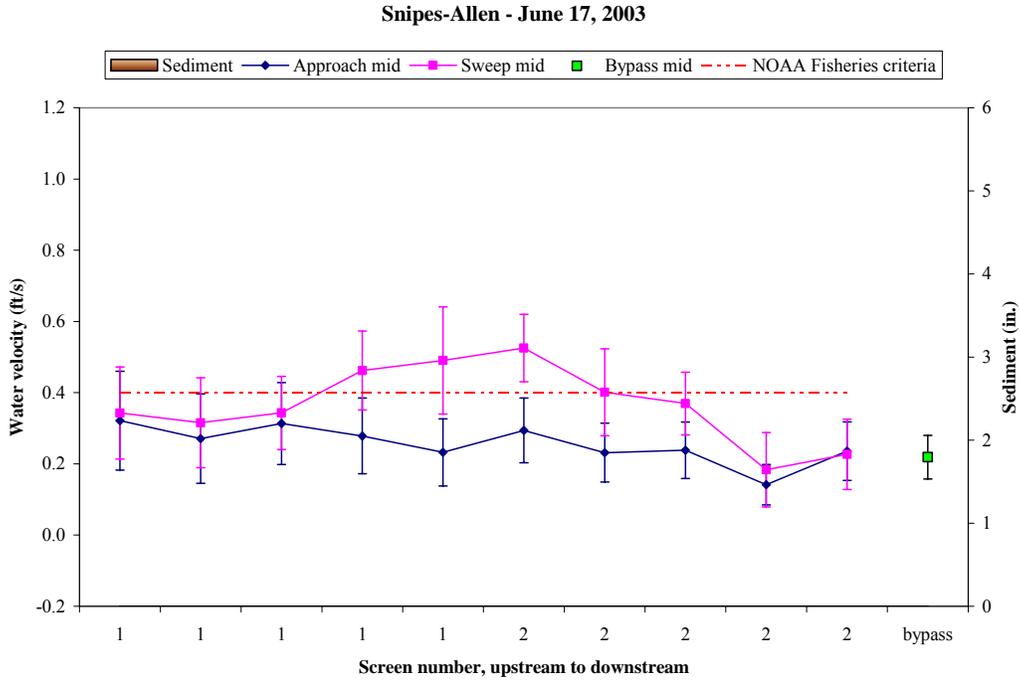
**Figure 35.** Water Velocities and Sediment Depths at Snipes-Allen in June 2003. Error bars show turbulence ( $\pm$  the root-mean-squared [RMS]) at each point.

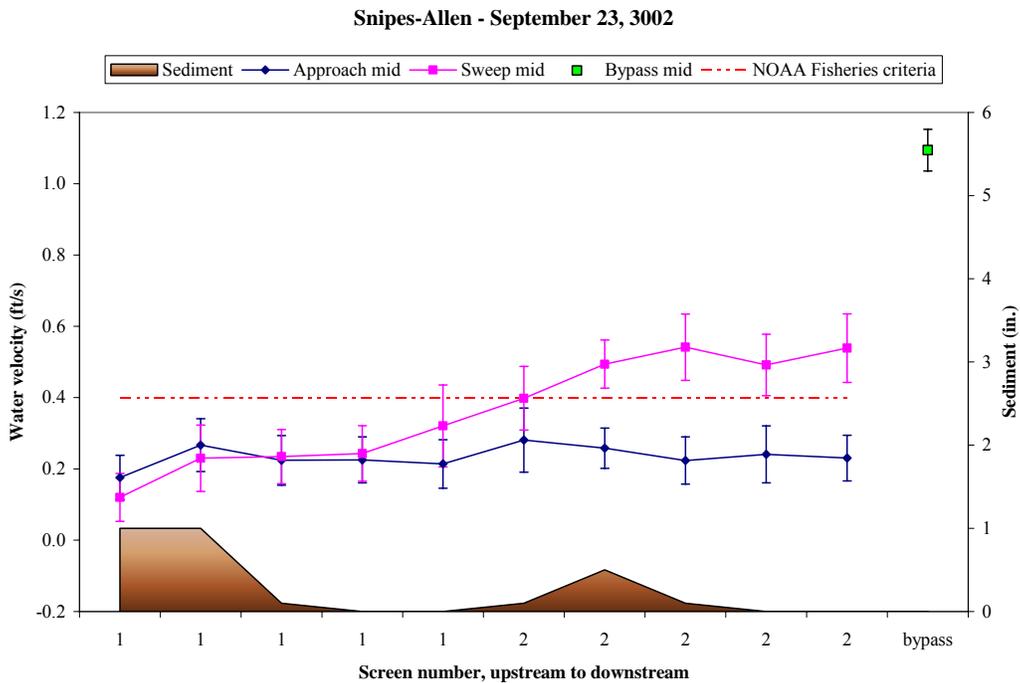
**Figure 36.** Water Velocities and Sediment Depths at Snipes-Allen in September 2003. Error bars show turbulence ( $\pm$  the root-mean-squared [RMS]) at each point.

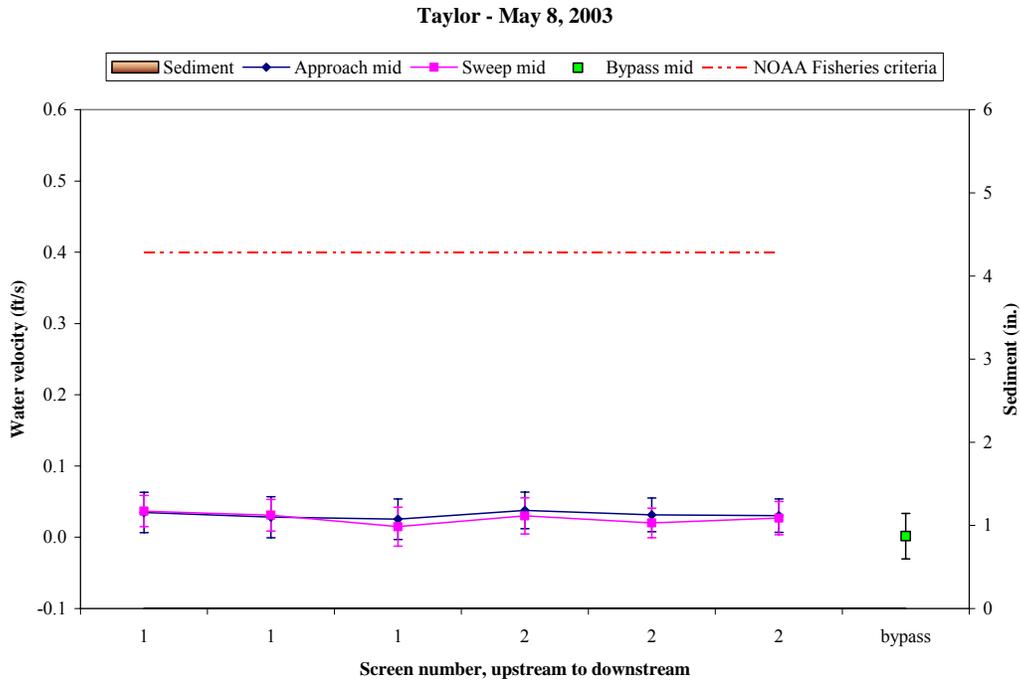
The Taylor site was evaluated on May 8, 2003; June 26, 2003; and September 16, 2003, although the site was essentially shut down for the season before our September survey. All approach velocities met NOAA Fisheries criteria in May and June (Figures 37 and 38). Sweep velocities were greater than approach velocities in June, but the bypass velocity was always less than the average sweep velocity. Percent submergence was below criteria during the survey in May at 35%. In June, submergence met criteria with 72%.

This site has had many problems meeting submergence and flow criteria over the past several years. Flows in the stream tend to be inconsistent within the irrigation season, and the main channel has shifted away from the screen site, making it even more difficult to divert water to the site, especially when flows are low. Notes in the site logbook indicate that submergence fluctuated between 20% and greater than 100% (screens were overtopped on June 8) between our May and June evaluations. Ray Gilmore was notified on May 12, 2003 of the low submergence, although there was nothing he could do about it because the stream level was low.

**Figure 37.** Water Velocities and Sediment Depths at Taylor in May 2003. Error bars show turbulence ( $\pm$  the root-mean-squared [RMS]) at each point.

Because of the history of problems at this site and the change in stream conditions, we strongly recommend that the design of this site and its diversion be reevaluated and that changes be made to put the site into compliance with the NOAA Fisheries criteria.

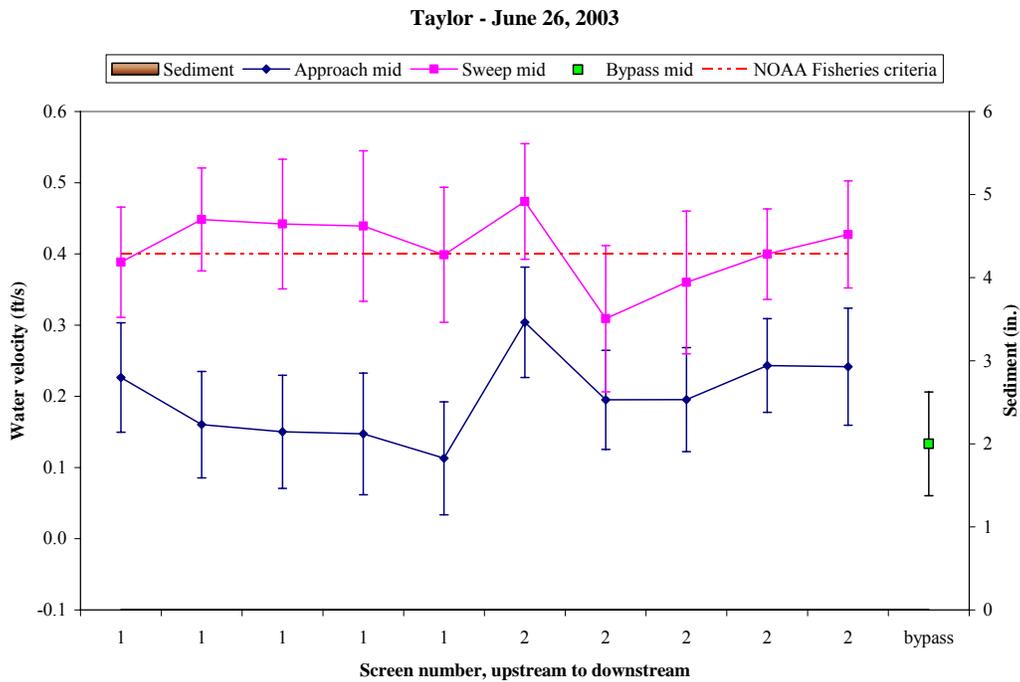
**Figure 38.** Water Velocities and Sediment Depths at Taylor in June 2003. Error bars show turbulence ( $\pm$  the root-mean-squared [RMS]) at each point.

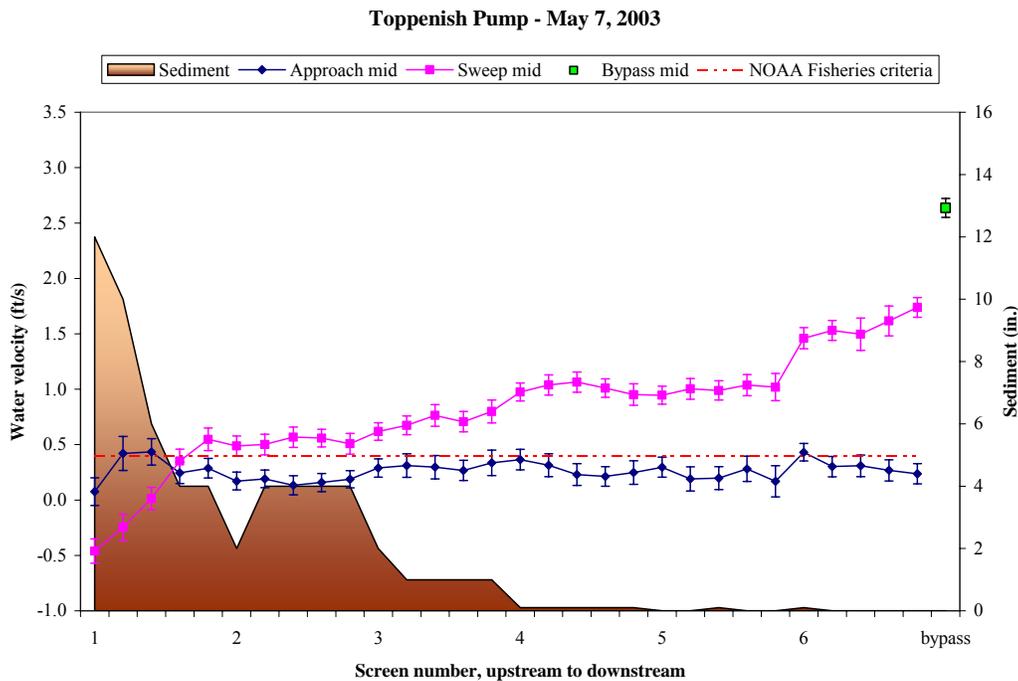
The Toppenish Pump site was visited on May 7, 2003; June 17, 2003; and September 23, 2003. In May, June, and September, 90%, 95%, and 97% of approach velocities met NOAA Fisheries criteria, respectively. This was a great improvement over 2002, when an average of 31% of approach velocities were >0.4 ft/s. Sweep velocities were generally higher than approach velocities, except in front of screen 1 (Figures 39, 40, and 41). Sweep velocities generally increased towards the bypass, and bypass velocities were always higher than sweep velocities. Submergence was calculated to be slightly low in May at 64% and met criteria in June and September at 79% and 72%, respectively.

**Figure 39.** Water Velocities and Sediment Depths at Toppenish Pump in May 2003. Error bars show turbulence ( $\pm$  the root-mean-squared [RMS]) at each point.

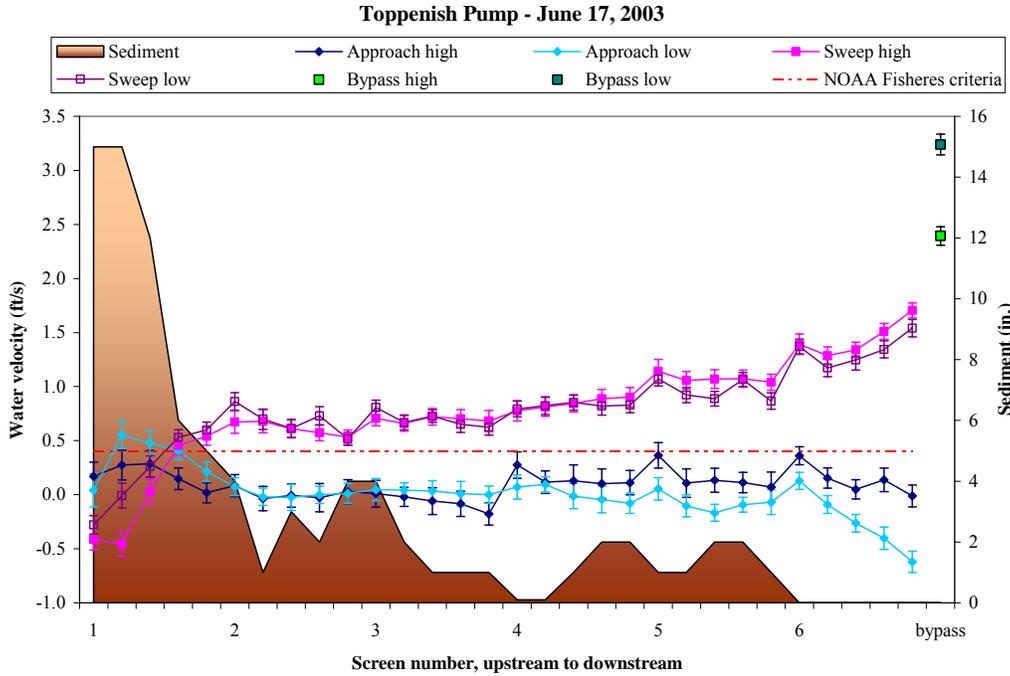
**Figure 40.** Water Velocities and Sediment Depths at Toppenish Pump in June 2003. Error bars show turbulence ( $\pm$  the root-mean-squared [RMS]) at each point.

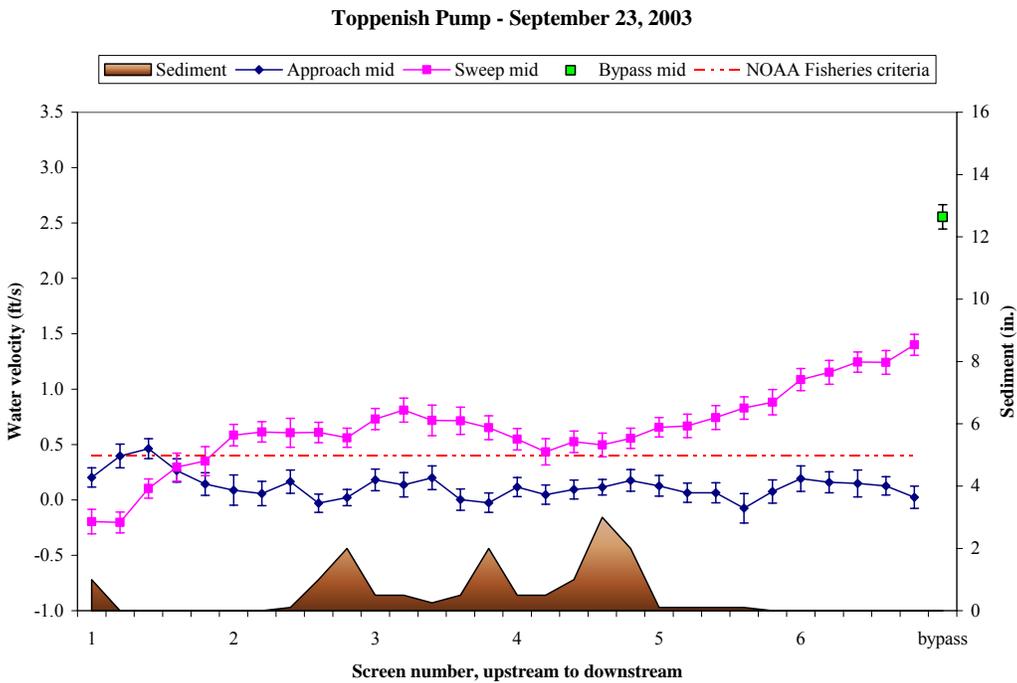
**Figure 41.** Water Velocities and Sediment Depths at Toppenish Pump in September 2003. Error bars show turbulence ( $\pm$  the root-mean-squared [RMS]) at each point.

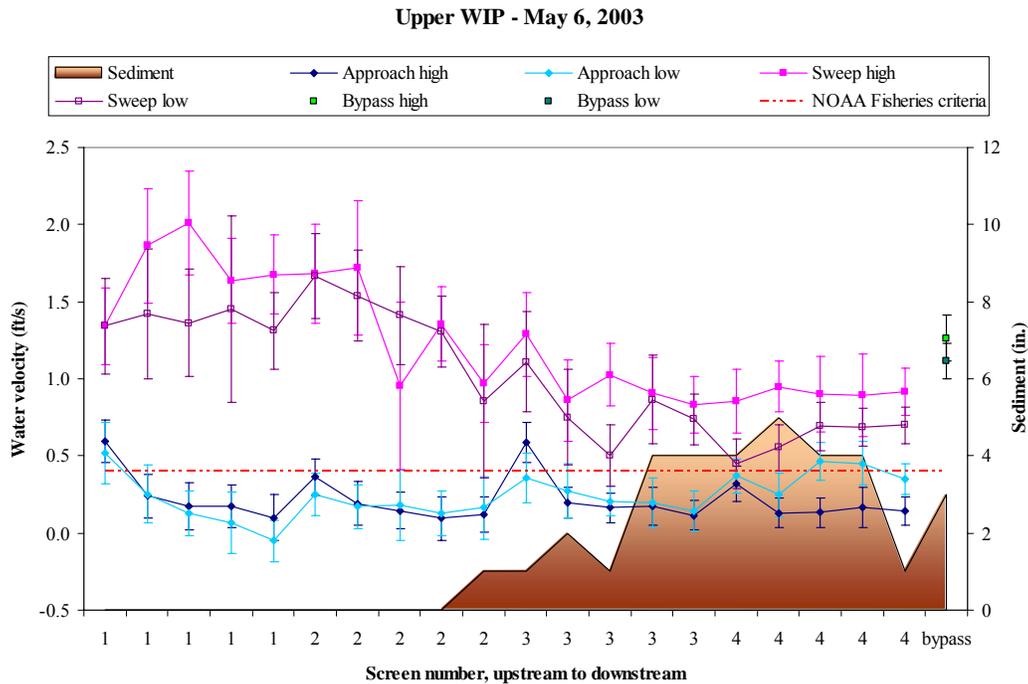
The Upper WIP site was visited on May 6, 2003; June 18, 2003; and September 19, 2003. The site was shut down for the season before the survey in September. Eighty-eight percent of approach velocities met NOAA Fisheries criteria in May, and 100% of approach velocities met NOAA Fisheries criteria in June (Figures 42 and 43). During both surveys, sweep velocities were much more turbulent than approach velocities. Sweep velocities did not increase towards the bypass, and the bypass velocity was only slightly greater than the average sweep velocity.

**Figure 42.** Water Velocities and Sediment Depths at Upper Wapato Irrigation Project (WIP) in May 2003. Error bars show turbulence ( $\pm$  the root-mean-squared [RMS]) at each point.

The gaps between the metal frames of the drums and the cement walls of the forebay were not caulked. The PNNL researchers recommend that these be filled with expanding foam insulation to prevent harm to migrating fish.

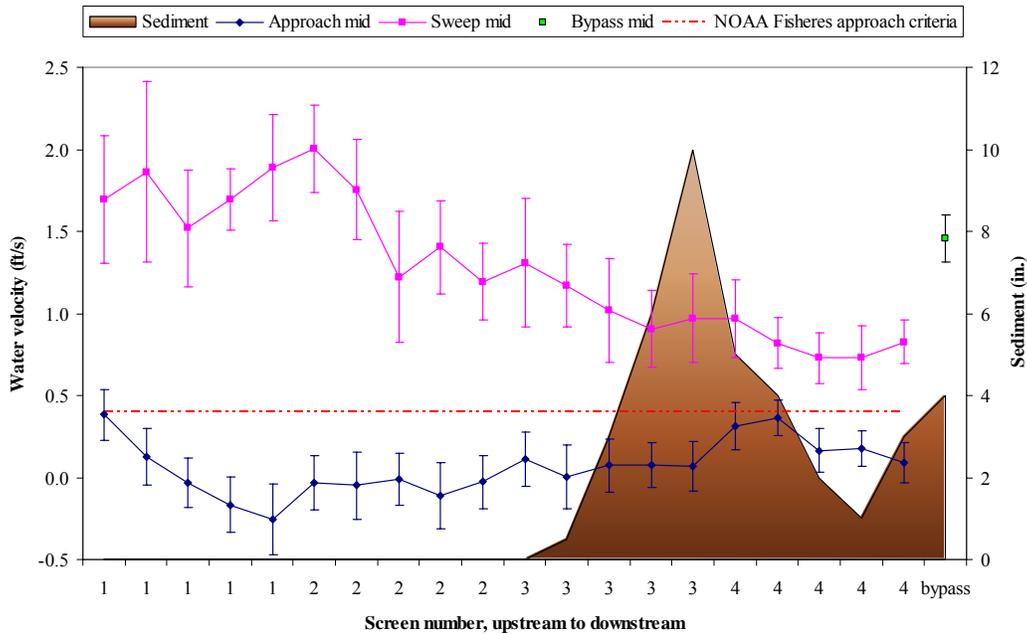
**Figure 43.** Water Velocities and Sediment Depths at Upper Wapato Irrigation Project (WIP) in June 2003. Error bars show turbulence ( $\pm$  the root-mean-squared [RMS]) at each point.

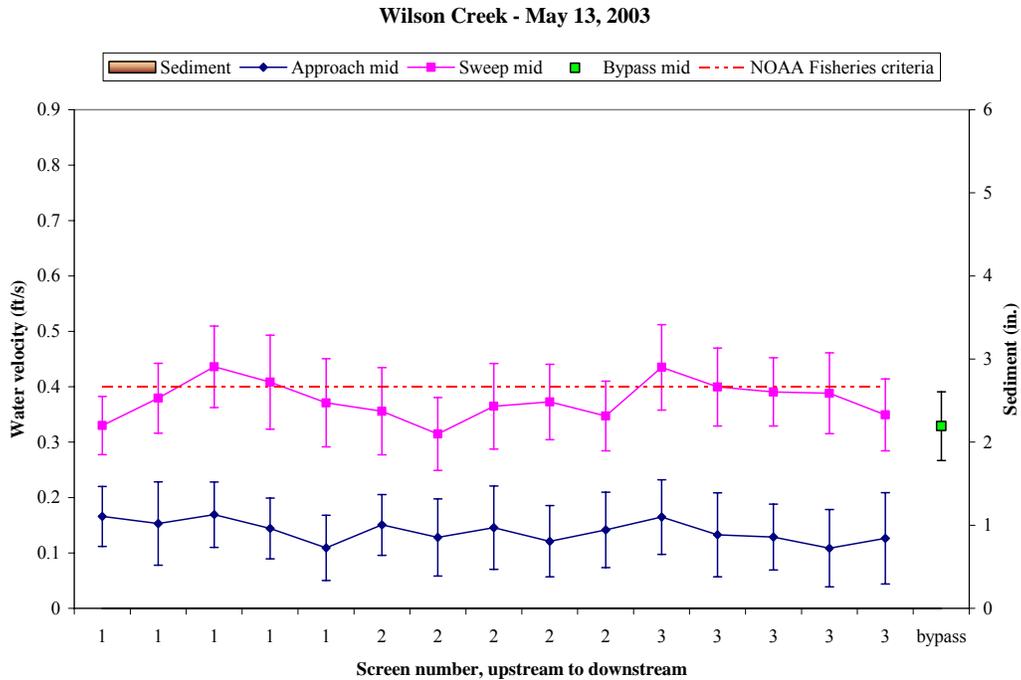
The Wilson Creek site was visited on May 13, 2003; June 25, 2003; and September 15, 2003. All measured approach velocities met NOAA Fisheries criteria during all surveys (Figures 44, 45, and 46). Sweep velocities were always greater than approach velocities. Sweep velocities did not increase towards the bypass except in September, and the average bypass velocity was slower than the average sweep velocity in May and June.

Submergence met criteria during all surveys. There was 2 in. of head loss over the screens in May. This was probably due to growth of algae on and inside of the screens, which tends to partially or fully plug the screen holes. The screen material was in good condition during all surveys, as were all seals. The gaps between the metal frames of the drums and the concrete walls of the forebay were filled with expanding foam insulation to prevent harm to migrating fish.

**Figure 44.** Water Velocities and Sediment Depths at Wilson Creek in May 2003. Error bars show turbulence ( $\pm$  the root-mean-squared [RMS]) at each point.

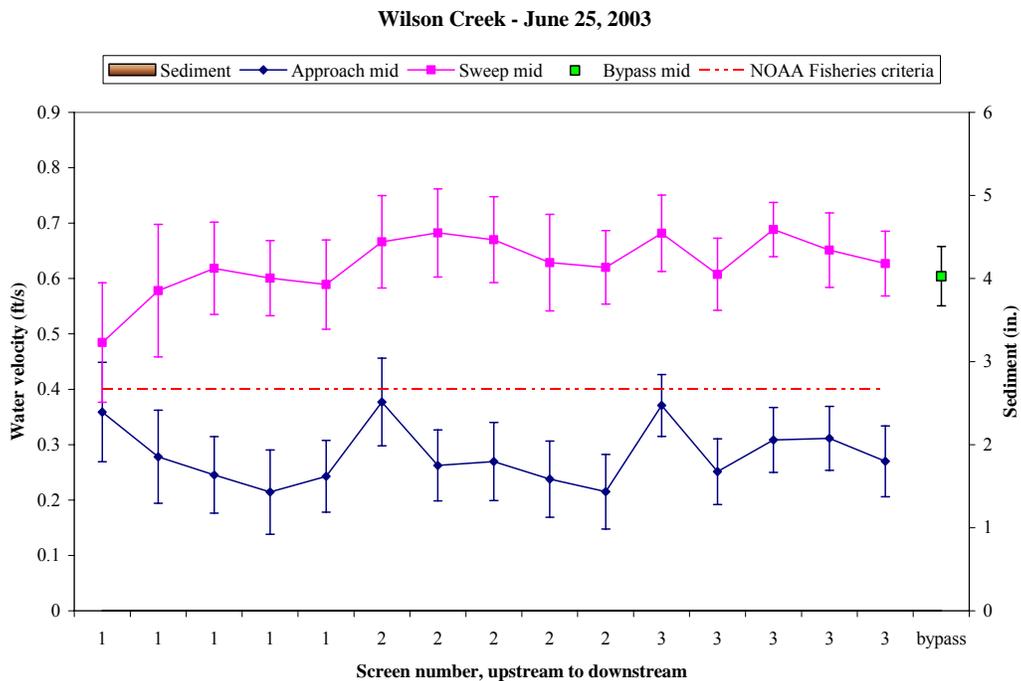
**Figure 45.** Water Velocities and Sediment Depths at Wilson Creek in June 2003. Error bars show turbulence ( $\pm$  the root-mean-squared [RMS]) at each point.

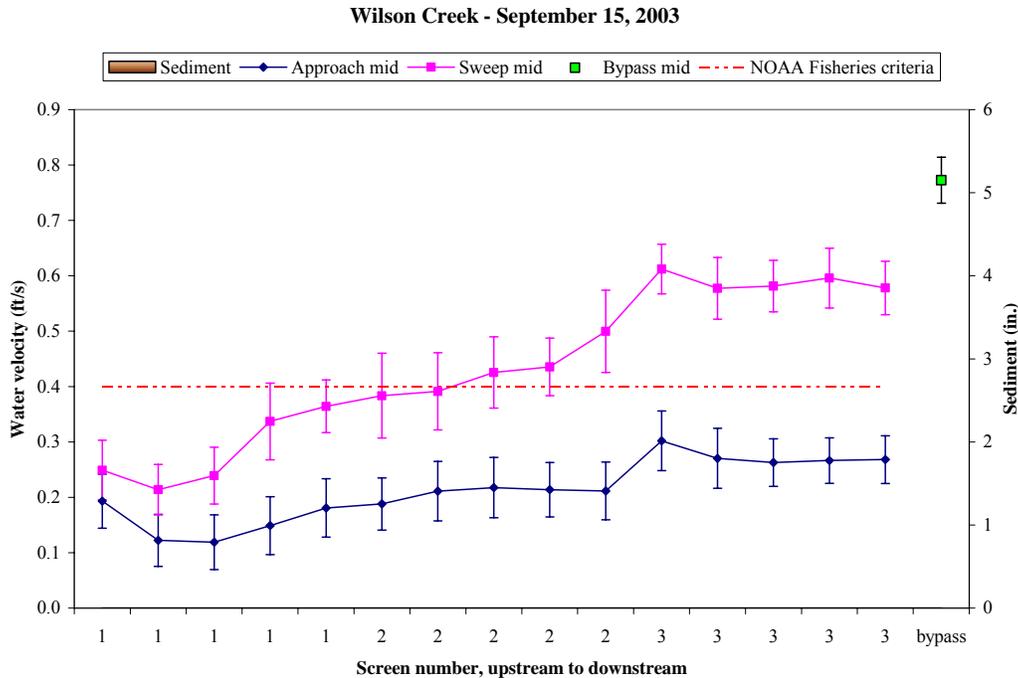
**Figure 46.** Water Velocities and Sediment Depths at Wilson Creek in September 2003. Error bars show turbulence ( $\pm$  the root-mean-squared [RMS]) at each point.

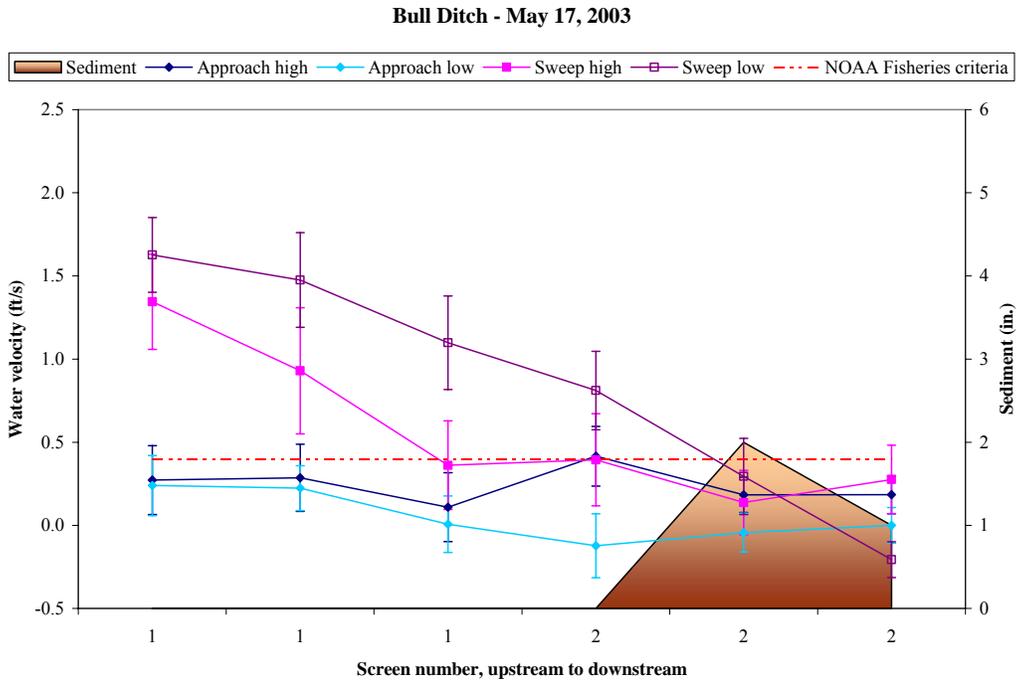
The Bull Ditch site was evaluated on May 12, 2003; June 25, 2003; and September 16, 2003. Sweep velocities were generally higher than approach velocities in May but not in June or September (Figures 47, 48, and 49). Approach velocities met NOAA Fisheries criteria 92%, 94%, and 100% of the time in May, June, and September, respectively. Sweep velocities tended to decrease over the length of the site, and in September, both sweep and approach velocities at the downstream end of the site were approximately zero.

Low-sweeping velocities at the downstream end of the site combined with the presence of predator habitat may result in the delay of and predation on migrating salmonids. Low-sweeping velocities are controlled in part by the metal plates placed between the screens and the channel, and changes in their position may help increase sweep velocities. The slower water may also cause sediment accumulation at

**Figure 47.** Water Velocities and Sediment Depths at Bull Ditch in May 2003. Error bars show turbulence ( $\pm$  the root-mean-squared [RMS]) at each point.

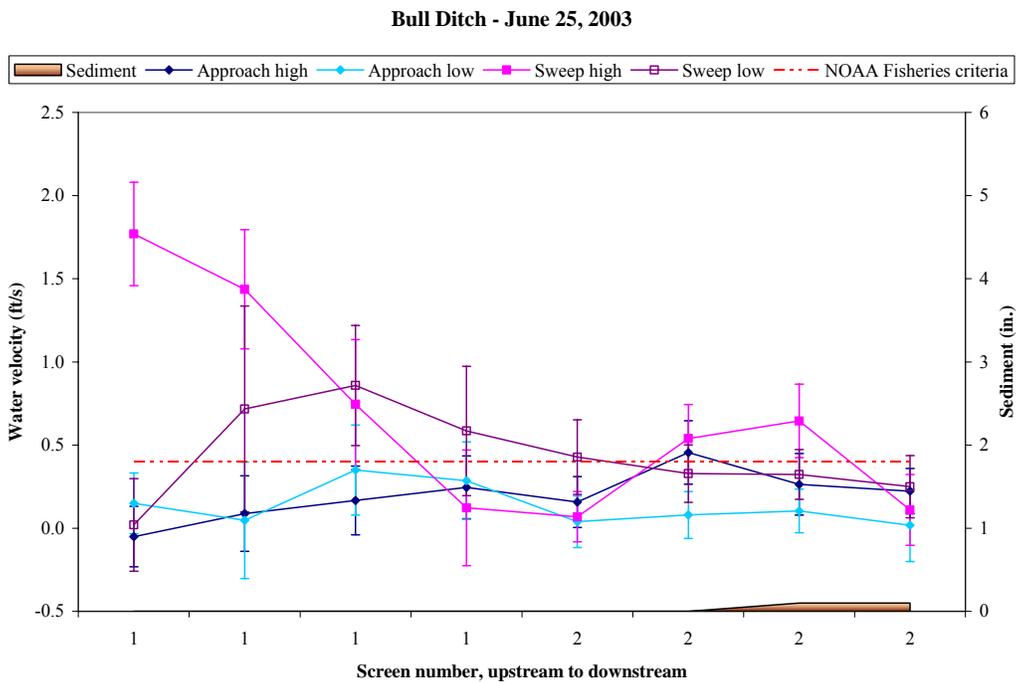
**Figure 48.** Water Velocities and Sediment Depths at Bull Ditch in June 2003. Error bars show turbulence ( $\pm$  the root-mean-squared [RMS]) at each point.

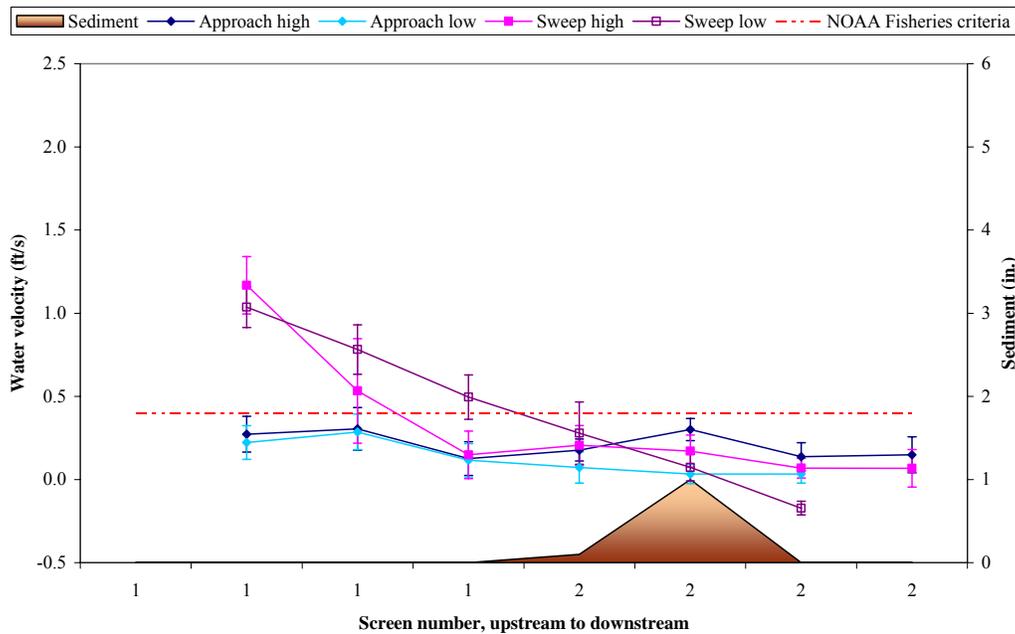
### Bull Ditch - September 16, 2003

**Figure 49.** Water Velocities and Sediment Depths at Bull Ditch in September 2003. Error bars show turbulence ( $\pm$  the root-mean-squared [RMS]) at each point.

the downstream end of the site. This site has been tentatively scheduled for removal during the 2003 winter. If it continues to be used, the PNNL researchers recommend that procedures be evaluated to increase sweep velocities and minimize predator habitat growth and sediment accumulation.

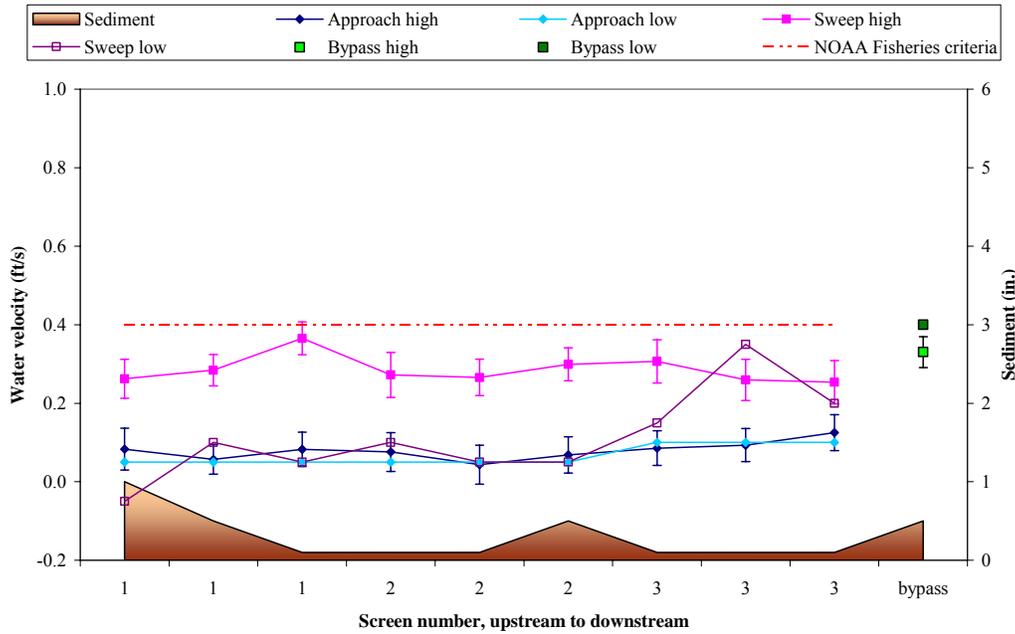
Ellensburg Mill - May 12, 2003

The Ellensburg Mill site was visited on May 12, 2003; June 25, 2003; and September 15, 2003. Because of aquatic vegetation growth in the forebay, the Marsh-McBirney 511<sup>®</sup> flow meter was used to measure velocity at the low position in May and June; consequently, turbulence values are not available for those measurements. All approach velocities met NOAA Fisheries criteria during all surveys (Figures 50, 51, and 52). Sweep velocities were generally higher than approach velocities. Sweep velocities did not increase towards the bypass, although the bypass velocity was greater than the average sweep velocity during all surveys.

Figure 50. Water Velocities and Sediment Depths at Ellensburg Mill in May 2003. Error bars show turbulence ( $\pm$  the root-mean-squared [RMS]) at each point.

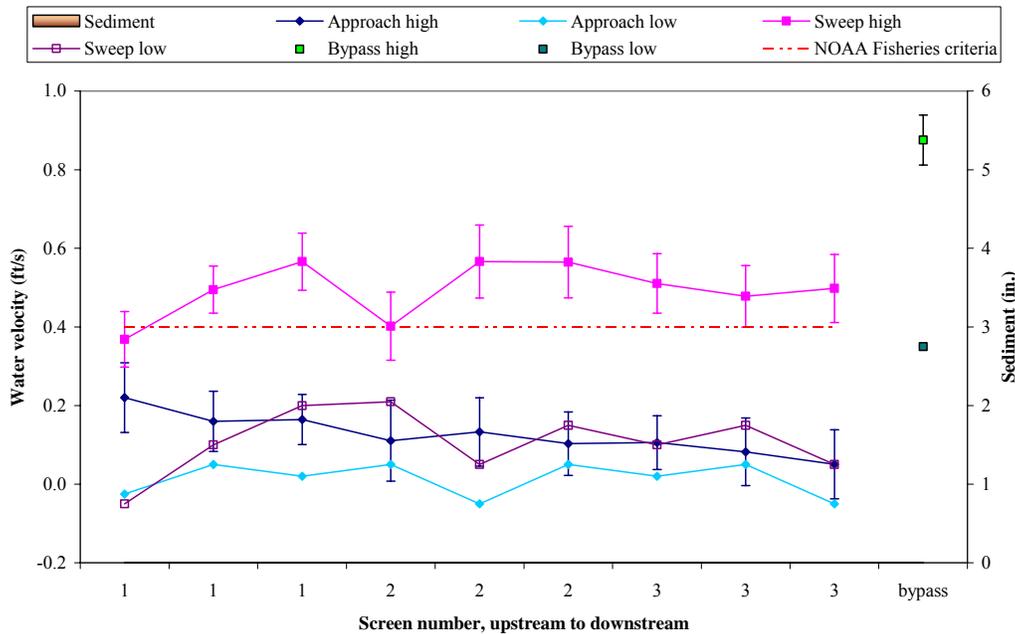
Ellensburg Mill - June 25, 2003

Figure 51. Water Velocities and Sediment Depths at Ellensburg Mill in June 2003. Error bars show turbulence ( $\pm$  the root-mean-squared [RMS]) at each point.

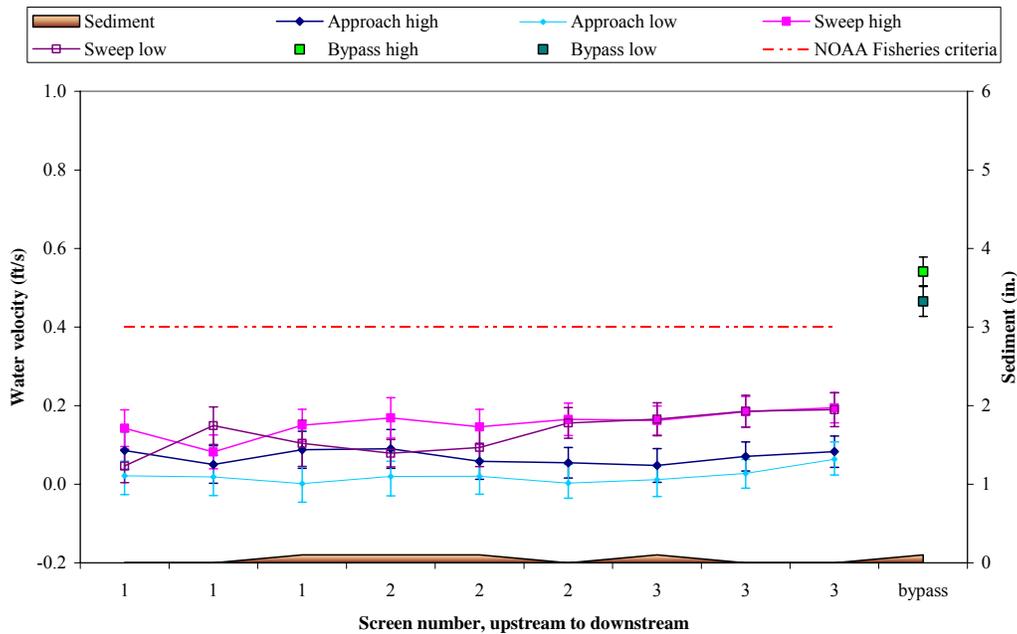
Ellensburg Mill - September 15, 2003

**Figure 52.** Water Velocities and Sediment Depths at Ellensburg Mill in September 2003. Error bars show turbulence ( $\pm$  the root-mean-squared [RMS]) at each point.

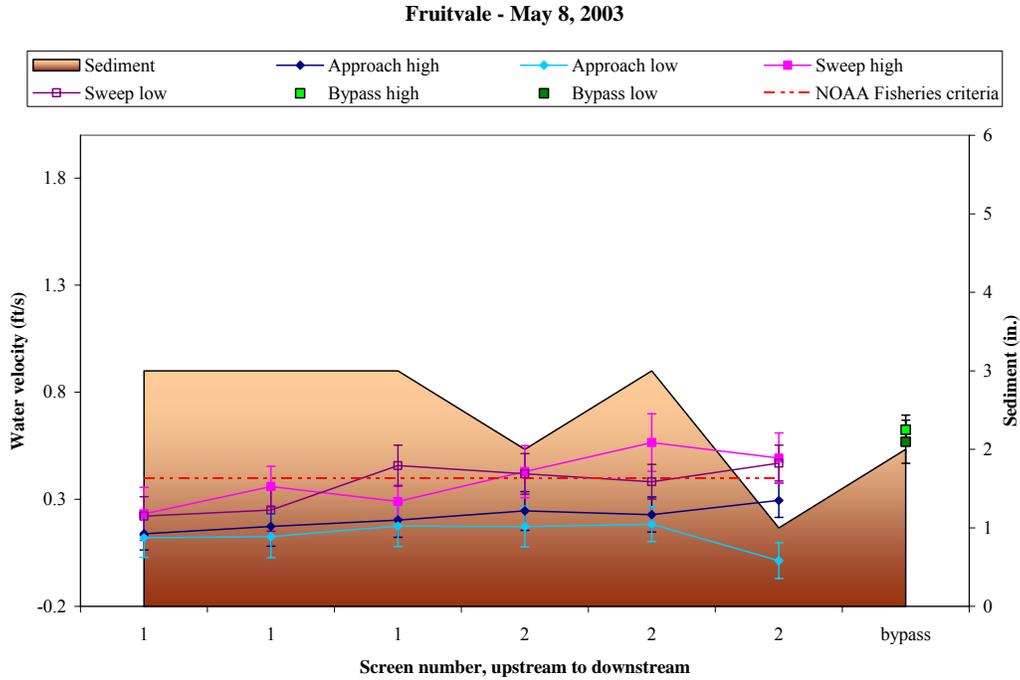
The Fruitvale site was visited on May 8, 2003; June 26, 2003; and September 16, 2003. During all surveys, 100% of approach velocities met NOAA Fisheries criteria (Figures 53, 54, and 55). Sweep velocities were generally higher than approach velocities and increased towards the bypass in September. Bypass velocities were higher than the average sweep velocity in May and September.

**Figure 53.** Water Velocities and Sediment Depths at Fruitvale in May 2003. Error bars show turbulence ( $\pm$  the root-mean-squared [RMS]) at each point.

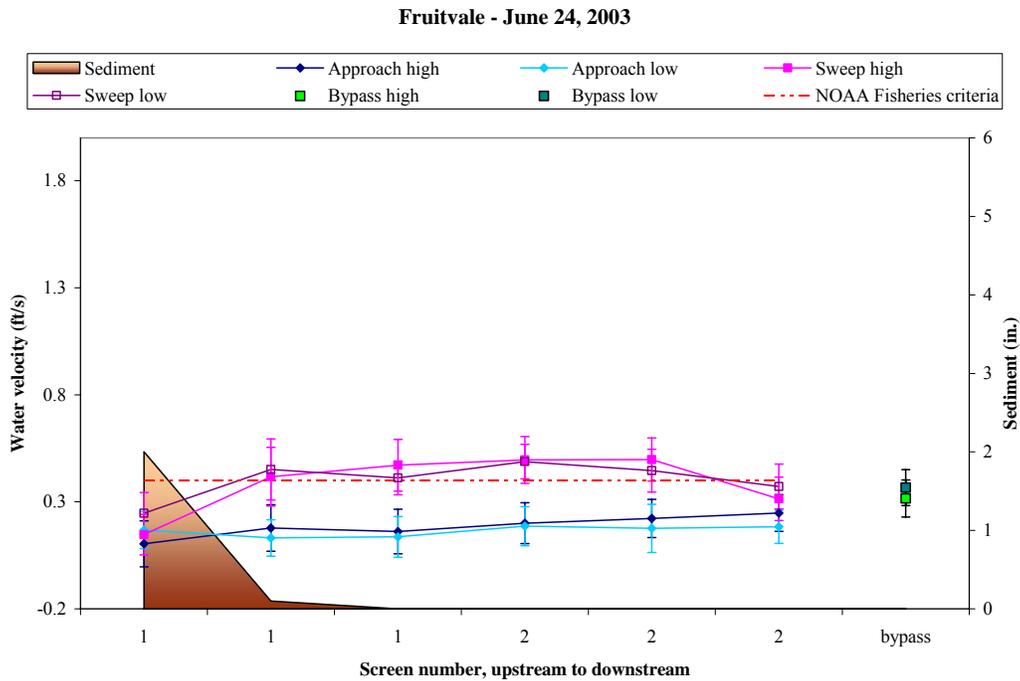
**Figure 54.** Water Velocities and Sediment Depths at Fruitvale in June 2003. Error bars show turbulence ( $\pm$  the root-mean-squared [RMS]) at each point.
