# Washington Phase II Fish Diversion Screen Evaluations in the Yakima River Basin

**Annual Report  
2003**

## Yakima River Basin Phase II Fish Screen Evaluations, 2003

May 2004

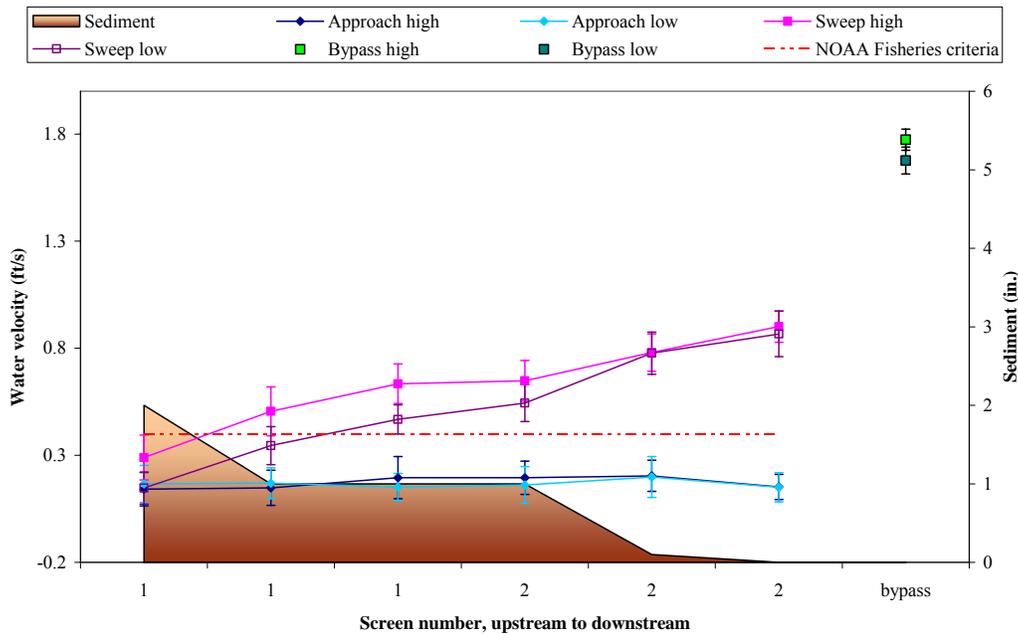
Fruitvale - September 16, 2003

The Fruitvale site was visited on May 8, 2003; June 26, 2003; and September 16, 2003. During all surveys, 100% of approach velocities met NOAA Fisheries criteria (Figures 53, 54, and 55). Sweep velocities were generally higher than approach velocities and increased towards the bypass in September. Bypass velocities were higher than the average sweep velocity in May and September.

**Figure 55.** Water Velocities and Sediment Depths at Fruitvale in September 2003. Error bars show turbulence ( $\pm$  the root-mean-squared [RMS]) at each point.

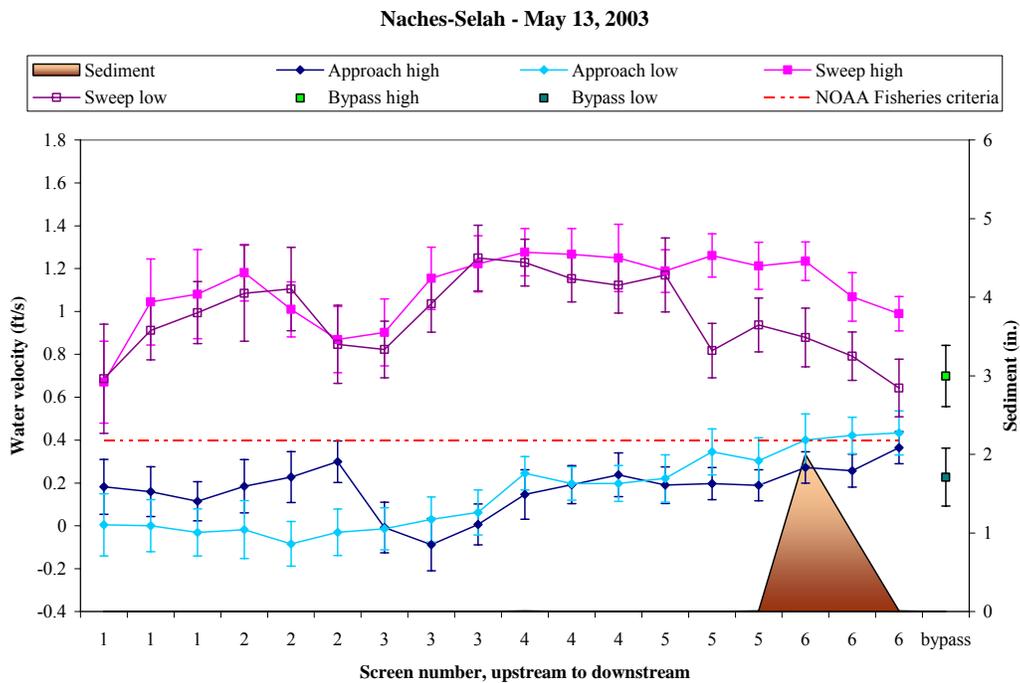
The Naches-Selah site was visited on May 13, 2003; June 24, 2003; and September 16, 2003. In May, June, and September, 92%, 72%, and 75% of approach velocities met NOAA Fisheries criteria, respectively (Figures 56, 57, and 58). Sweep velocities were always greater than approach velocities but did not increase towards the bypass. The average bypass velocity was slower than the average sweep velocity during all surveys. Ray Gilmore was notified of the high approach velocities on June 26. Dave Floyd made changes to the operating conditions on July 2, but the changes did not put the site in compliance with the NOAA Fisheries criteria, and in September the approach velocities were still high. Ray Gilmore was notified again on September 17, although there was not much he could do. This site has

**Figure 56.** Water Velocities and Sediment Depths at Naches-Selah in May 2003. Error bars show turbulence ( $\pm$  the root-mean-squared [RMS]) at each point.

one of the worst records as far as meeting NOAA Fisheries velocity criteria, and while the numbers for 2003 are an improvement over 2002, they are still low (Table 4). The PNNL researchers recommend that site operating procedures and/or site structure be modified to protect migrating fish from injury as they pass through this site.

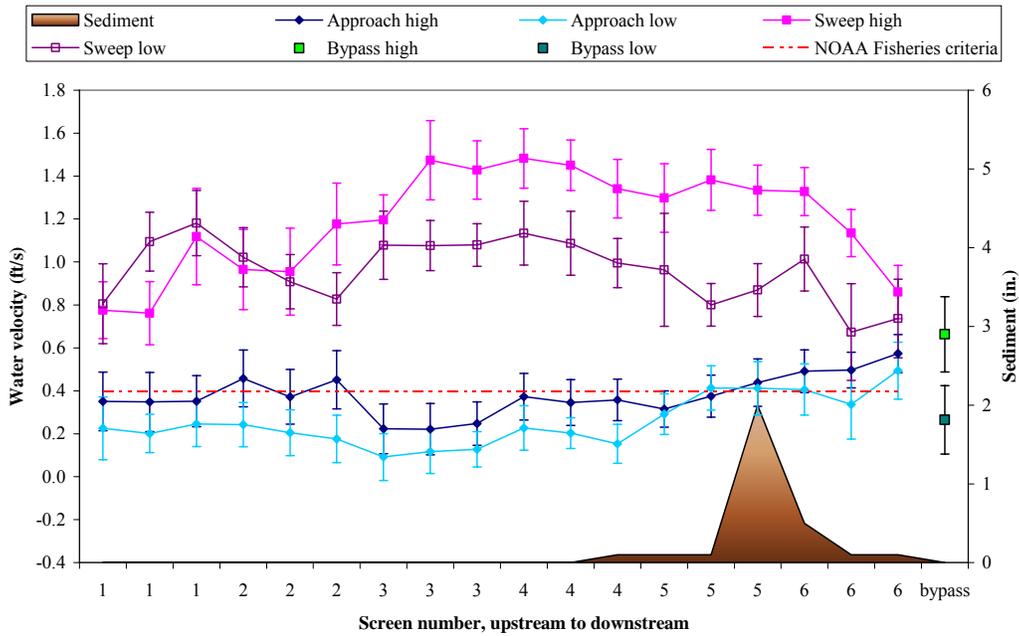
Naches-Selah - June 24, 2003

**Figure 57.** Water Velocities and Sediment Depths at Naches-Selah in June 2003. Error bars show turbulence ( $\pm$  the root-mean-squared [RMS]) at each point.

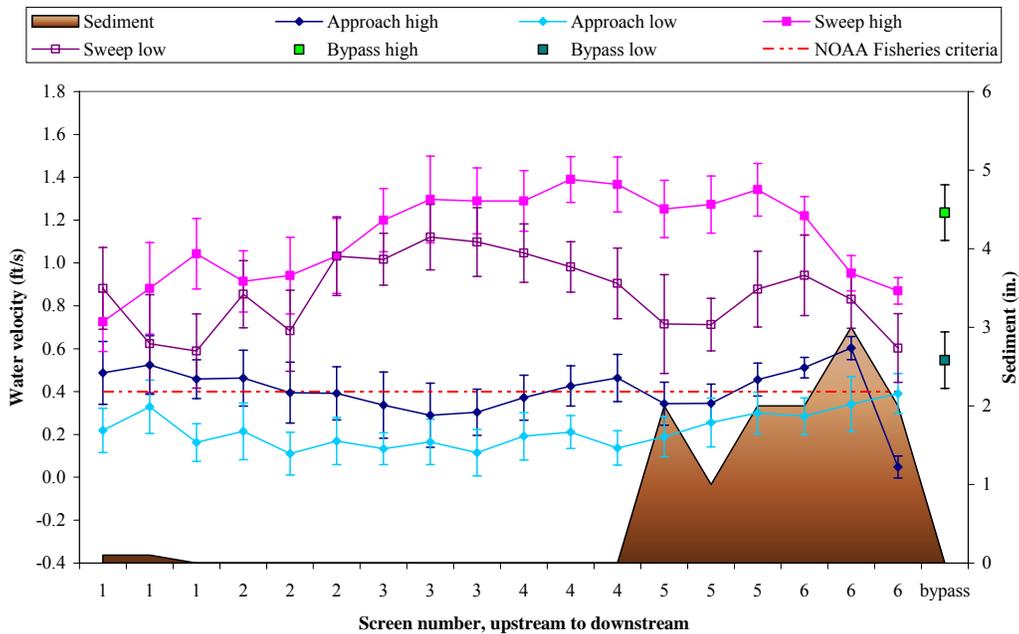
Naches-Selah - September 16, 2003

**Figure 58.** Water Velocity and Sediment Depths at Naches-Selah in September 2003. Error bars show turbulence ( $\pm$  the root-mean-squared [RMS]) at each point.

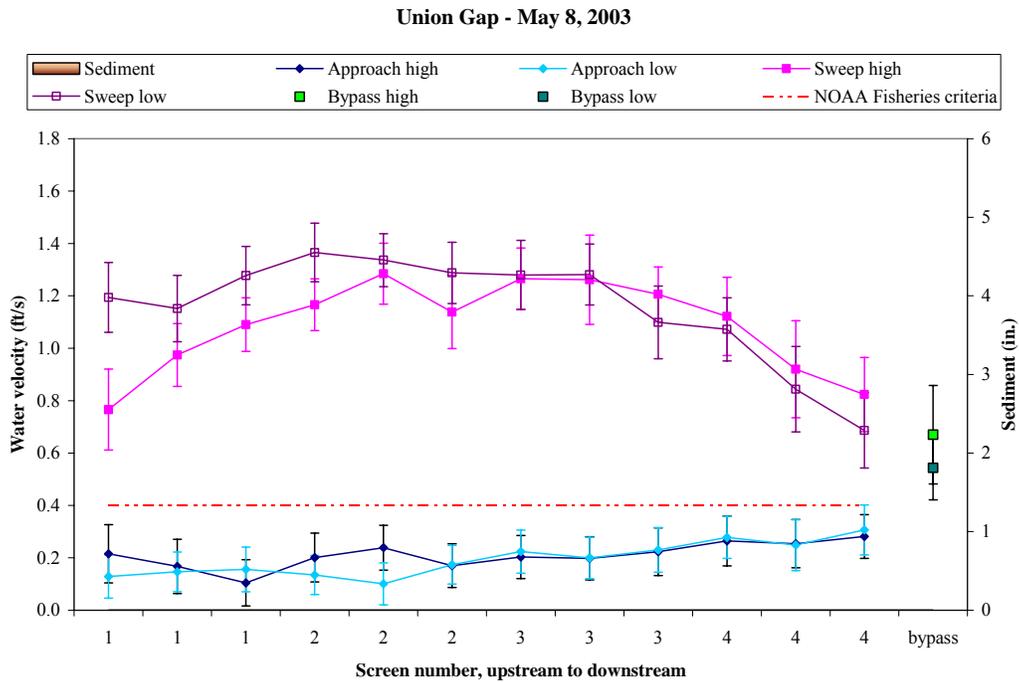
The Union Gap site was evaluated on May 8, 2003; June 24, 2003; and September 16, 2003. In May, June, and September, 100%, 71%, and 100% of approach velocities met NOAA Fisheries criteria, respectively (Figures 59, 60, and 61). Sweep velocities were always higher than approach velocities, but did not increase toward the bypass. The average bypass velocity was slower than the average sweep velocity. Ray Gilmore was notified on June 24 that greater than 10% of the approach velocity measurements exceeded 0.4 ft/s. Follow-up measurements taken on June 26 after changes in operating conditions showed that velocities were still high. PNNL followed up again on July 2, and approach velocity conditions met the NOAA Fisheries criteria.

**Figure 59.** Water Velocities and Sediment Depths at Union Gap in May 2003. Error bars show turbulence ( $\pm$  the root-mean-squared [RMS]) at each point.

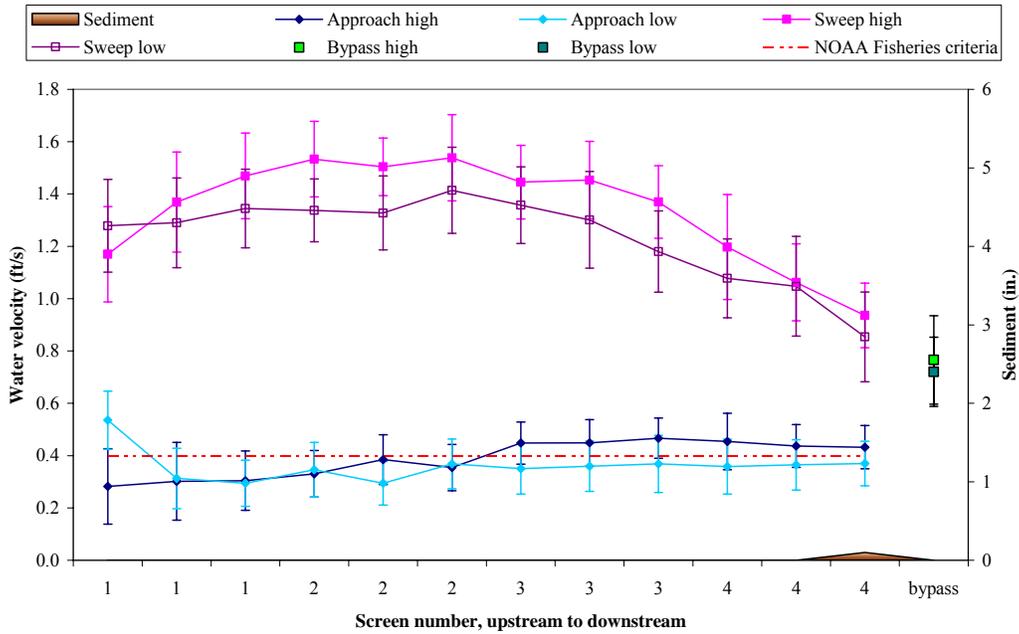
Union Gap - June 24, 2003

Figure 60. Water Velocities and Sediment Depths at Union Gap in June 2003. Error bars show turbulence ( $\pm$  the root-mean-squared [RMS]) at each point.

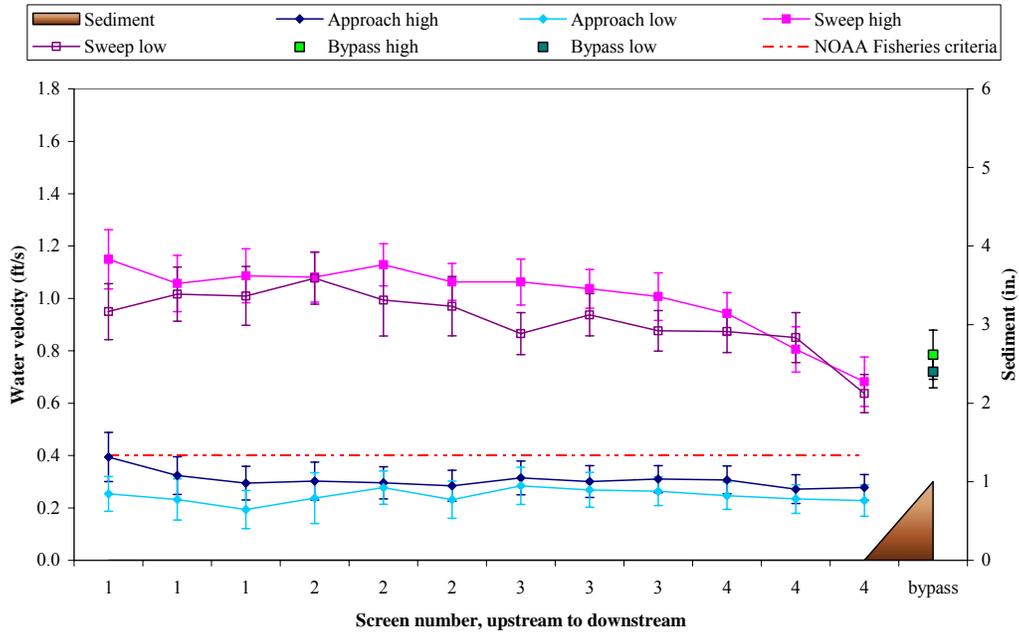
Union Gap - September 16, 2003

Figure 61. Water Velocities and Sediment Depths at Union Gap in September 2003. Error bars show turbulence ( $\pm$  the root-mean-squared [RMS]) at each point.

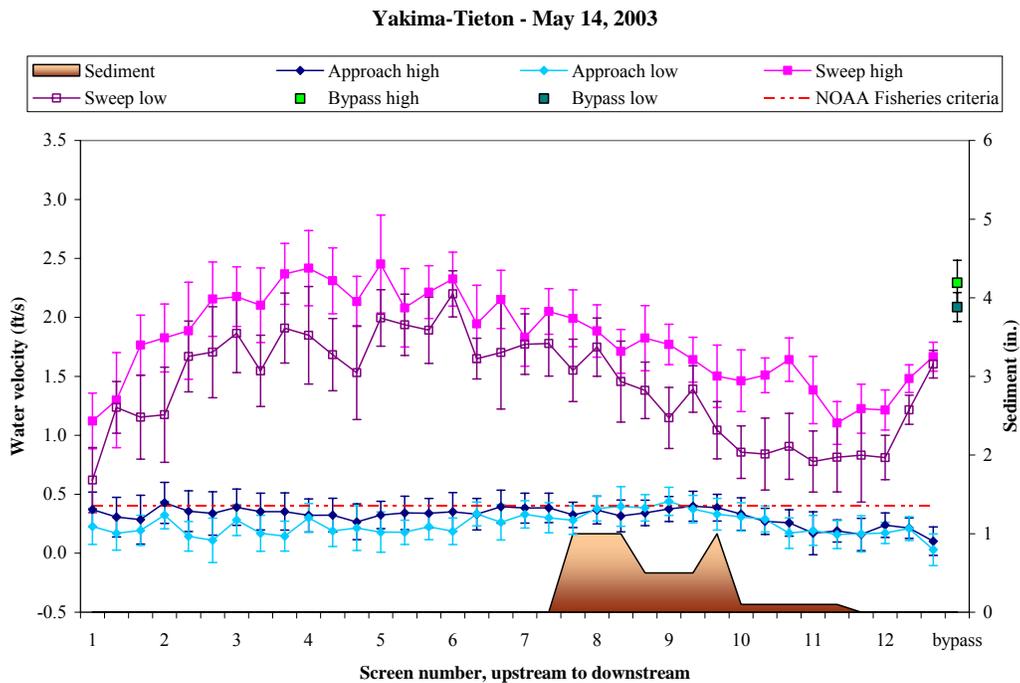
The Yakima-Tieton site was evaluated on May 14, 2003; June 19, 2003; and September 17, 2003. In May, June, and September, 97%, 94%, and 100% of approach velocities met NOAA Fisheries criteria, respectively (Figures 62, 63, and 64). Sweep velocities were always higher than approach velocities. Sweep velocities did not increase towards the bypass, and the average bypass velocity was always higher than the average sweep velocity.

**Figure 62.** Water Velocities and Sediment Depths at Yakima-Tieton in May 2003. Error bars show turbulence ( $\pm$  the root-mean-squared [RMS]) at each point.

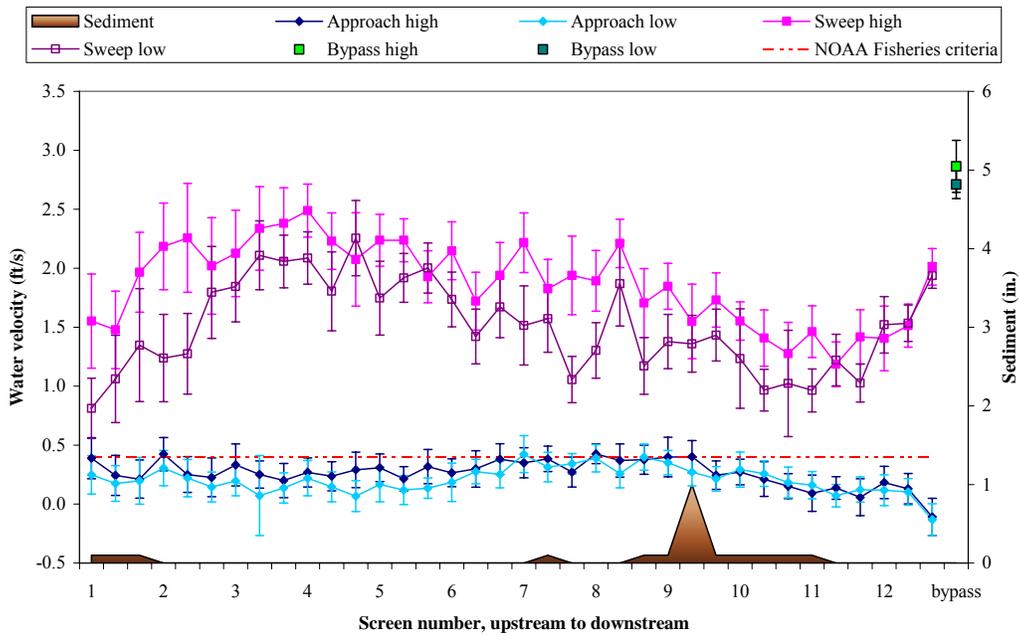
Yakima-Tieton - June 19, 2003

Figure 63. Water Velocities and Sediment Depths at Yakima-Tieton in June 2003. Error bars show turbulence ( $\pm$  the root-mean-squared [RMS]) at each point.

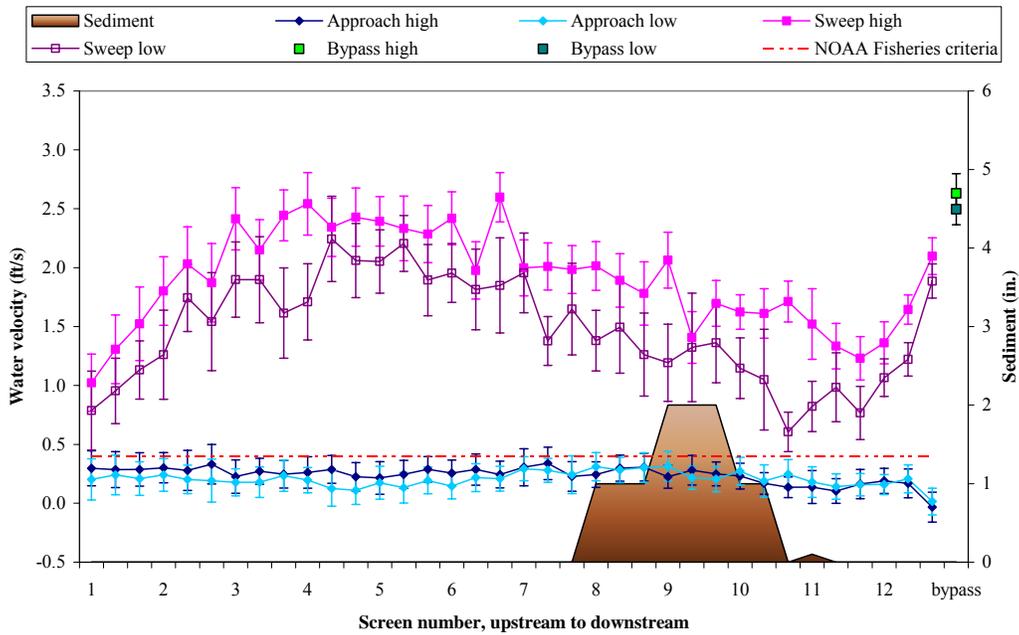
Yakima-Tieton - September 17, 2003

Figure 64. Water Velocities and Sediment Depths at Yakima-Tieton in September 2003. Error bars show turbulence ( $\pm$  the root-mean-squared [RMS]) at each point.

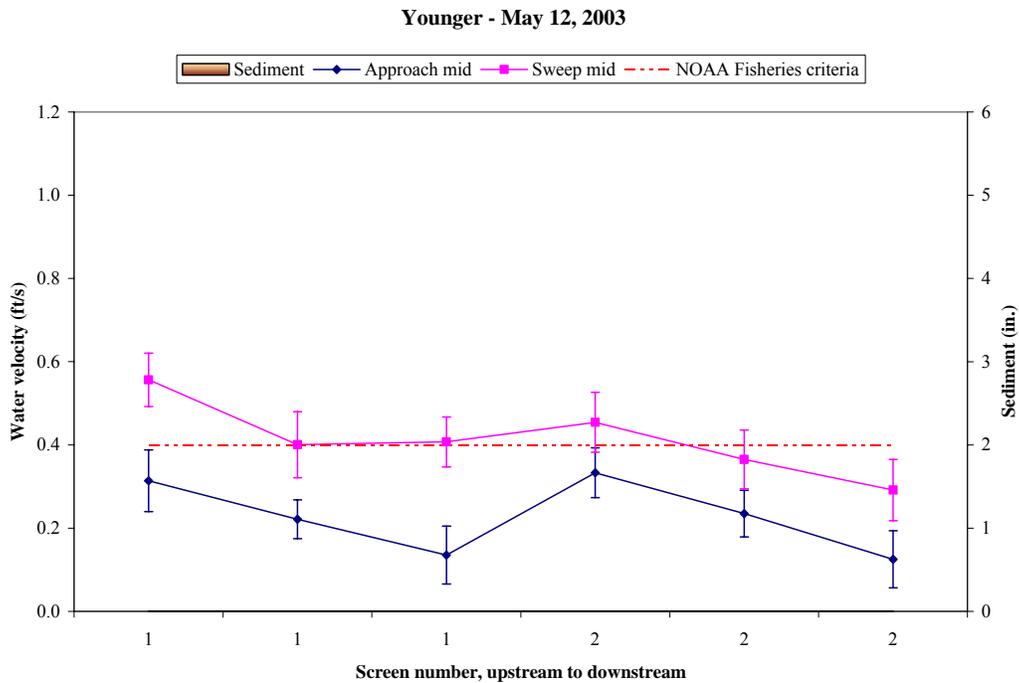
The Younger site was visited on May 12, 2003; June 25, 2003; and September 15, 2003. All approach velocities met NOAA Fisheries criteria during all surveys (Figures 65, 66, and 67). Sweep velocities were generally higher than approach velocities, though they did not increase towards the downstream end of the site.

**Figure 65.** Water Velocities and Sediment Depths at Younger in May 2003. Error bars show turbulence ( $\pm$  the root-mean-squared [RMS]) at each point.

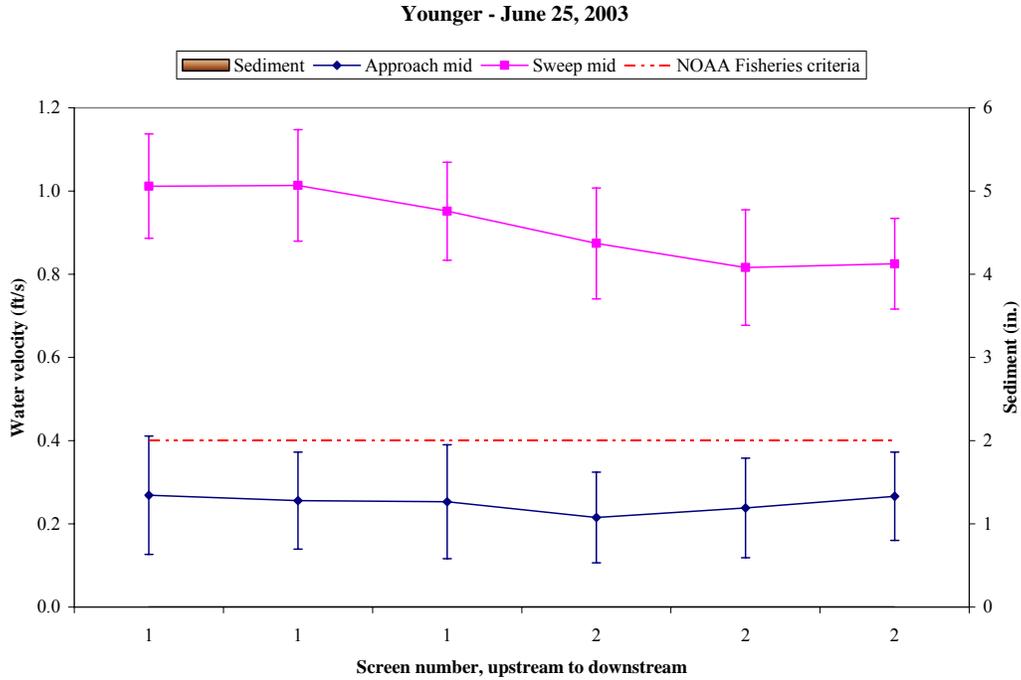
**Figure 66.** Water Velocities at Younger in June 2003. Error bars show turbulence ( $\pm$  the root-mean-squared [RMS]) at each point.

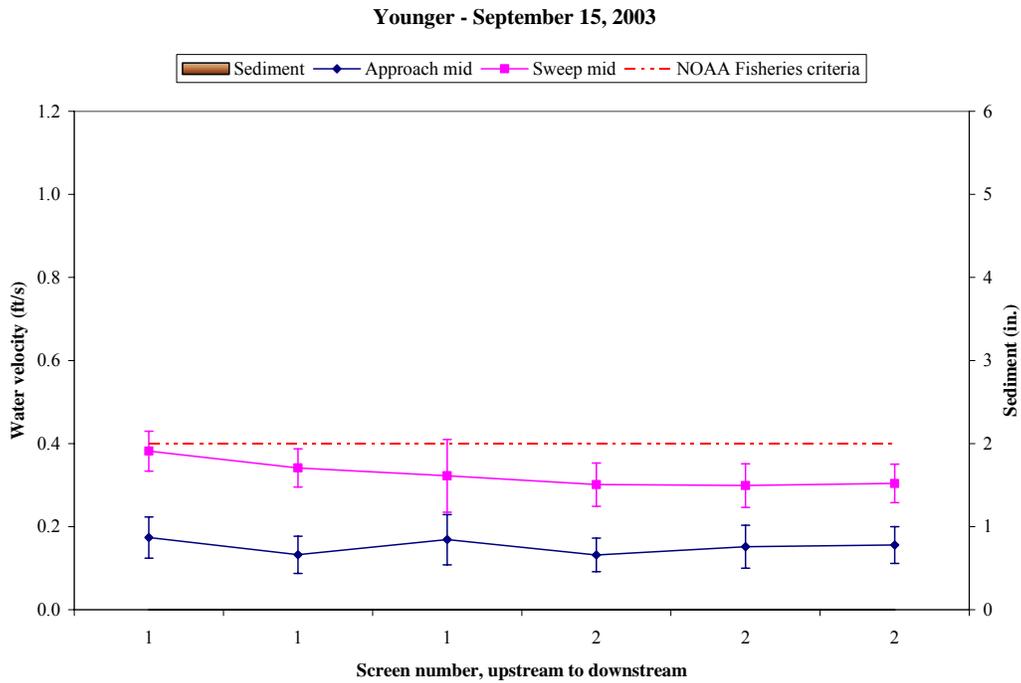
**Figure 67.** Water Velocities at Younger in September 2003. Error bars show turbulence ( $\pm$  the root-mean-squared [RMS]) at each point.

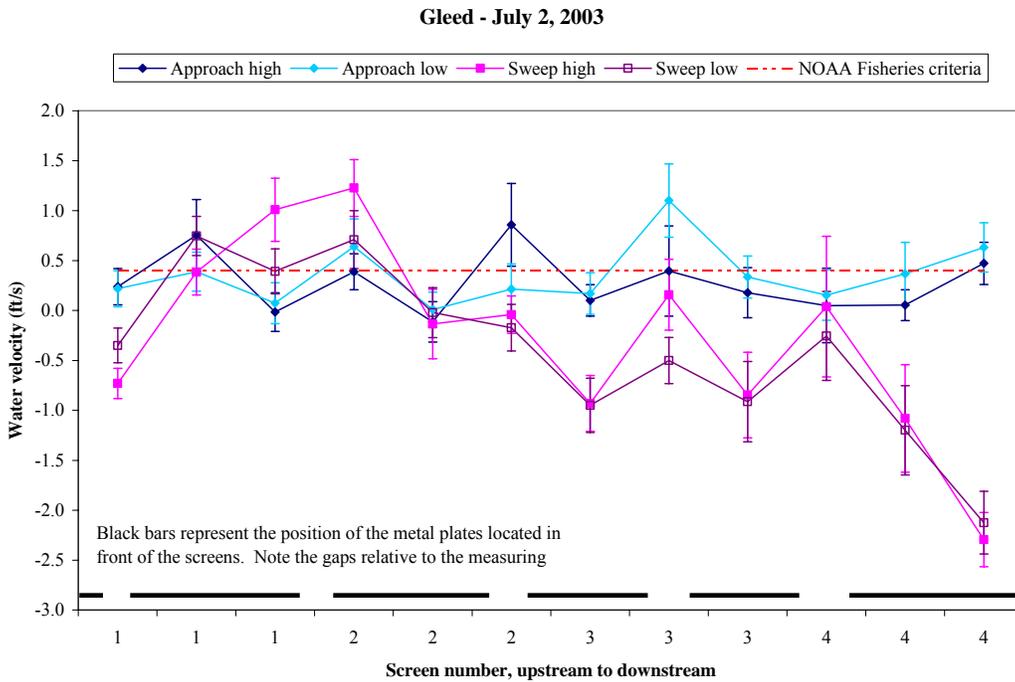
The Gleed site was evaluated on May 13, 2003; July 2, 2003; and September 19, 2003. In May, July, and September, 56%, 75%, and 79% of approach values met NOAA Fisheries criteria of less than or equal to 0.4 ft/s, respectively (Figures 68, 69, and 70). In May, anti-silt boards were positioned in front of screen 1, so no velocity data were taken. Aside from fast water, fish encountering this site also had to deal with highly turbulent water, without a clear trajectory. Sweep velocities were not always greater than approach velocities and did not increase towards the downstream end of the site.

**Figure 69.** Water Velocities and Sediment Depths at Gleed in July 2003. Error bars show turbulence ( $\pm$  the root-mean-squared [RMS]) at each point.

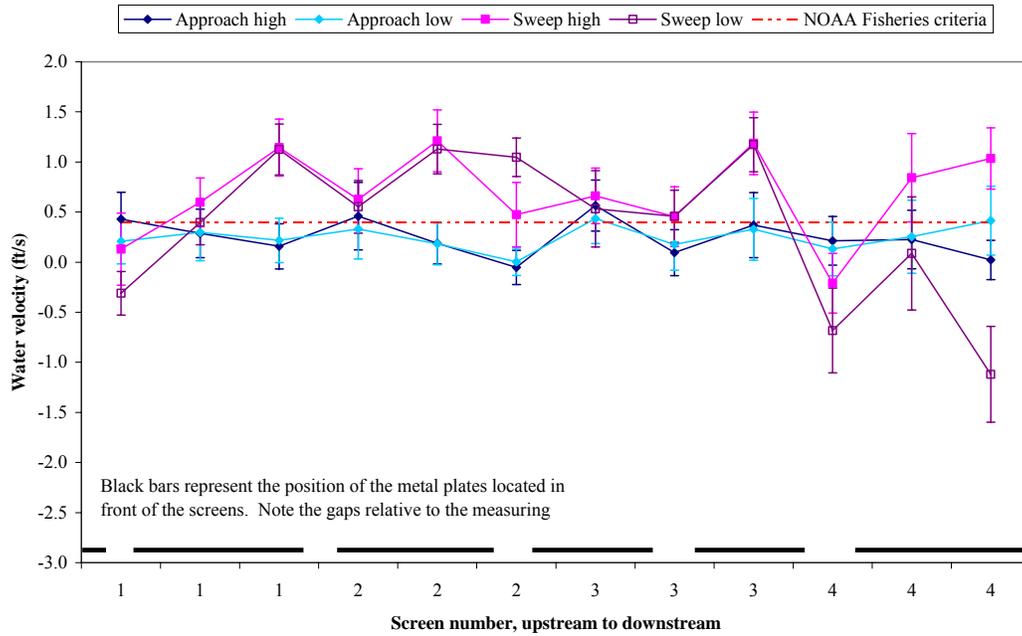
Gleed - September 19, 2003

**Figure 70.** Water Velocities and Sediment Depths at Gleed in September 2003. Error bars show turbulence ( $\pm$  the root-mean-squared [RMS]) at each point.
